Pre-Listing Inspection Report

Property Address:
510 N Market Street
Salem VA 24153

Bateman Home Inspections, LLC

Date: 5/2/2024	Time: 09:00 AM	Report ID: 0524510
Property: 510 N Market Street Salem VA 24153	Customer: Catherine Potter	Real Estate Professional:

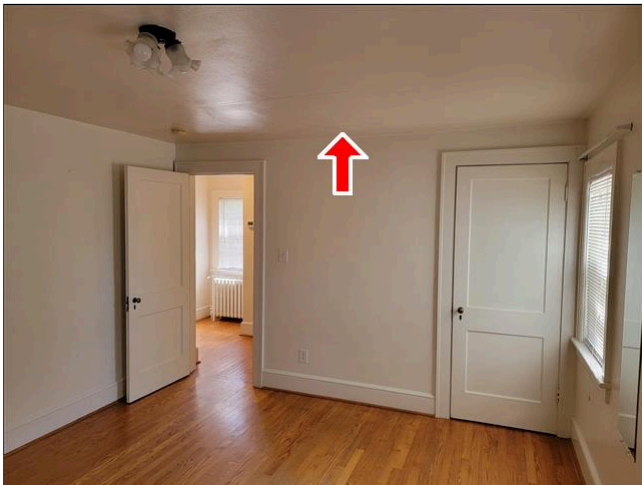
- ☞ Ceiling staining, and mildew/organic growth were observed in areas. No elevated levels of moisture was measured at the time of the inspection. The staining may have been from past condensate drain leaks as the air handler is directly above this location. The mildew may be from the lack of a bathroom exhaust fan. Suggest spraying and wiping mildew surfaces with an approved disinfectant, routine cleaning of the condensate drain, and installing an exhaust fan for the bathroom.

1.0 Item 1(Picture) Upstairs Right Side Bedroom (Staining and Repairs - Air Handler Above)

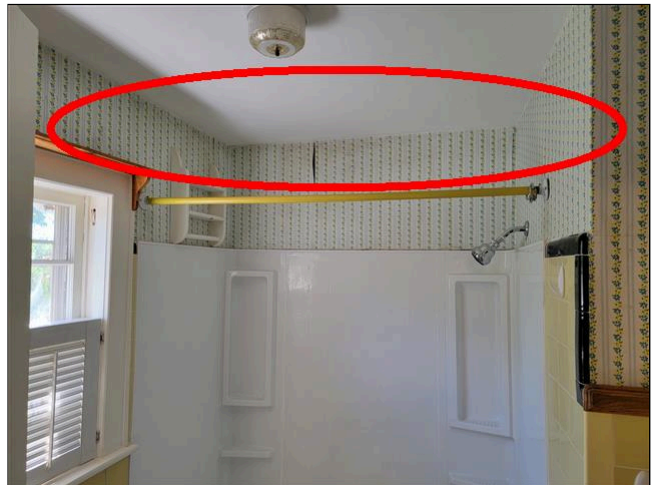
1.0 Item 2(Picture) Mildew (Upstairs Bathroom)

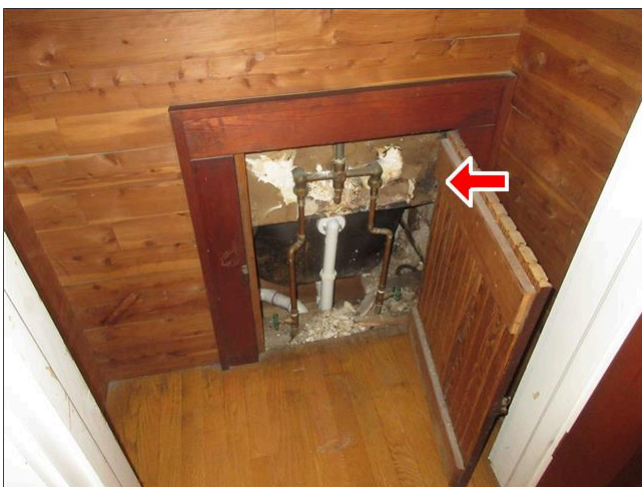
- ☞ (1) Signs of organic growth were observed on the wall surfaces behind the upstairs shower. No sampling was performed. Typically this is a result of reduced air circulation, poor climate control, and past leaks. No elevated levels of moisture was measured at the time of the inspection. Suggest spraying and wiping surfaces with an approved disinfectant and monitoring.

1.1 Item 1(Picture) Organic Growth (Behind Upstairs Bathroom Shower)

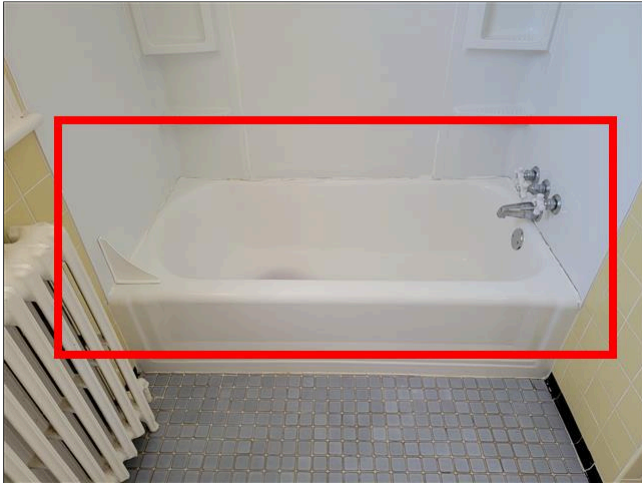
(2) Although typically a maintenance/cosmetic issue, open grout lines and/or open joints were observed around the upstairs bathroom tub. These areas should be sealed to reduce the potential of water intrusion behind surfaces.

1.1 Item 2(Picture) Open Joints

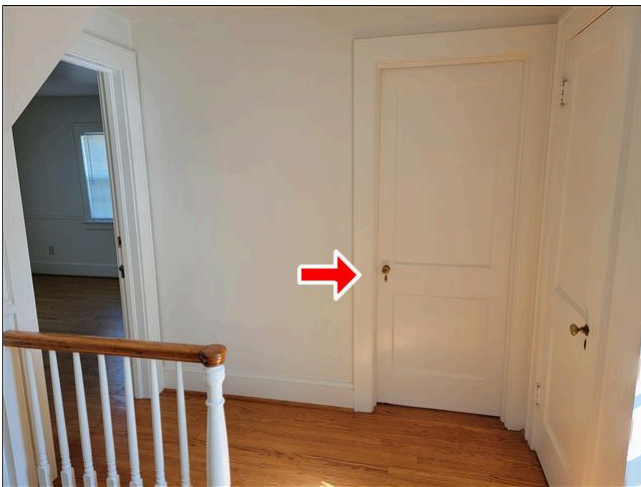
The noted doors were observed in poor closing operation (not latching, or closing). Routine maintenance (strike plate installation/adjustment, and trimming) should correct most observations.

1.5 Item 1(Picture) Upstairs Left Rear Room (Not Latching/Missing Strike Plate)

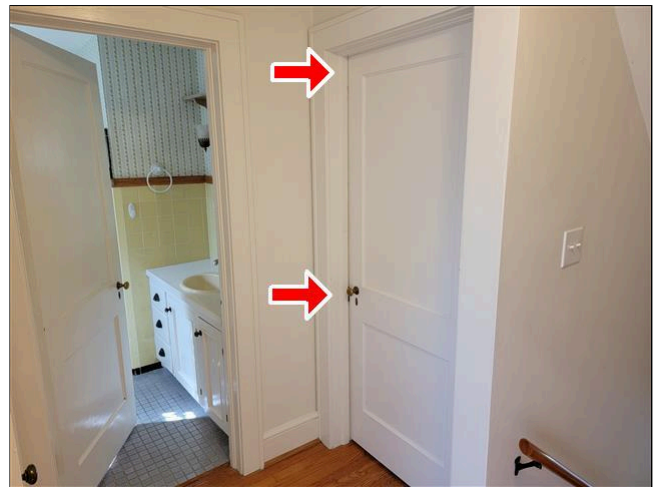
1.5 Item 2(Picture) Upstairs Front Right Bedroom (Not Latching and Jam Contact)

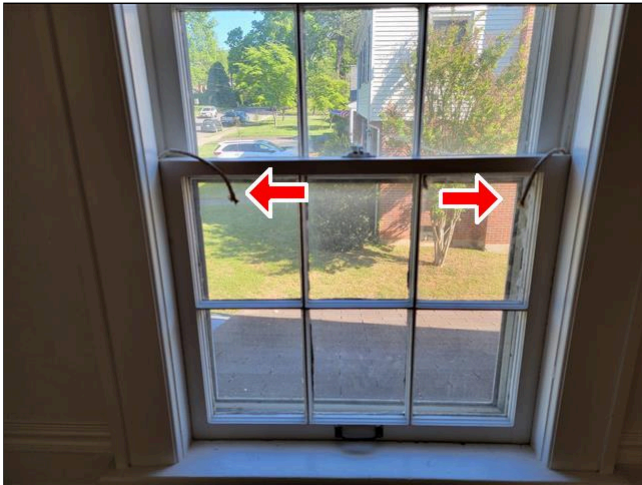
🔑 The windows were observed aged and fragile. Several would not open and many of the rope balances were observed missing/broken. The balance is the device that hold the window in the up position. Faulty or missing balances can allow the window to drop resulting in property damage and personal injury. Inoperable windows pose a safety concern as they impede an emergency exit. Additionally, several had cracked/broken glass, missing lock hardware, and painted shut were the locks will not align. Recommend repair to reduce safety concerns and sealing capacity.

1.6 Item 1(Picture) Broken Balance Cords (Multiple Windows)

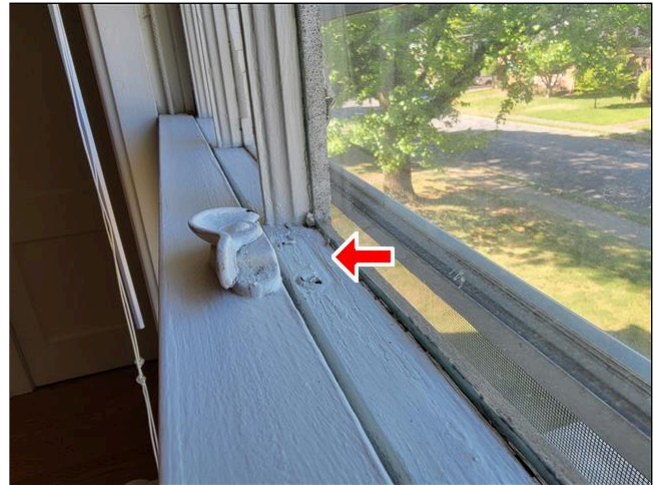
1.6 Item 2(Picture) Missing Lock Hardware (Multiple Windows Including Ground Access)

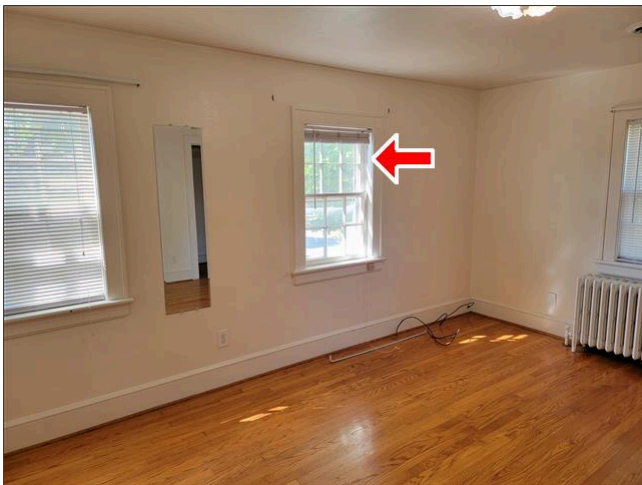
1.6 Item 3(Picture) Cracked Glass (Upstairs Right Bedroom)

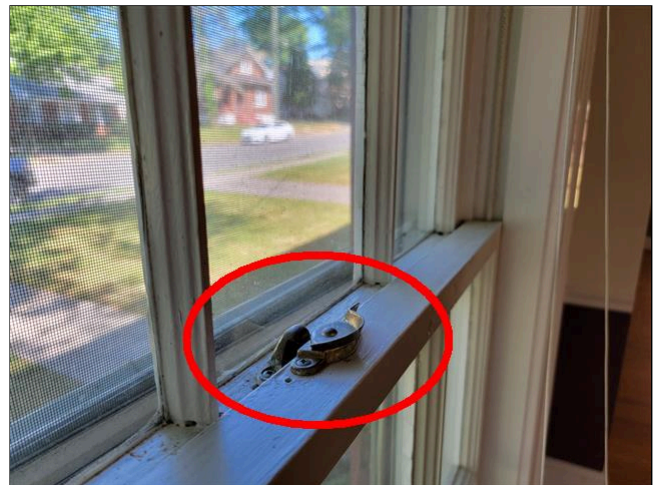
1.6 Item 4(Picture) Locks Don't Align (Multiple Windows)

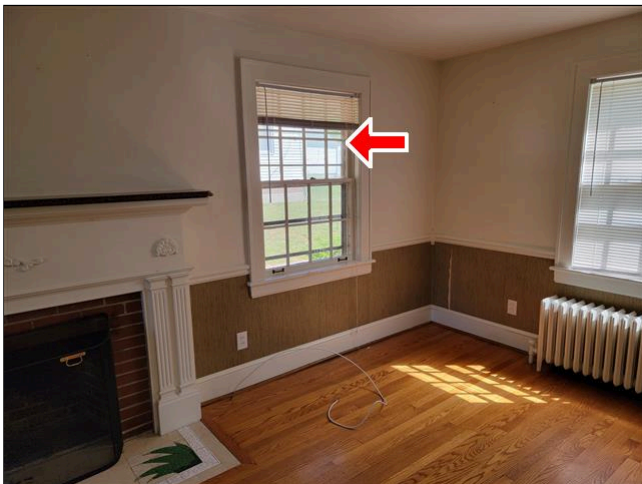
1.6 Item 5(Picture) Cracked Glass (Living Room)

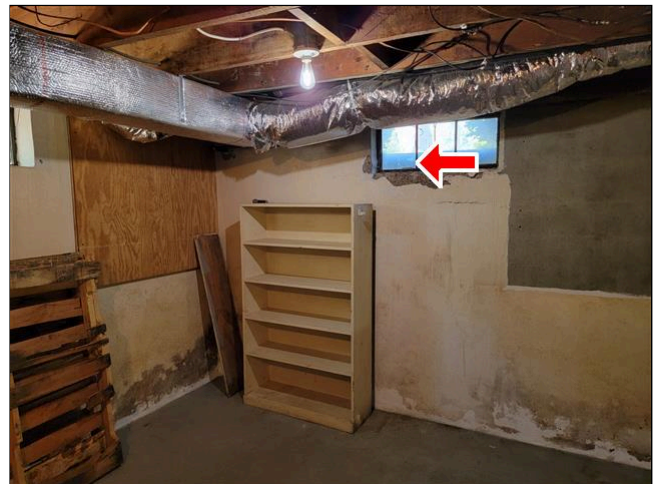
1.6 Item 6(Picture) Broken Glass (Basement)

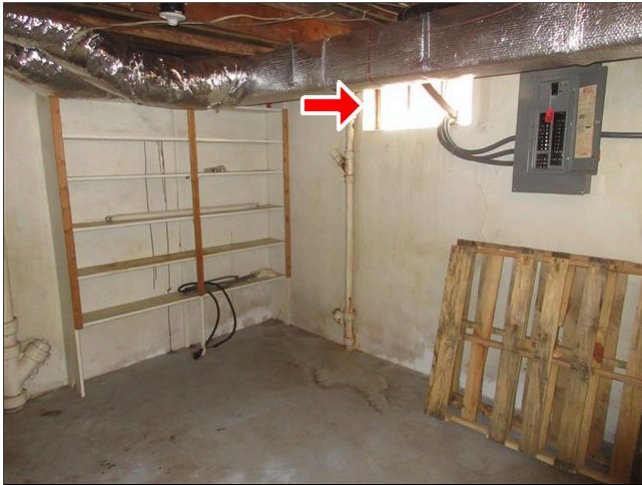
1.6 Item 7(Picture) Cracked Glass (Basement)

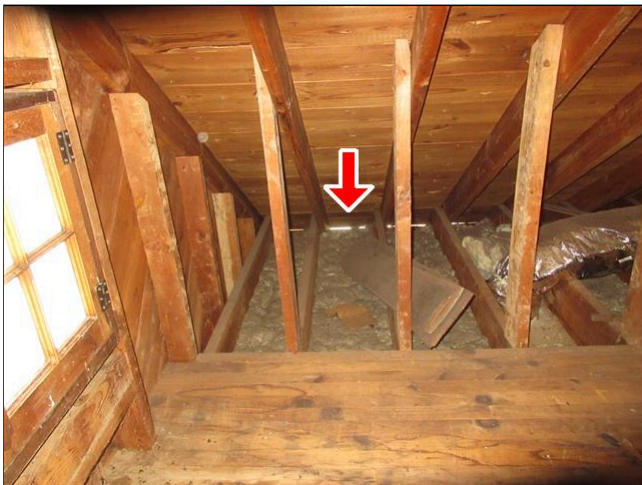
- 🔍 A gap between the fascia and roof sheathing exists which can allow potential insects or bees to enter attic area. Several small bee hives were observed. No active bees were noted at the time of the inspection. This appears to be from the lack of a drip edge around the perimeter of the roof. Suggest sealing any openings or installing a drip edge, and monitoring to eliminate nesting potential.

1.7 Item 1(Picture) Gap (Around Perimeter)

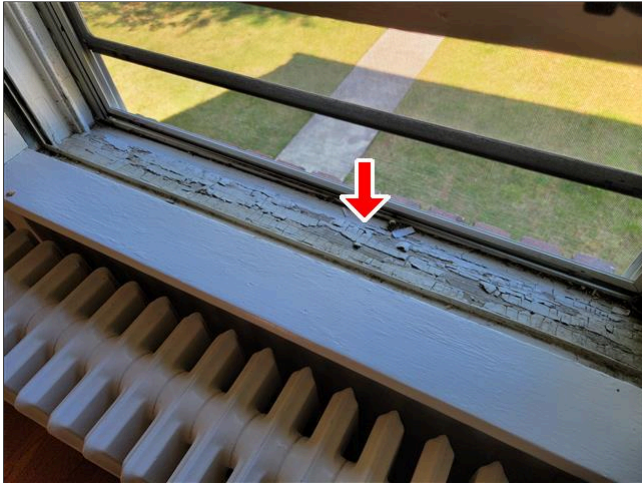
- (1) Peeling paint chips were observed at most window sills throughout the home. Due to the age of the home this could be an indication of lead based paint which is consist with the construction era. Suggest removing loose pieces and sealing.

1.8 Item 1(Picture) Peeling Paint Chips (Most Window Sills)

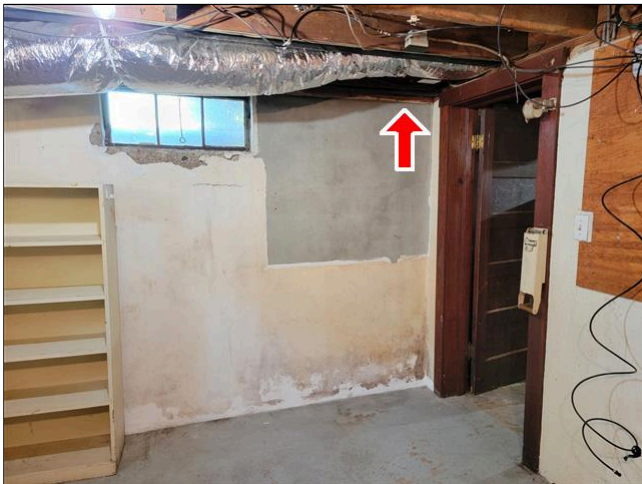
- (1) What appeared to be insect damage was observed in areas of the rim joist and sill plate. No active insects were observed at the time of the inspection. Suggest having a qualified contractor inspect and advise if any insect treatment is necessary. Recommend having a qualified contractor further inspect the framing and repair any damaged areas as needed.

1.9 Item 1(Picture) Rim Joist Damage (Basement Front Wall)

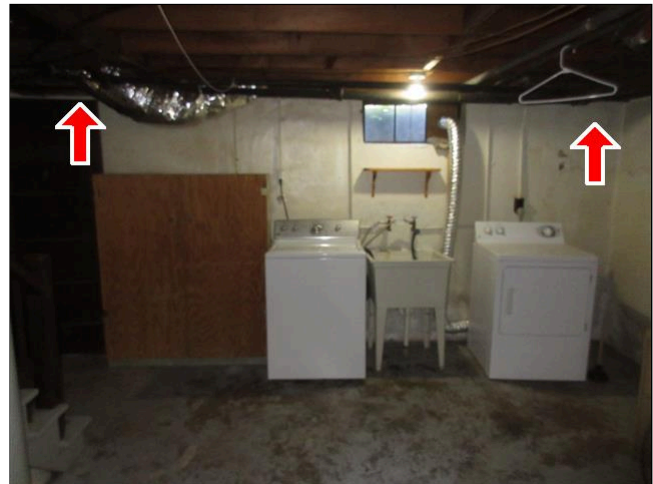
1.9 Item 2(Picture) Rim Joist Damage (Basement Front Wall)

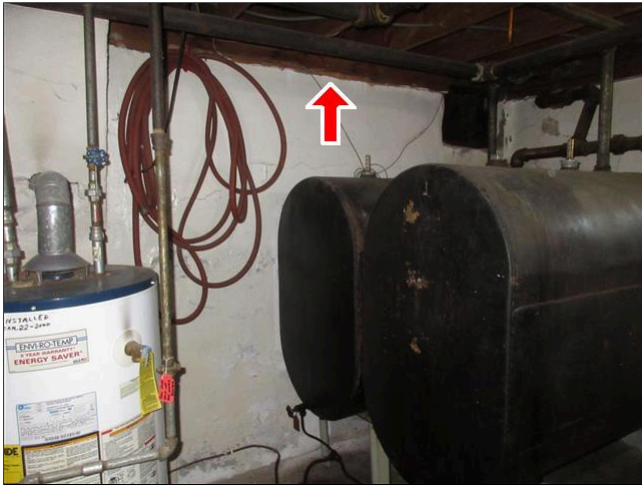
1.9 Item 3(Picture) Sill and Rim Joist Damage (Left Wall)

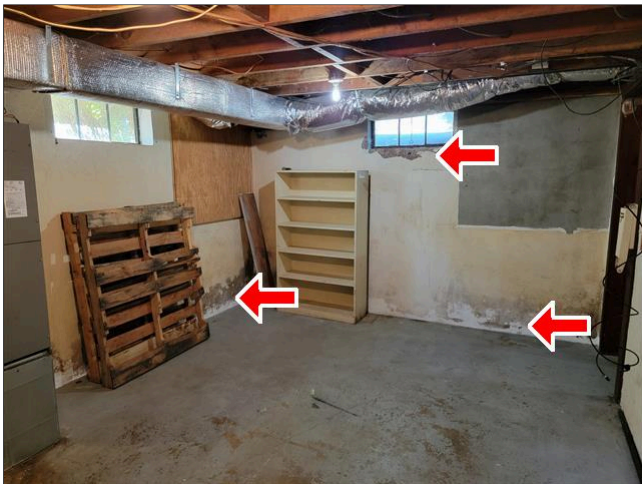
(2) Although no active water was observed in the basement at the time of inspection, historical indications of water intrusion were noted (staining, foundation spalling, and organic surface growth). The spalling indicates water has been in contact with the masonry. It is not uncommon for older foundations to leak under certain rain event conditions. If this occurs, improper exterior grading against the home and clogged or improperly discharging gutters are almost always the cause. Poor exterior siding conditions (openings) can also allow water intrusion at above grade locations. Signs of what appeared to be mildew/organic surface growth was also observed and may be related to past water intrusion events. No sampling was performed. This is also common when the home has been vacant for a period of time as a result of reduced air circulation, poor climate control, and moisture. Suggest spraying and wiping surfaces with an approved disinfectant. Restoring home use and the introduction of a dehumidifier will significantly reduce surface contamination. If leaking occurs, recommend having a qualified contractor further evaluate and advise corrective actions as needed.

1.9 Item 4(Picture) Staining, Spalling and Mildew/Organic Growth (Multiple Areas)

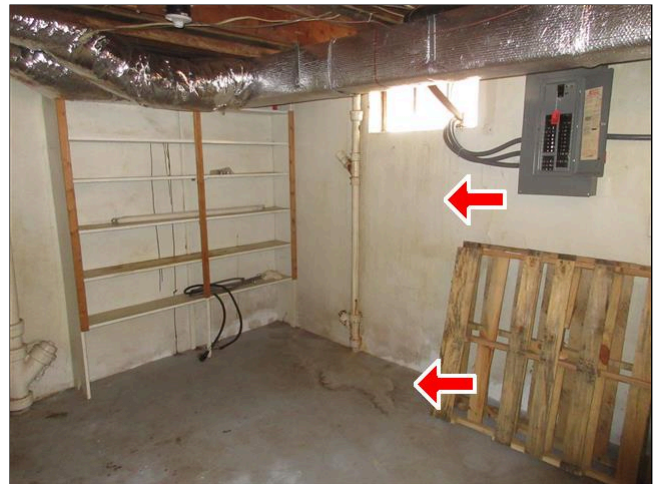
1.9 Item 5(Picture) Staining and Spalling

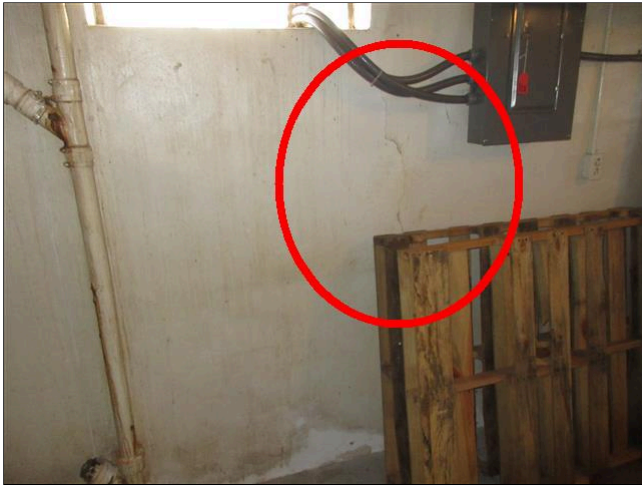
1.9 Item 6(Picture) Spalling/Cracking

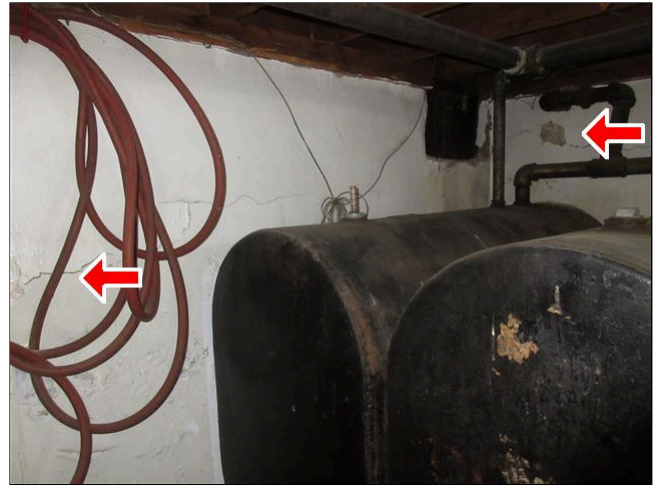
1.9 Item 7(Picture) Spalling/Cracking

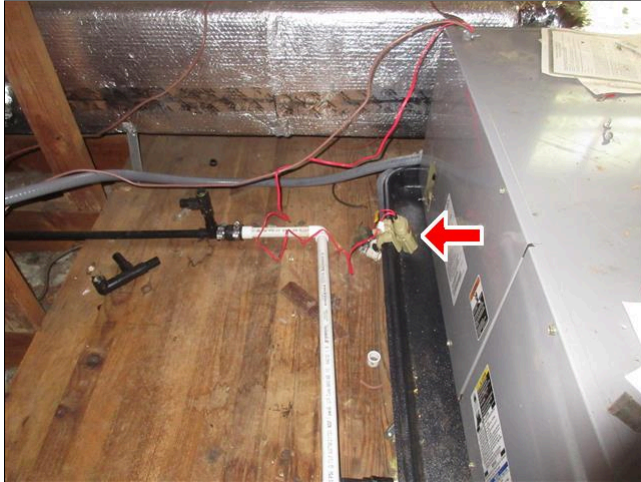
Condensate overflow detection controls were observed but are not activated. They are inspected for necessity, presence, completeness and lack of damage. Identified for reference.

2.9.A Item 1(Picture) Pan Switch (Attic Air Handler)

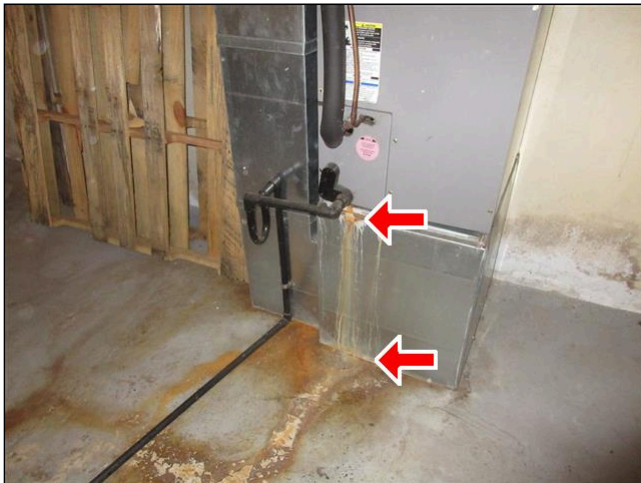
Staining was present below the condensate drain on the basement air handler. Suggest routine cleaning of the drain and monitoring.

2.2.B Item 1(Picture) Staining

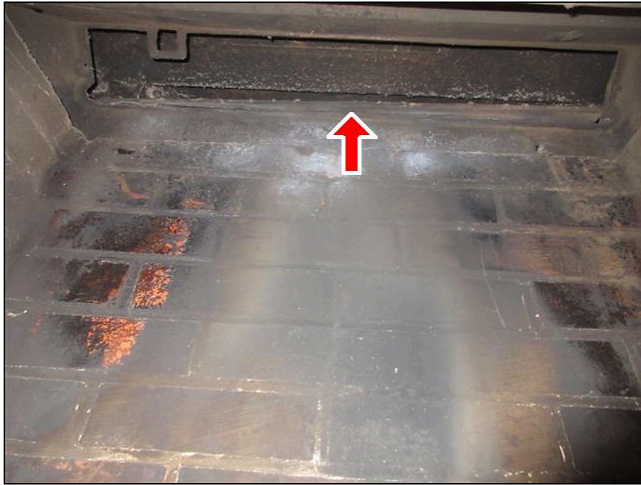
The living room chimney appeared to be in good condition but was only partially viewed from the damper area. Additionally, the damper was missing. As a full evaluation of the flue is outside the scope of a home inspection, suggest having a qualified contractor clean and perform a Level 1 chimney inspection prior to any use as a wood burning unit to ensure safe and proper operation.

2.5.B Item 1(Picture) No Damper (Living Room)

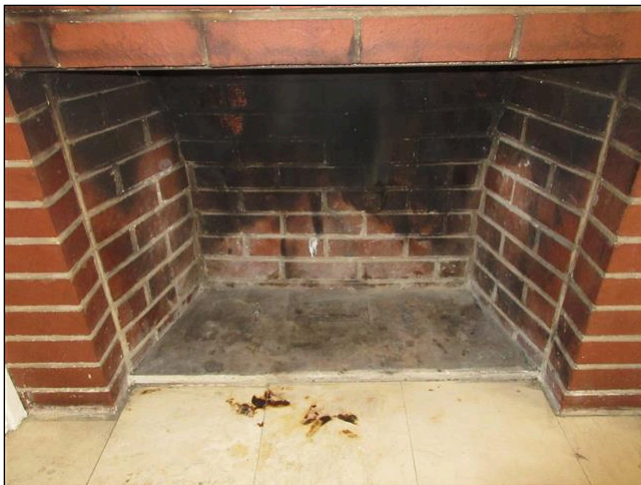
- Minor mortar deterioration/ open joints were observed in the living room firebox. A gas log unit can be installed and utilized. Suggest having a qualified contractor fully inspect and repair as necessary the firebox prior to any use as a wood burning unit to ensure safe and proper operation.

2.6.B Item 1(Picture) Cracking and Open Joints (Living Room Fireplace)

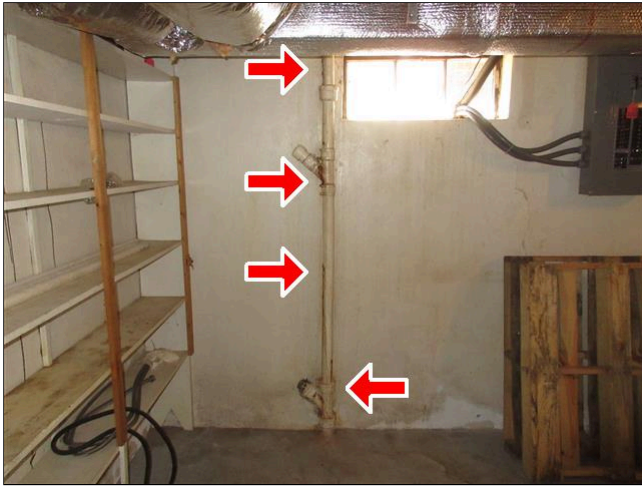
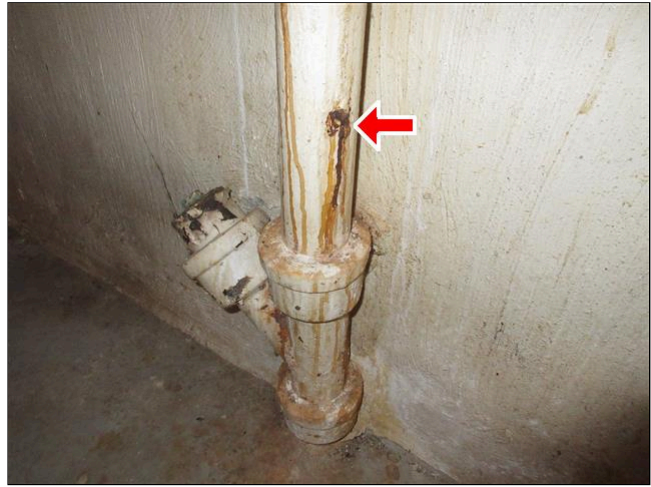
(1) A cast iron waste line has areas of deterioration and indications of leaks. Recommend having a qualified contractor further evaluate and replace to reduce future leaks.

3.0 Item 1(Picture) Waste Line Deterioration and Staining

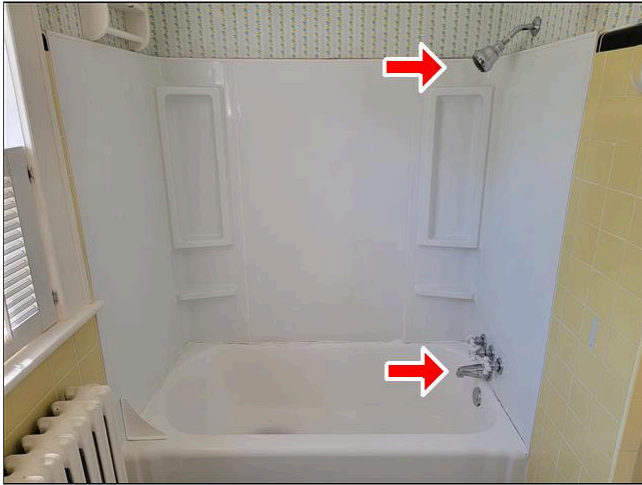
- (1) The water pressure for the upstairs bathroom shower only was over-all weak and did not pass a "functional flow." This is determined by running water in the highest bathroom sink and shower while the toilet is flushed. If shower spray remains reasonable, the pressure system is deemed acceptable. Recommend having a qualified contractor evaluate the pressure system and correct as necessary

3.1 Item 1(Picture) Upstairs Shower Water Pressure

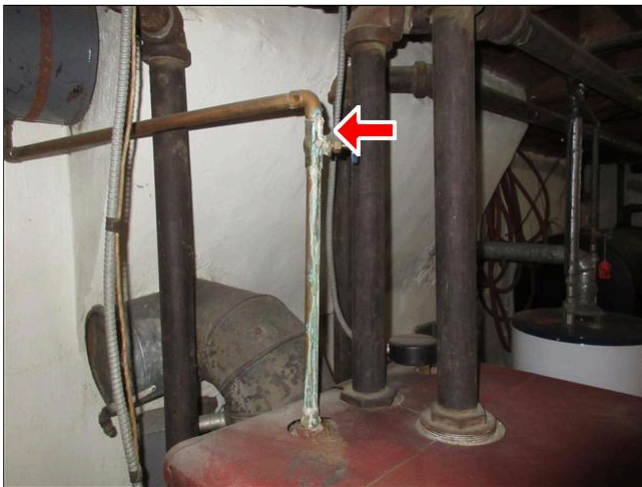
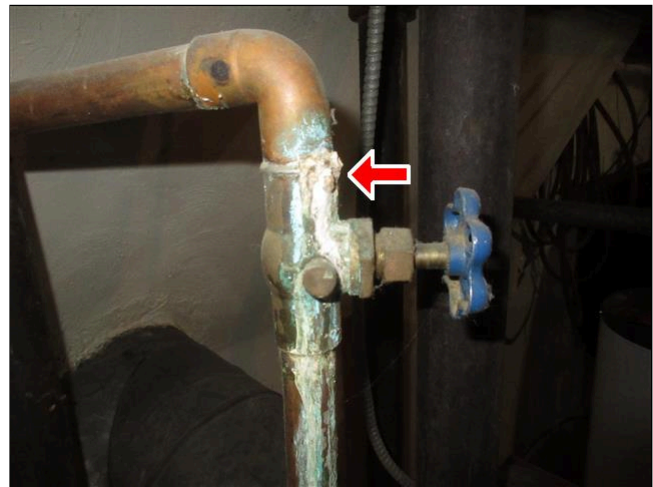
- (1) A leak was observed at a connection above the old oil fired boiler in the basement. Recommend having a qualified contractor further evaluate and repair.

3.2 Item 1(Picture) Active Leak

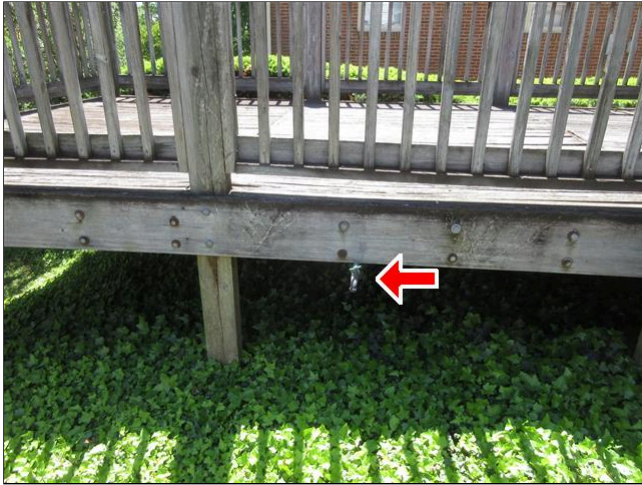
3.2 Item 3(Picture) Rear Deck

(2) The noted hose bibbs were off. This may be for winterization.

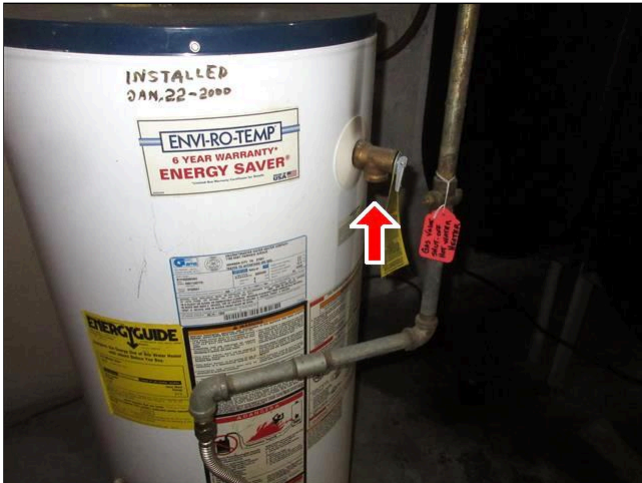
- (1) No temperature / pressure (T&P) relief valve discharge pipe was observed attached to the water heater at the time of inspection. The T&P relief valve on the water heater is designed to safely discharge hot water in the event of a water heater failure. A 3/4" discharge pipe is required to safely direct the discharging hot water to within 6" of the floor. Suggest installation of a discharge pipe.

3.3 Item 1(Picture) No Discharge Tube

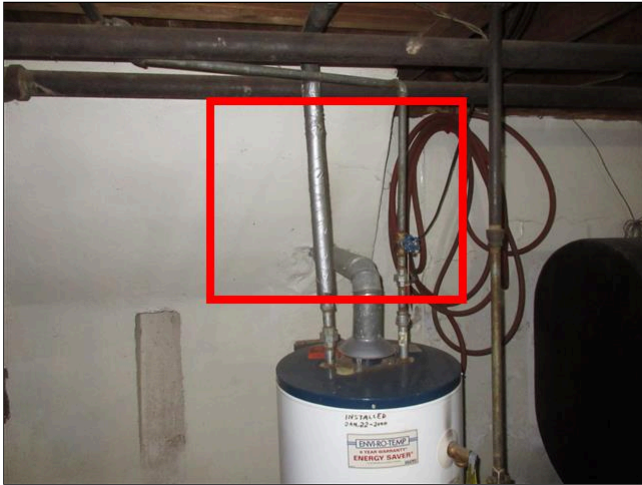
(2) The homes water supply is delivered by a city water main. Typically a back flow preventer will be present at the meter. This provides a hard stop preventing house water from flowing back into the city water main. This feature in combination with the ability of the homes gas water heater to quickly heat water can cause excess pressure to develop in the homes water supply system. Excess pressure will leak out of the water heater temperature and pressure (T&P) relief valve. This valve is designed for release of pressure as an emergency safety feature and not for sporadic operation. To prevent sporadic valve operation, a thermal expansion tank is used to absorb the excess pressure. Although no expansion tank was observed, the valve appeared stable and not leaking. If the valve begins to leak, suggest having a qualified contractor evaluate and advise on the installation of an expansion tank. Identified for reference only.

3.3 Item 2(Picture) Typical Expansion Tank Location

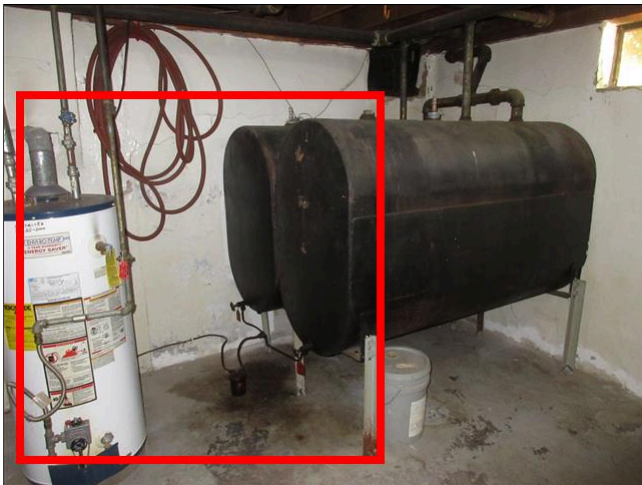
The gas fired water heater has been installed in close proximity to the oil tanks that currently have oil in them, per the gauges on the tanks. This creates a safety hazard for combustible materials located in close proximity to an active flame. Suggest having tanks emptied to reduce the concerns.

3.4 Item 1(Picture) Water Heater and Oil Tanks

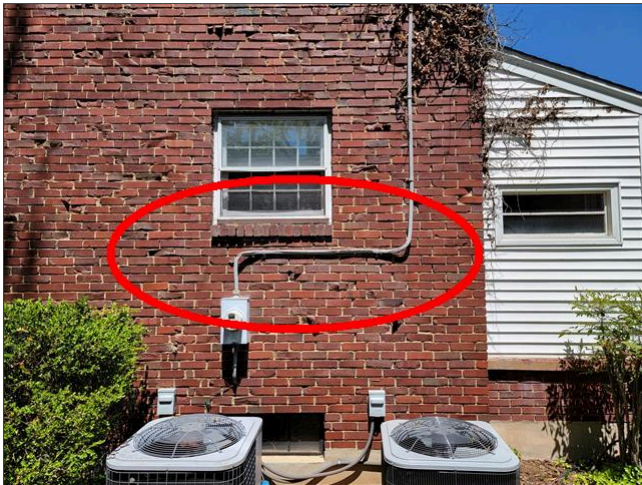
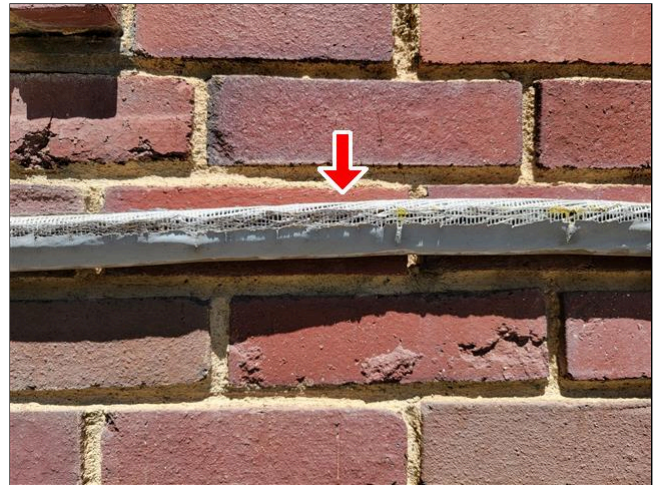
**The electrical service entrance conductor sheathing was observed deteriorated. This has allowed moisture to enter the electrical meter and distribution panel resulting in corrosion on the main lugs and the bottom of the panel. Recommend having a qualified contractor evaluate and repair as necessary.**

4.1 Item 1(Picture) Deteriorated Sheathing

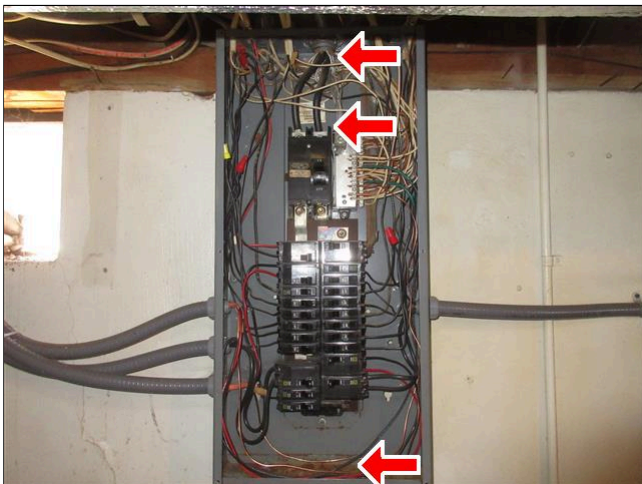
4.1 Item 3(Picture) Staining/Corrosion

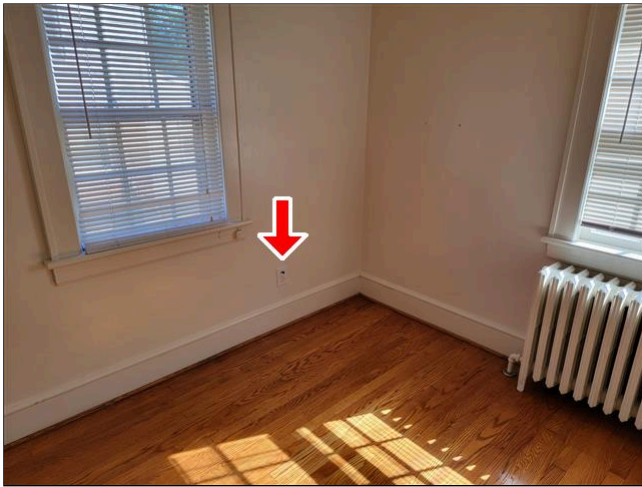
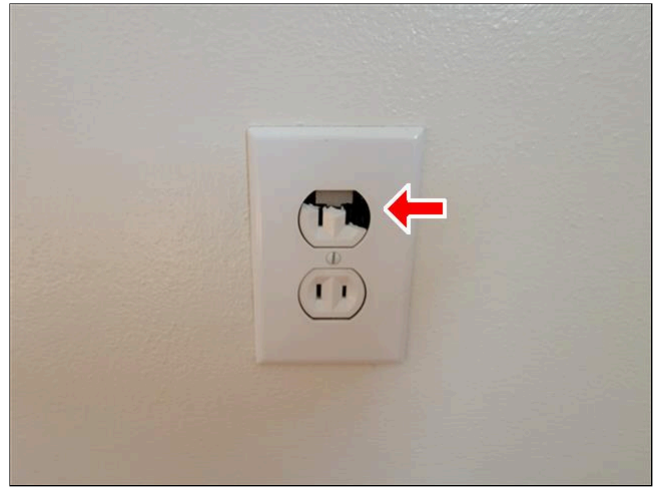
A broken outlet, and a seized light fixture pull chain was observed. A broken outlet creates a potential safety concern for direct access to active electrical components. Suggest replacing the outlet, and the

4.4 Item 1(Picture) Broken Outlet (Upstairs Left Rear Room)

light fixture to reduce the safety concern and restore normal use.

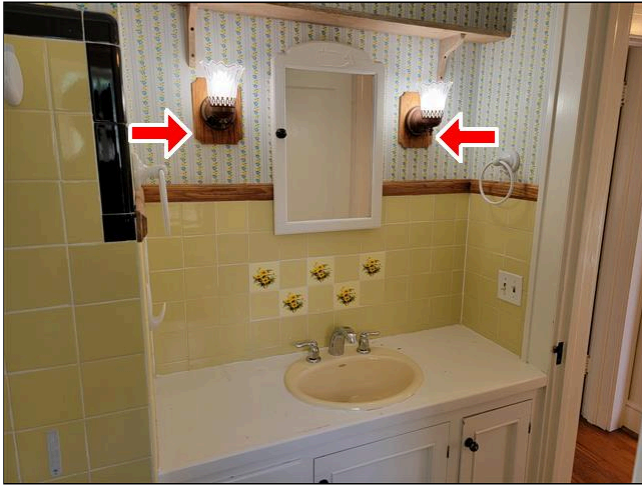
(1) Although the noted outlet(s) are grounded, outlets near water sources pose an increased shock concern. GFCI devices provide additional electrical safety in these locations. GFCI devices were not required when the home was built. Suggest upgrading noted outlets or circuit to improve electrical safety.

4.5 Item 1(Picture) Upstairs Bathroom Outlets

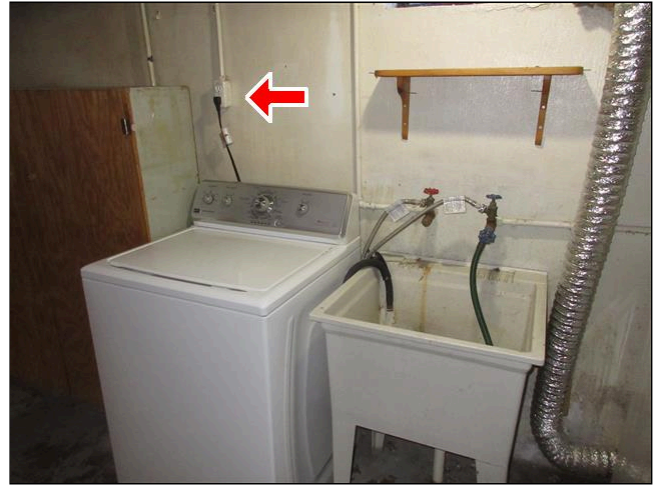
4.5 Item 2(Picture) Basement Laundry Area

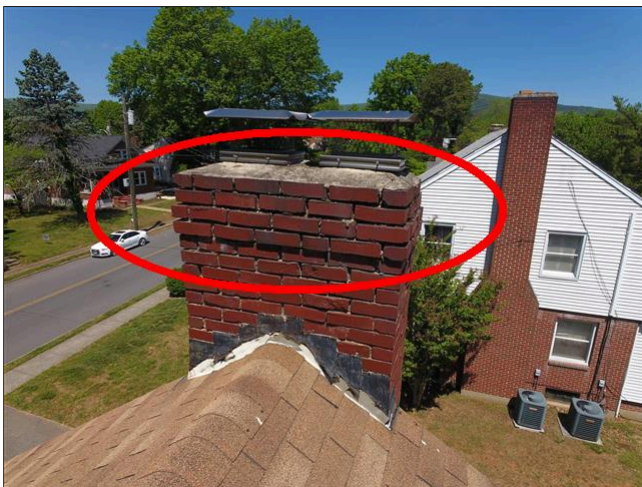
Mortar deterioration was observed in areas. This is common when the chimney is no longer used or has been abandoned. Suggest re-pointing of mortar joints to eliminate the potential of future deterioration.
-

6.6 Item 1(Picture) Mortar Joint Deterioration

Recommend having a qualified contractor further evaluate and repair as necessary.

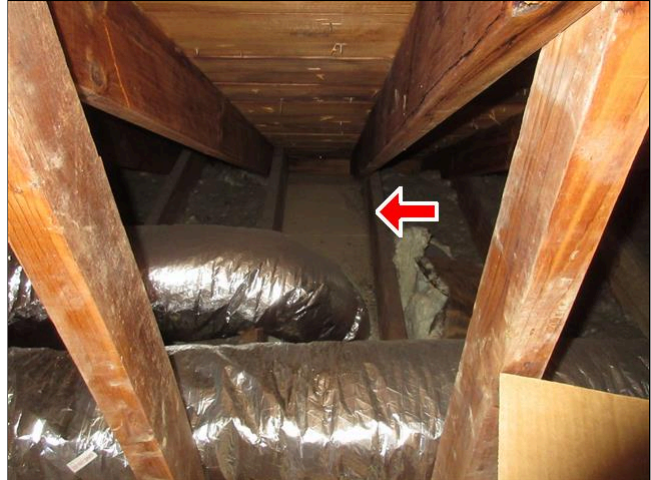
- 🔍 Although acceptable at the time of construction, observed insulation thickness is inadequate by current standards. Installation of an additional 6"-8" of insulation will reduce the thermal transfer between conditioned and unconditioned spaces.

7.0 Item 2(Picture) Little Insulation and Missing Insulation

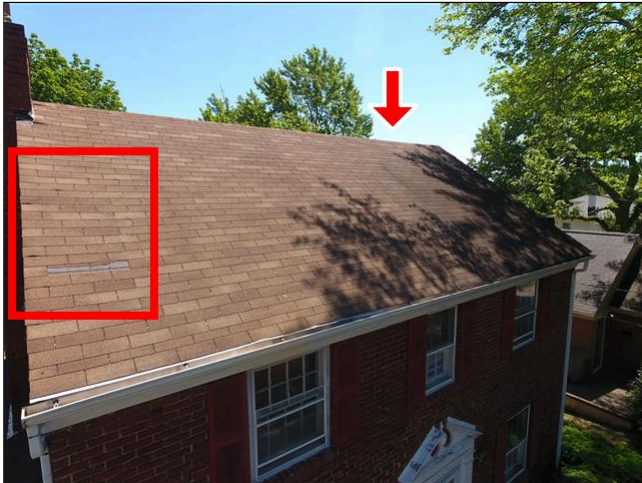
The shingles were observed in worn condition. They were mostly flat and adhered but the edges have thinned, exposed nail heads were visible, areas were damaged with openings to the attic along with visible staining, and minor wind lift damage was noted. As the shingles appear to be at the end of their typical life expectancy, suggest having a qualified contractor further evaluate and advise.

8.0 Item 1(Picture) Wind Lift Damage, Exposed Nail Heads, Nail Pops, and Shingle Damage

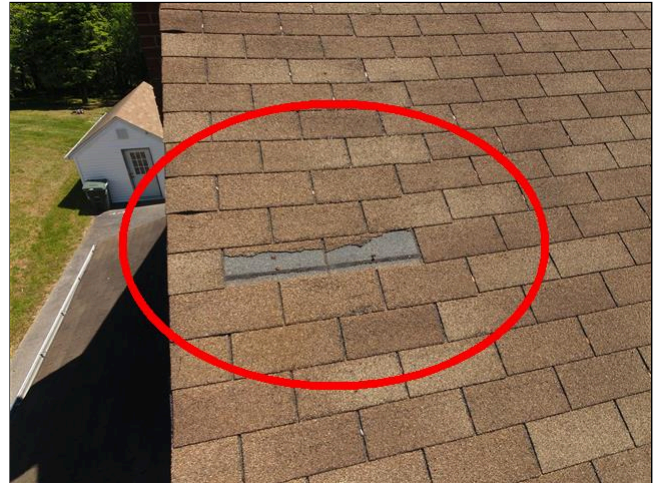
8.0 Item 2(Picture) Additional View

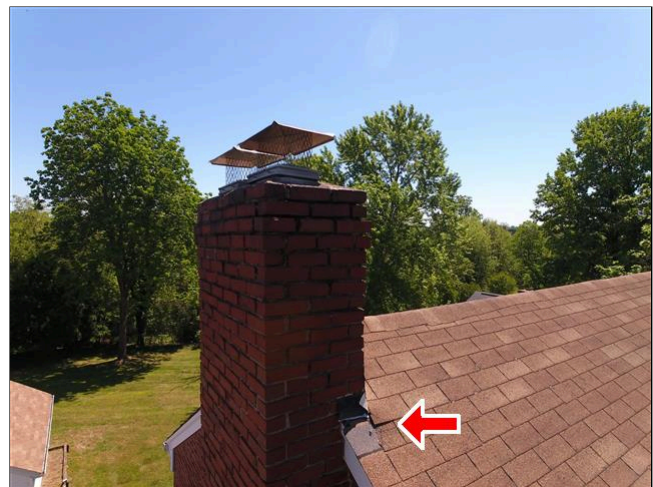
8.0 Item 4(Picture) Missing Flashing, Wind Lift Damage, Exposed Nail Heads and Exposed Roof Sheathing/Framing (Around Chimney)

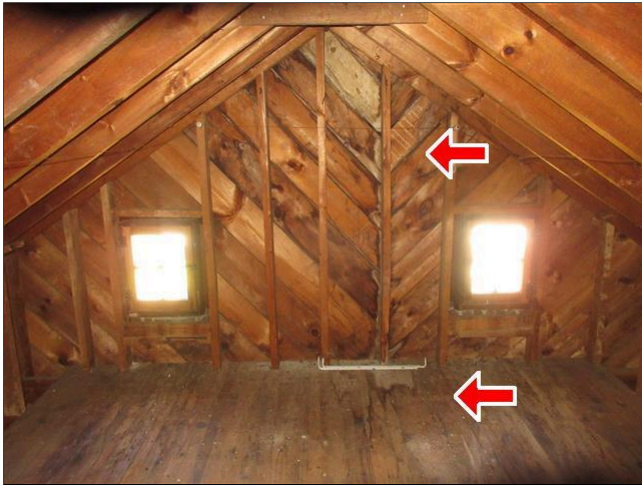
8.0 Item 5(Picture) Staining (Chimney Side)

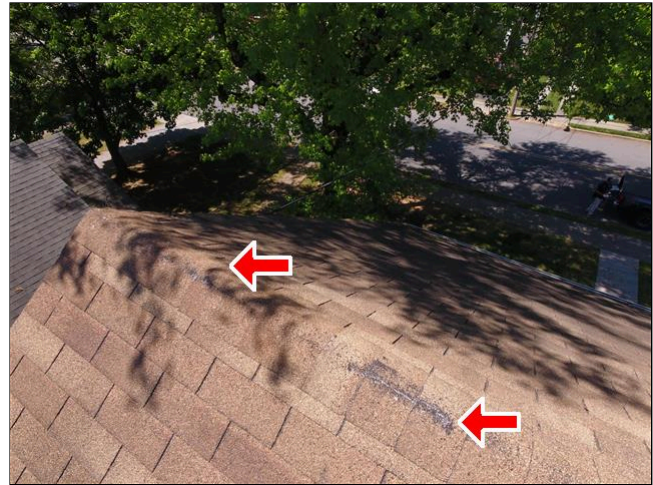
8.0 Item 6(Picture) Ridge Shingle Damage

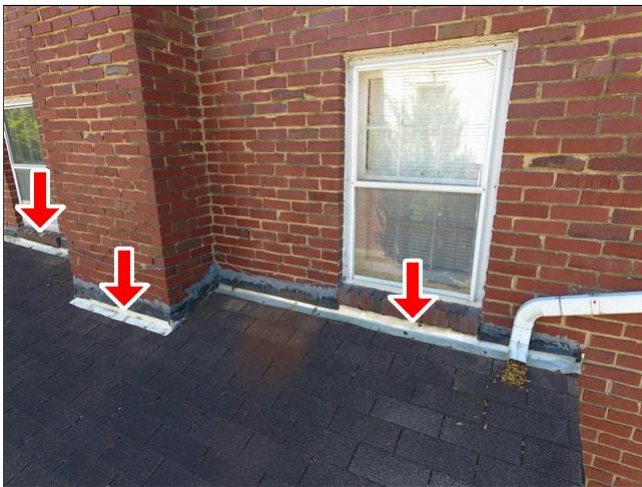
8.0 Item 7(Picture) Exposed Nail Heads (Sidewall Flashing)

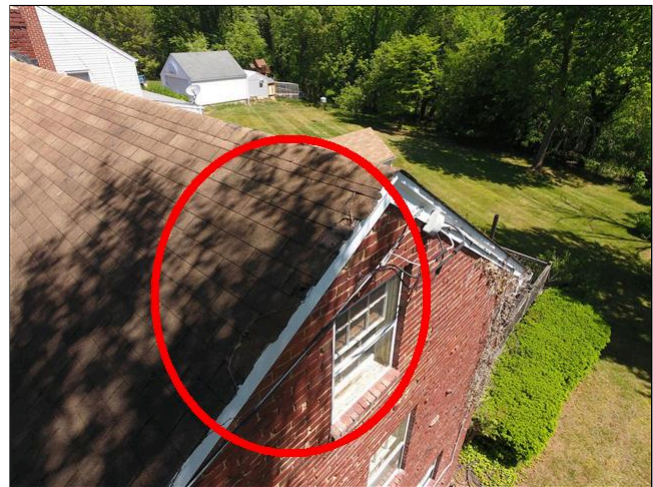
8.0 Item 8(Picture) Damaged Shingles and Exposed Roof Sheathing (Front Right)

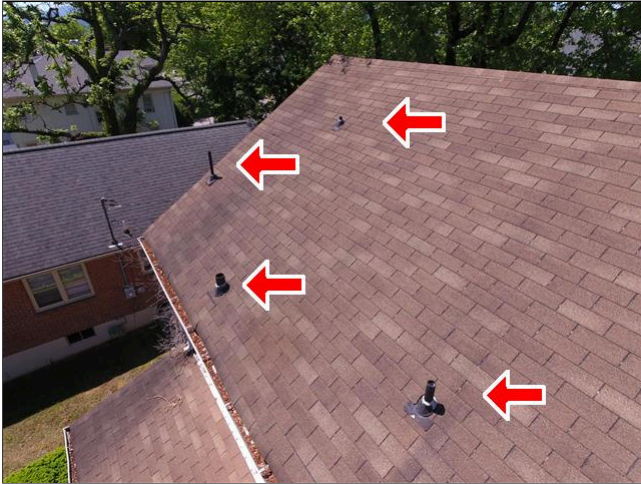
🔍 The plumbing vent pipe flange seals were observed covered in temporary sealant that is failing along with openings. This can allow potential moisture intrusion into the attic. The installation of a boot cover or replacing the vent pipe seals would be an improvement of the current configuration. Recommend having a qualified contractor evaluate and replace or repair seal as necessary. Additional sealant is not recommended.

8.2 Item 1(Picture) Vent Pipes

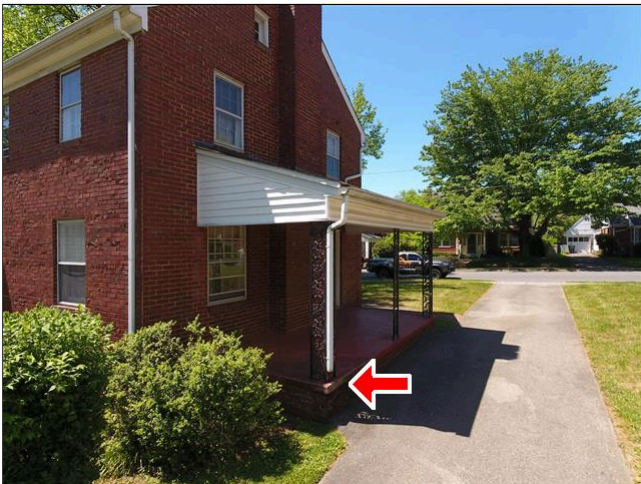
Although the gutters appear intact and complete, they were observed discharging at the foundation. Downspouts should discharge water 4'-6' away from the foundation. Due to the lack of rain during the inspection, gutter functionality was not determined. Suggest installation of downspout leaders, and monitoring gutter function during a moderate rain event to identify if any sections need slope adjustments.

8.3 Item 1(Picture) Left Discharge (Mortar Deterioration)

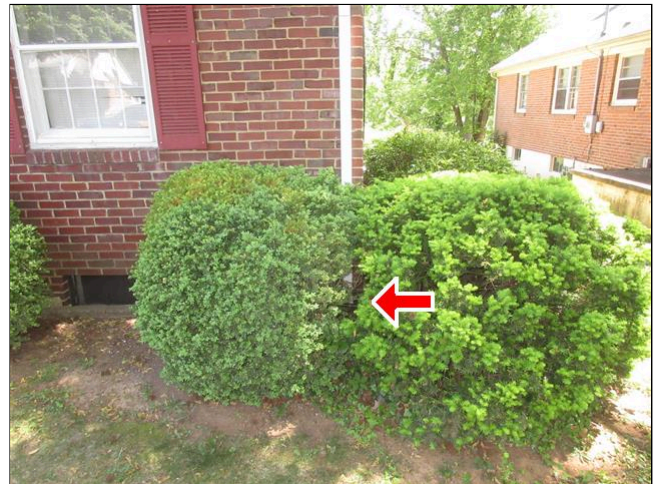
8.3 Item 2(Picture) Front Right Discharge

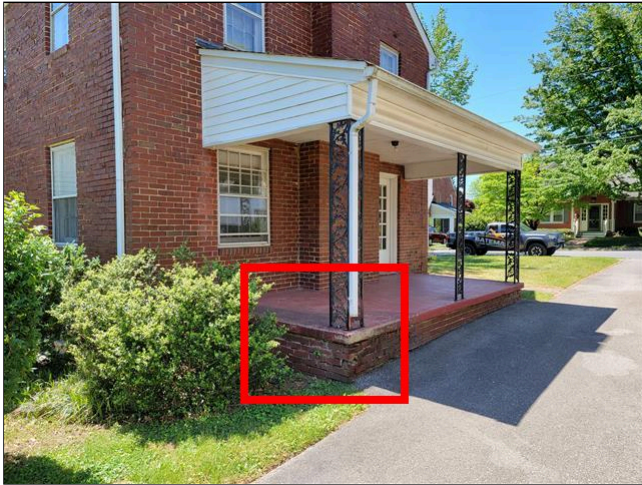
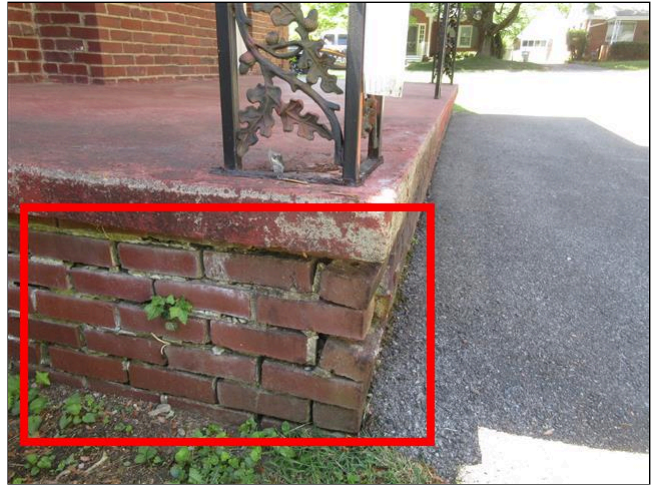
Although typically maintenance related and/or cosmetic issues, open joints, and un-painted or peeling painted surfaces on the exterior of the home can lead to premature decay. Exterior paint is liquid siding that protects the wood from weather. Suggest sealing any open joints (around windows, doors, thresholds, and trim/siding), repairing any damaged areas, and painting any exposed surfaces as needed to reduce the decay potential.

9.0 Item 1(Picture) Mortar Deterioration and Loose Bricks (Left Side)

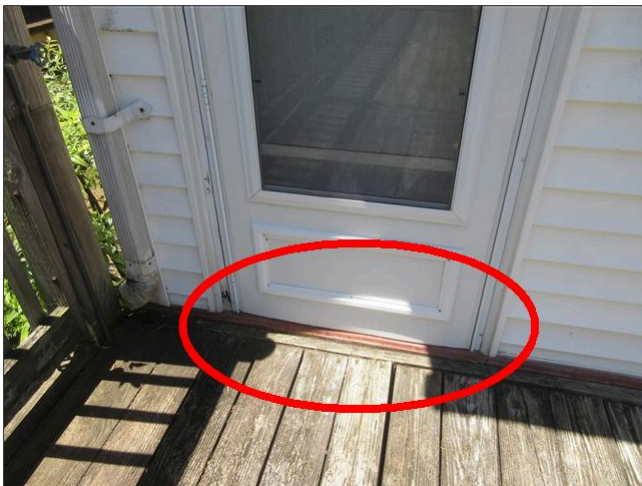
9.0 Item 3(Picture) Openings and Deterioration (Rear)

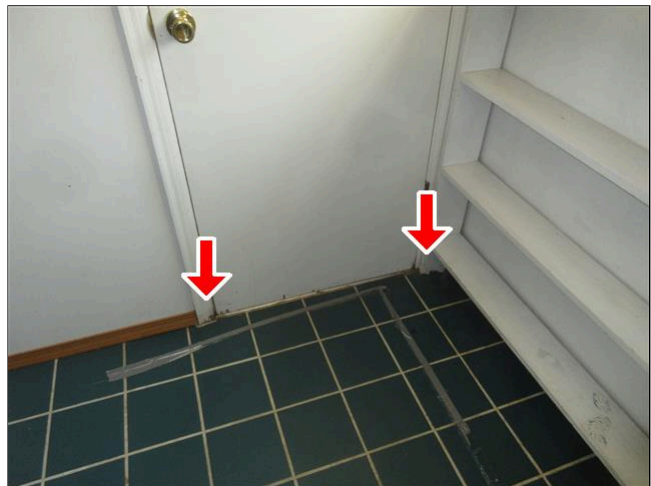
9.0 Item 4(Picture) Interior Staining (Rear Entrance)

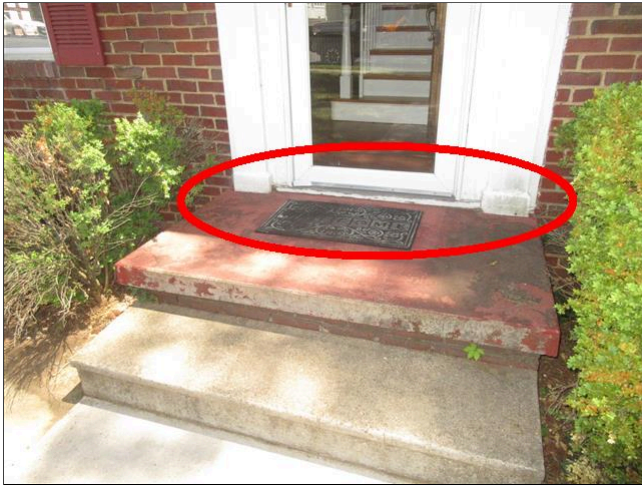
9.0 Item 5(Picture) Open Joints (Around Front Entrance)

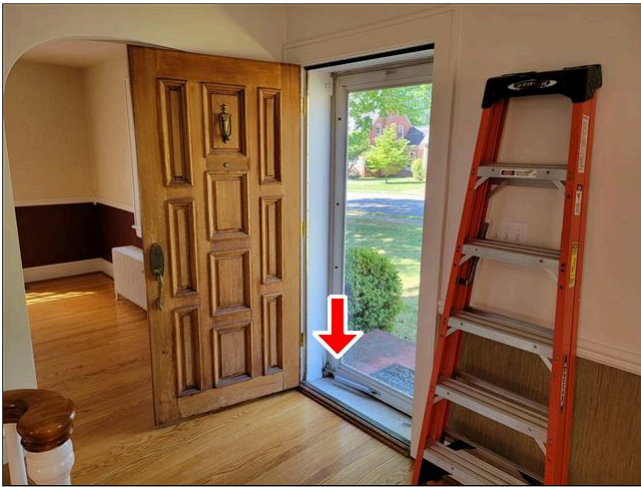
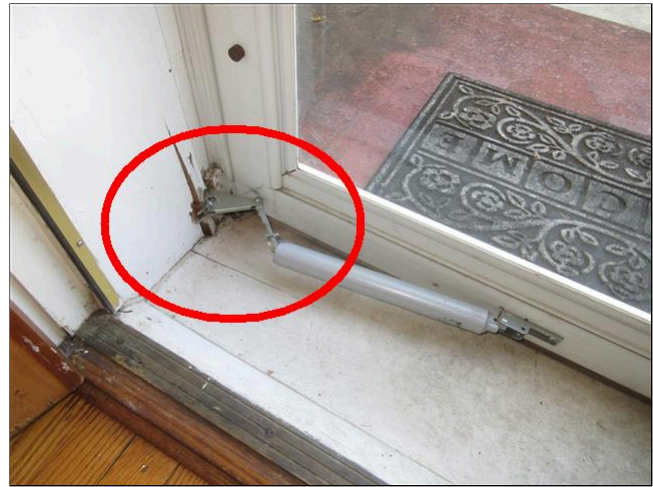
🔍 (1) The front storm door closer was damaged. Recommend replacement to restore normal use.

9.1 Item 1(Picture) Damaged Closer (Front Storm Door)
