Pre-Listing Inspection Report

Property Address:
510 N Market Street
Salem VA 24153

Bateman Home Inspections, LLC

Date: 5/2/2024	Time: 09:00 AM	Report ID: 0524510
Property: 510 N Market Street Salem VA 24153	Customer: Catherine Potter	Real Estate Professional:

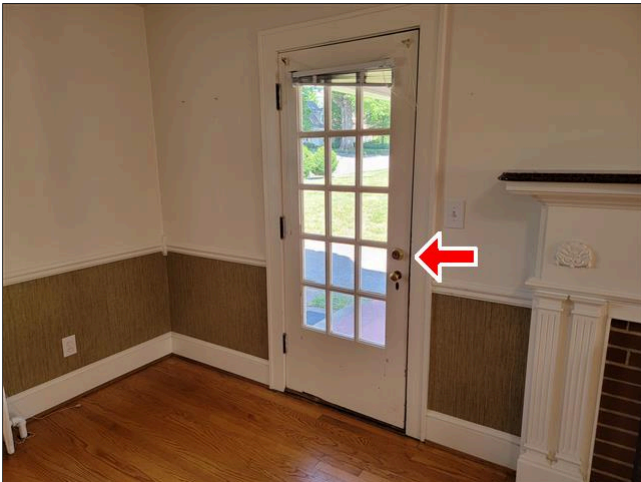
9.1 Item 3(Picture) Left Side

(2) A double cylinder (keyed both sides) lock was observed on the noted exterior entry doors. This is a potential safety concern as it can impede an emergency exit. Although not required, suggest replacing double cylinder locks with single cylinder lock as needed.

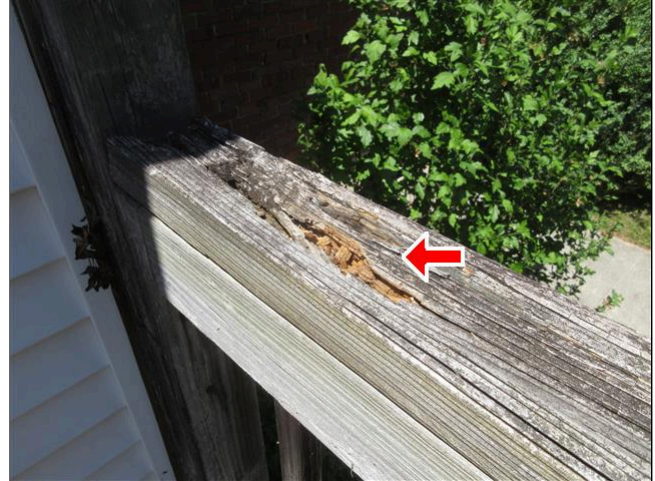
🔍 Although the deck appears to be structurally stable, common exposure related dry rot and deterioration was observed in all of the horizontal deck surfaces (decking, treads and rail top). Suggest replacement of damaged components.

9.3 Item 2(Picture) Deterioration (Top Rail)

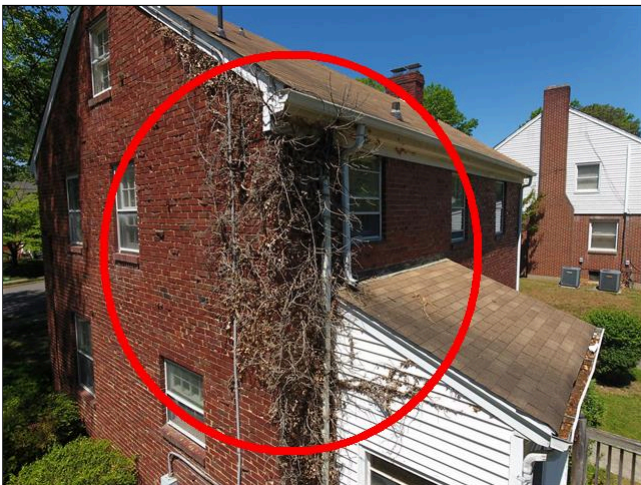
(1) Vegetation was observed in contact with the home. Suggest trimming to reduce the potential of contact related material damage.

9.4 Item 1(Picture) Dead Overgrowth (Right Rear Corner)

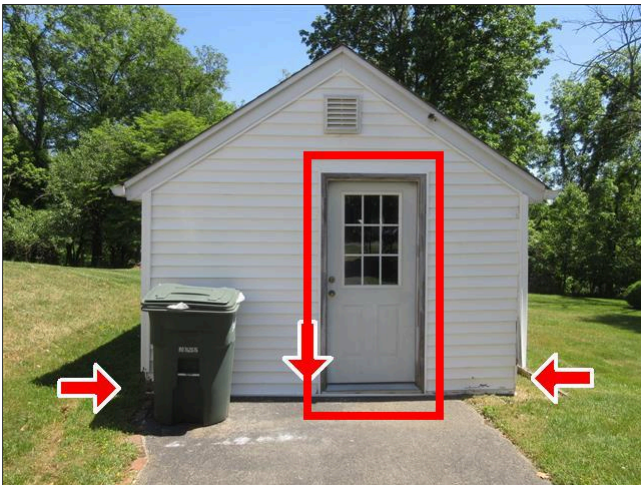
The driveway slopes towards the storage shed and has caused staining on the inside. Additionally, siding damage and openings were observed. The electrical has also been disconnected. Suggest repair and sealing as needed.

9.6 Item 1(Picture) Openings, Slope and Minor Siding Damage

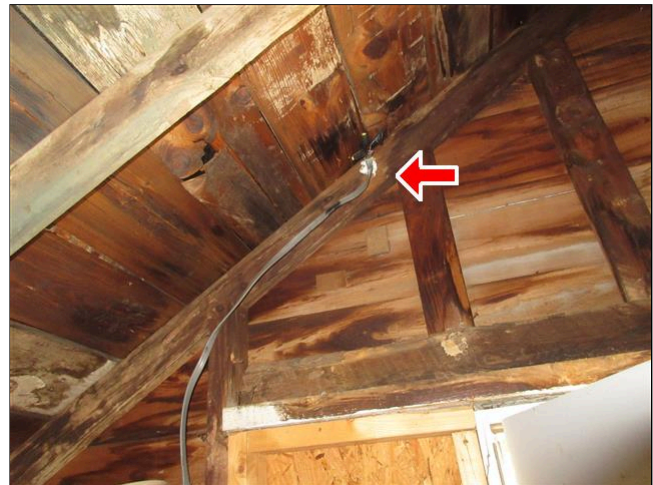
9.6 Item 2(Picture) Disconnected Electrical

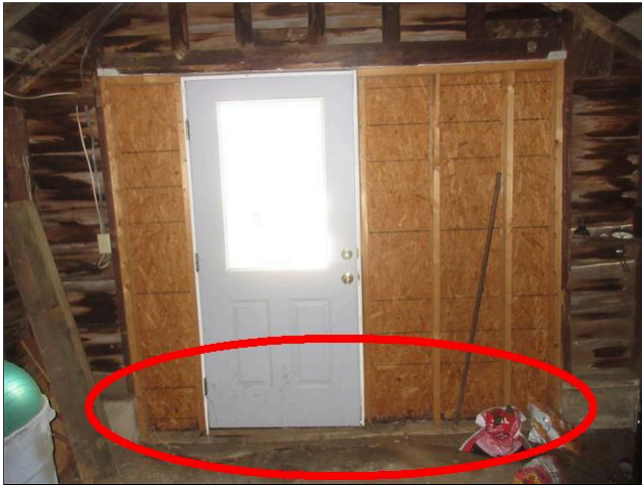
9.6 Item 3(Picture) Interior Staining
