Home Inspection Report

Property Address:
528 N Market Street
Salem VA 24153

Bateman Home Inspections, LLC

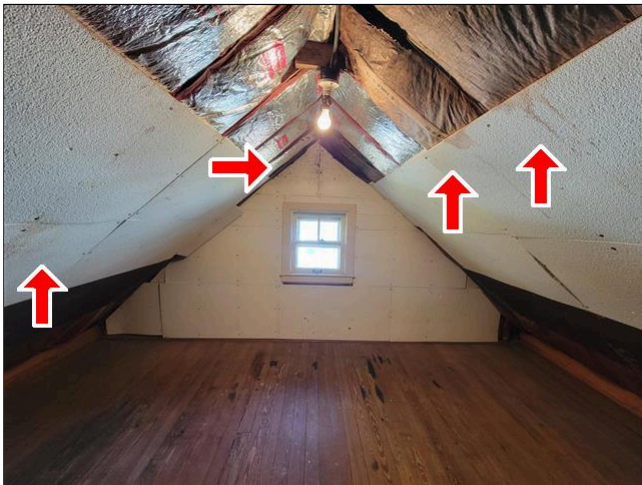
Ceiling staining was observed in multiple locations throughout the home. Moisture was measured in areas and appeared to be an ongoing concern as deterioration is also occurring. Additionally, what appears to be organic growth was also visible in areas and may be from leaks, and poor air circulation. Suggest directing attention to section roofing section 8.0 plus spraying and wiping areas affected with potential organic growth. Recommend having a licensed contractor further evaluate and repair.

1.0 Item 1(Picture) Staining and Potential Organic Growth (Left Access)

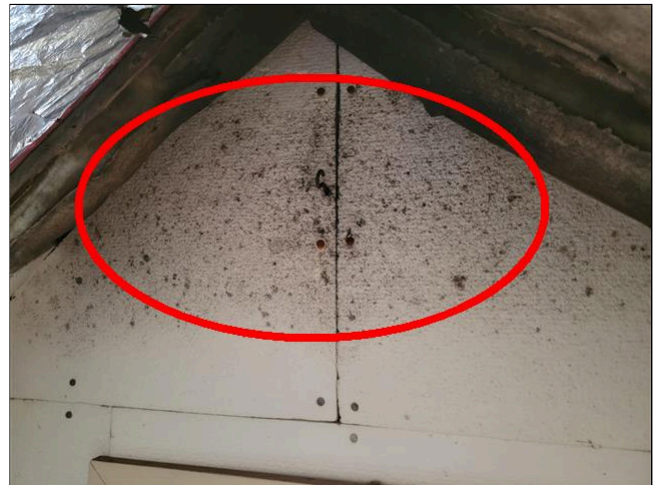
1.0 Item 2(Picture) Additional View of Potential Growth

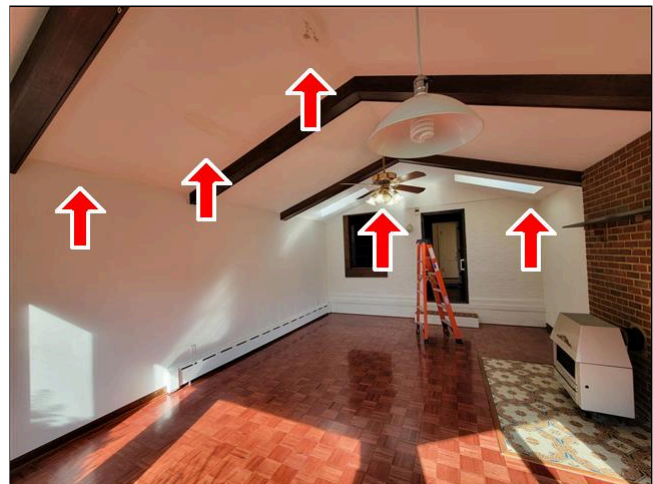
1.0 Item 4(Picture) Staining (Right Side Den)

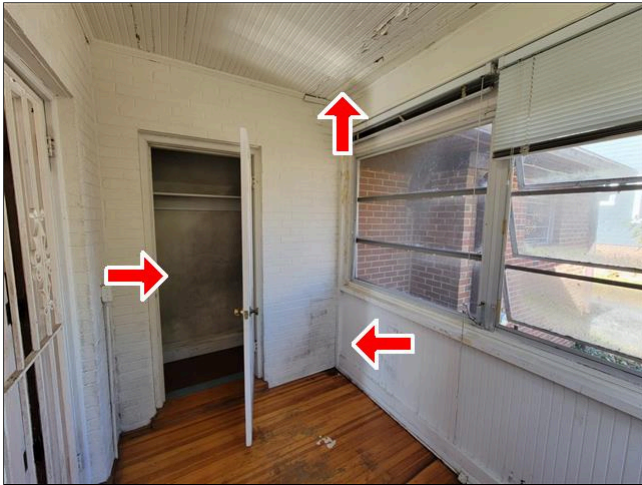
1.0 Item 5(Picture) Staining, Moisture, and Organic Growth (Rear Mud Room)

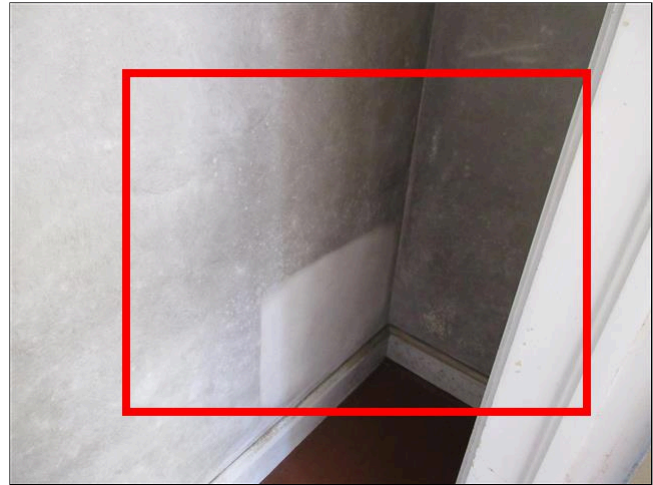
1.0 Item 6(Picture) Additional View of Organic Growth in Closet

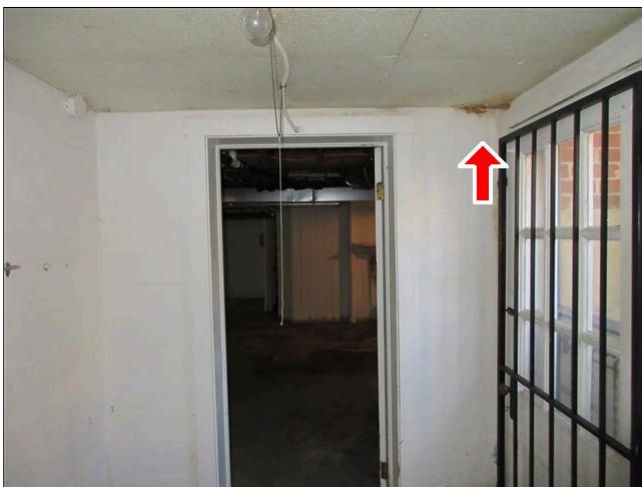
1.0 Item 7(Picture) Staining and Organic Growth (Above Basement Entrance)

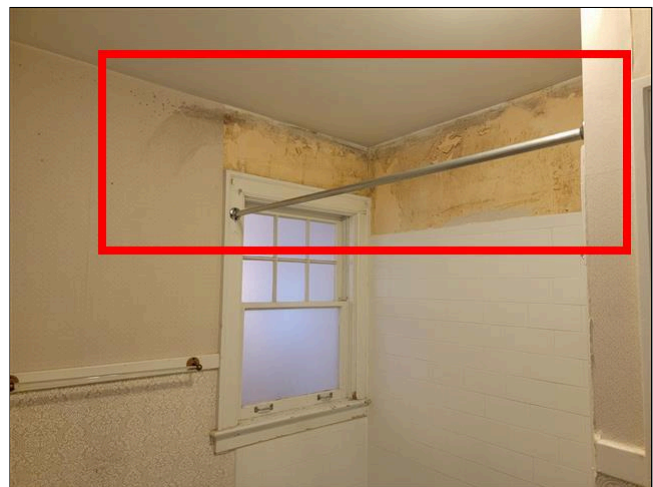
1.0 Item 8(Picture) Potential Organic Growth (Main Bathroom)

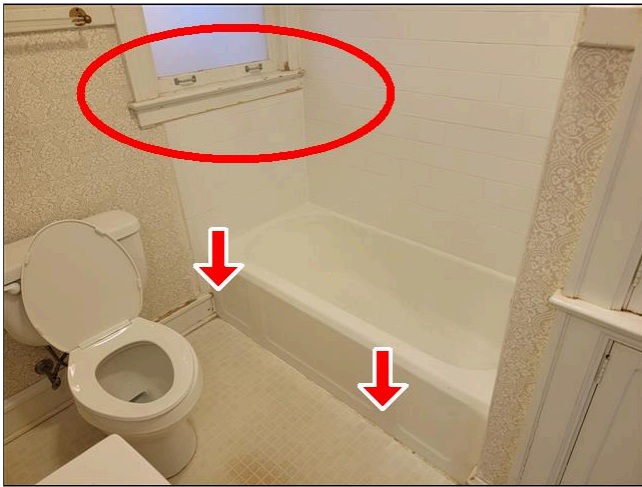
Although typically a maintenance/cosmetic issue, open joints were observed around the main and primary bathroom shower fixtures, plus a window. Disruptions are occurring around the primary bathroom shower flooring. These areas should be repaired and sealed to reduce the potential of water intrusion behind surfaces.

1.1 Item 1(Picture) Open Joints (Around Main Bathroom Shower and Window)

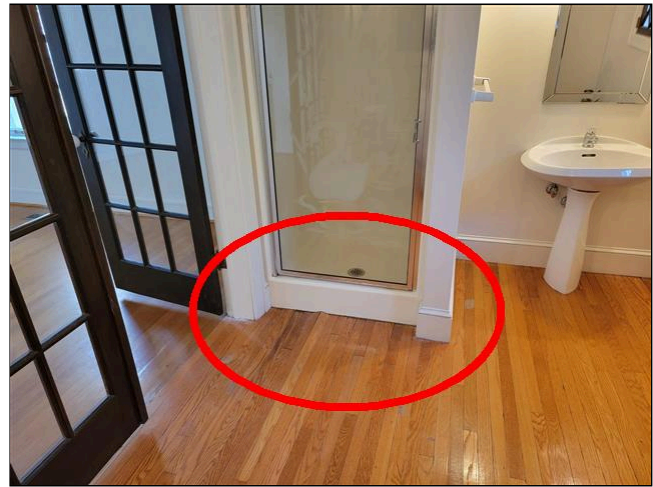
1.1 Item 2(Picture) Open Joints, Staining and Floor Disruptions (Around Primary Bathroom Shower)

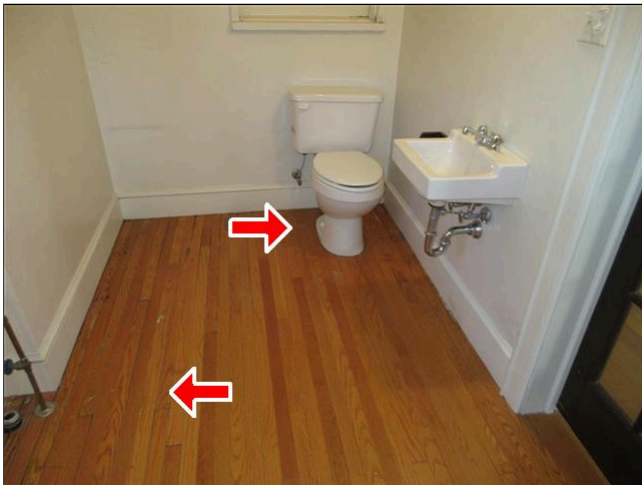
(1) Multiple sections of the flooring materials in the primary bathroom have disruption and were loose. This creates a potential foot safety hazard. Suggest repair to reduce the concerns.

1.2 Item 1(Picture) Loose Flooring and Slope (Primary Bathroom)

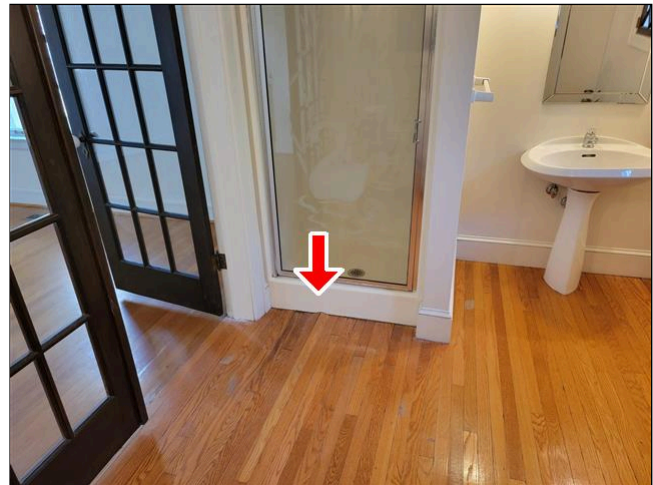
1.2 Item 2(Picture) Disruptions (Primary Bathroom)

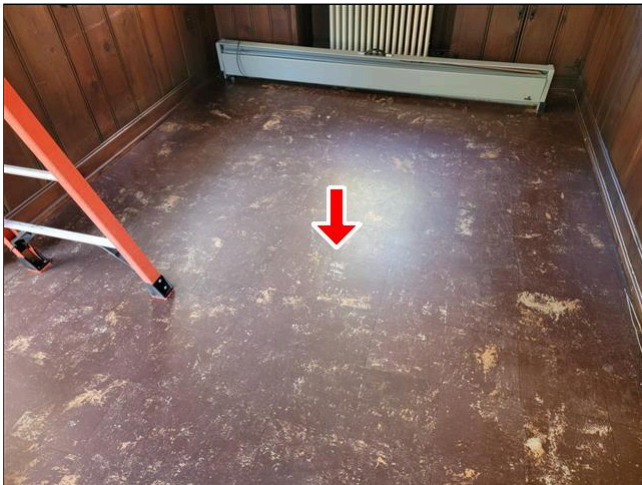
(2) The main level floor tile may contain asbestos fibers. The size of the tile and the year of the home are consistent with such tile. The tile appeared well adhered and in very good condition. If left alone, it does not pose a concern. The tile should not be removed by any means other than picking up and disposal of loose pieces. Only trained contractors should remove adhered tiles. Newer floor coverings may be laid directly over the existing tile without concern. Identified for reference.

1.2 Item 3(Picture) 9x9 Floor Tile

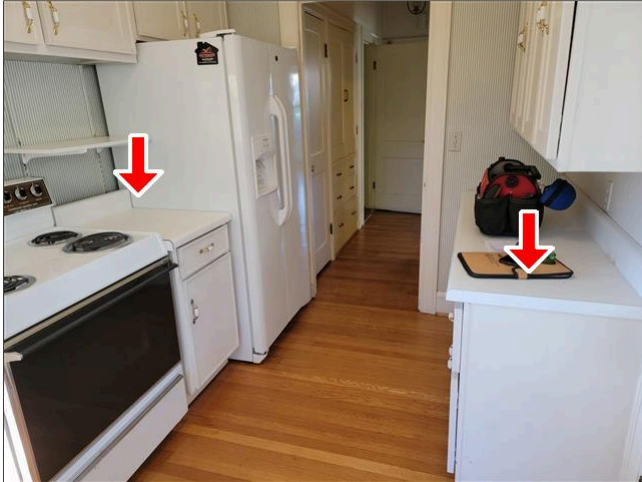
The noted kitchen countertops were observed loose. Suggest properly securing to reduce the potential of property damage and personal injury.

1.4 Item 1(Picture) Loose Countertops

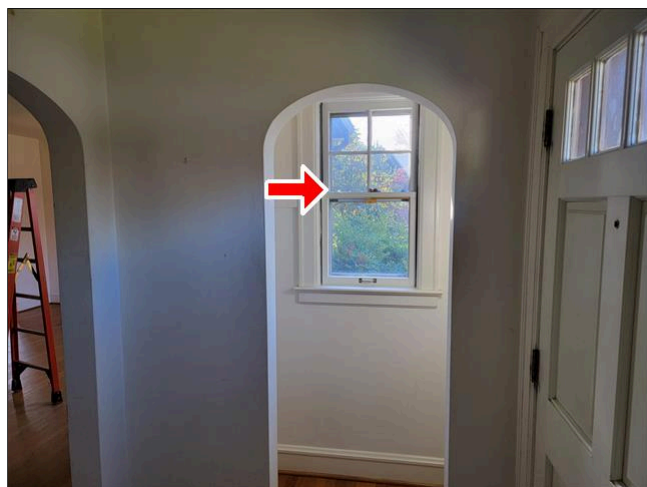
1. Broken/cracked glass was observed at the noted window(s). Recommend repair to reduce the safety concern and/or restore sealing capacity.
2. Although typically a cosmetic issue, haze was observed between the glass panes at the noted window(s). This is common when the seal begins to fail. Although the window is weather tight and mechanically operates as expected, the insulating capacity has been compromised.

1.6 Item 1(Picture) Broken Glass (Right of the front entrance)

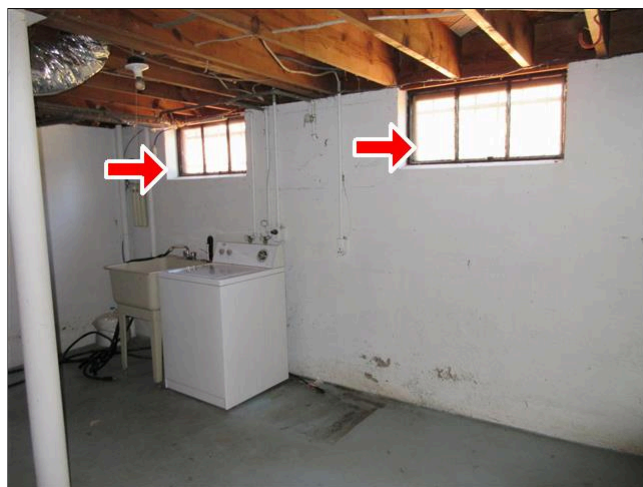
1.6 Item 2(Picture) Broken/ Cracked Glass (Basement)

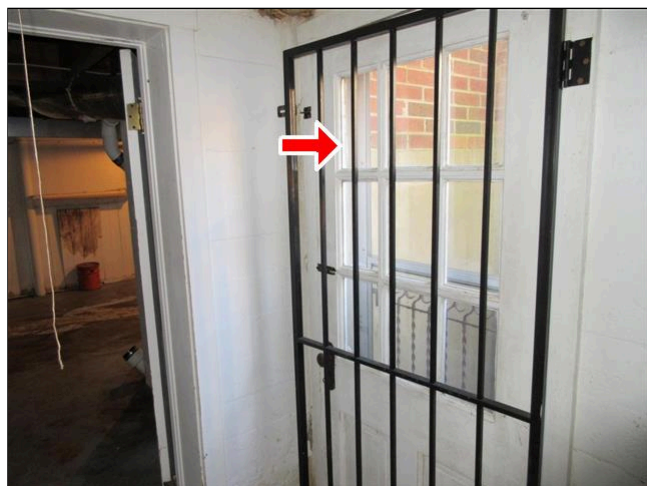
1.6 Item 3(Picture) Cracked Glass (Basement Door)

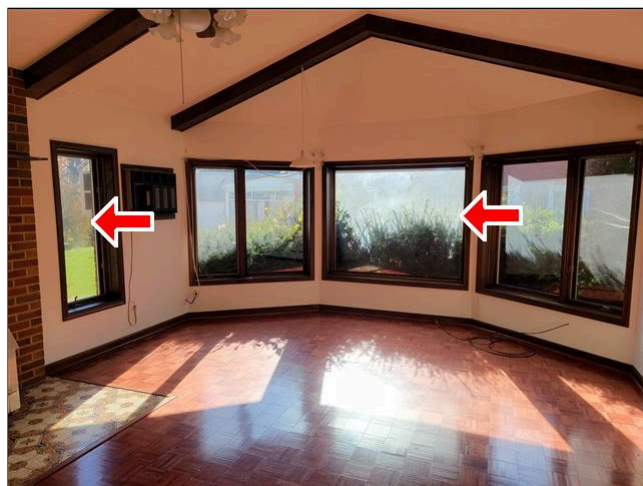
1.6 Item 4(Picture) Failed Seals (Right Side Den)

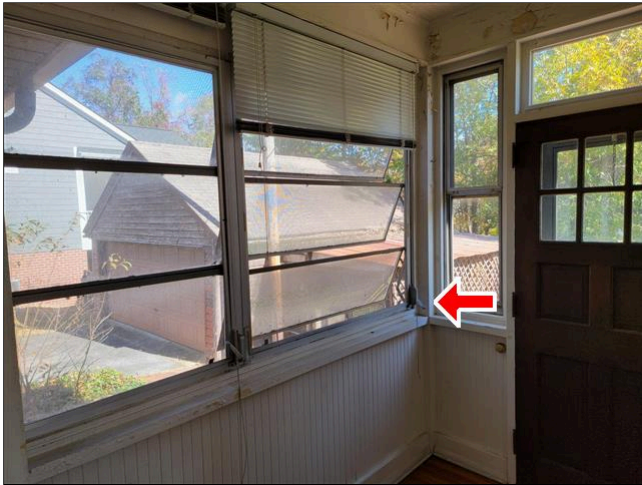
3. The crank arm assembly at the noted jalousie window was broken and the windows would not close. This can allow for water intrusion during moderate rain events. Suggest repair to restore normal use and reduce any future water related concerns.

1.6 Item 5(Picture) Faulty Crank Assembly

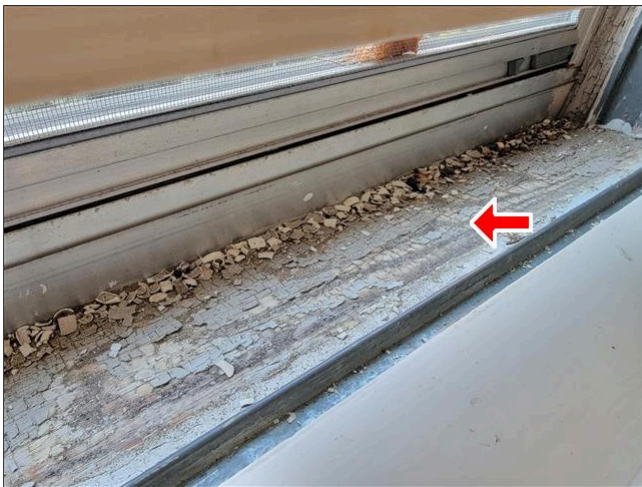
🔍 (1) Peeling paint chips and failing window glazing were observed at most window sills throughout the home. Additional peeling paint chips were observed in areas throughout the home. Due to the age of the home this could be an indication of lead based paint which is consist with the construction era. Suggest removing loose pieces and sealing the wood and glass. Recommend having a licensed contractor further evaluate and advise corrective actions and associated costs.

1.8 Item 1(Picture) Paint Chips

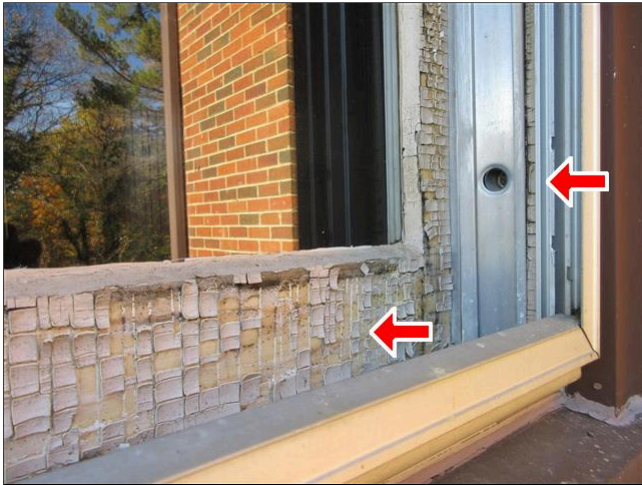
1.8 Item 3(Picture) Additional View

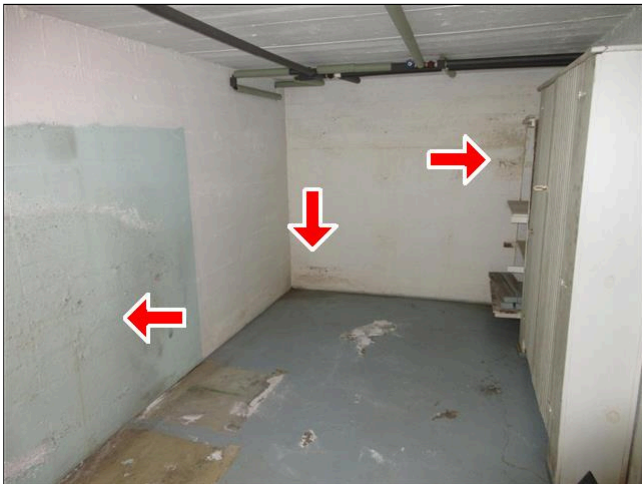
- (1) Although no active water was observed in the basement at the time of the inspection, staining and white efflorescence (powder substance) was observed on the foundation wall indicates moisture is, or has been in contact with the masonry. This does not necessarily indicate that intrusion will occur but the potential does exist. Efflorescence is found on many homes without water intrusion occurring inside the home. Suggest asking the seller about any historical water intrusion events, plus directing attention to ensuring that grading around the home is not allowing water to pool against the foundation and that the gutters are clear, functioning properly and discharging away from the home. If water intrusion occurs, recommend having a licensed contractor further evaluate and advise corrective actions.

1.9 Item 1(Picture) Staining, Efflorescence, and Organic Growth (Basement Storage Cellar)

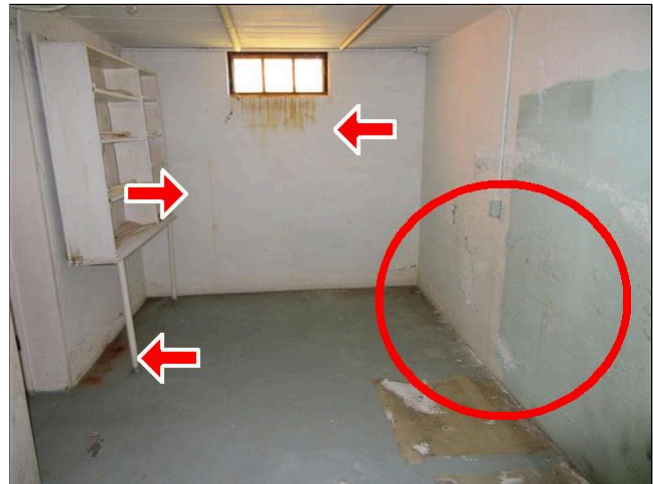
1.9 Item 2(Picture) Staining, Efflorescence (Basement Storage Cellar)

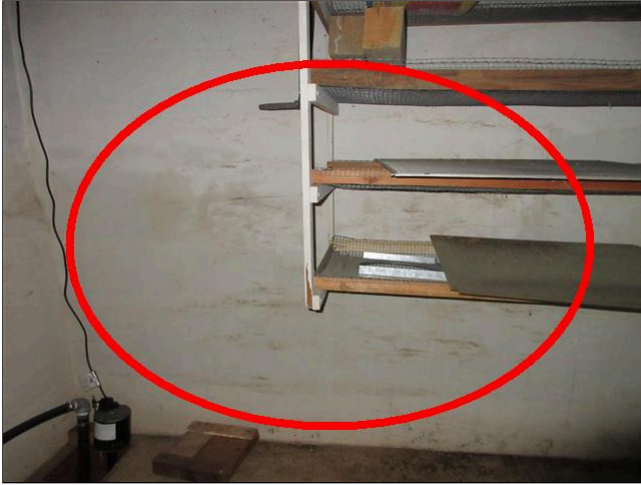
1.9 Item 3(Picture) Staining, Efflorescence, and Organic Growth (Basement Front Storage Area)

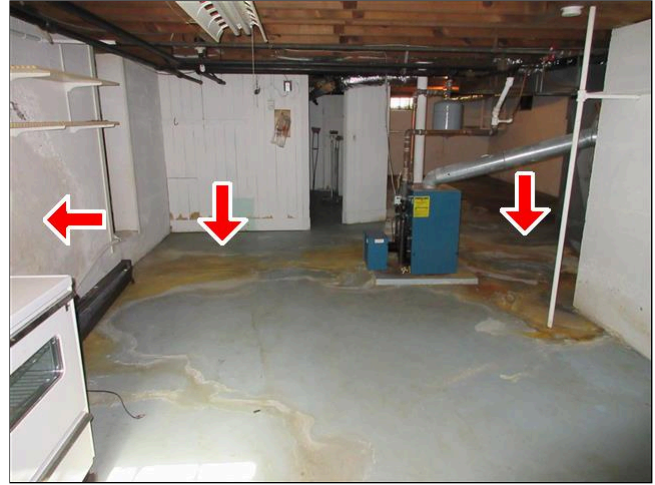
1.9 Item 4(Picture) Staining

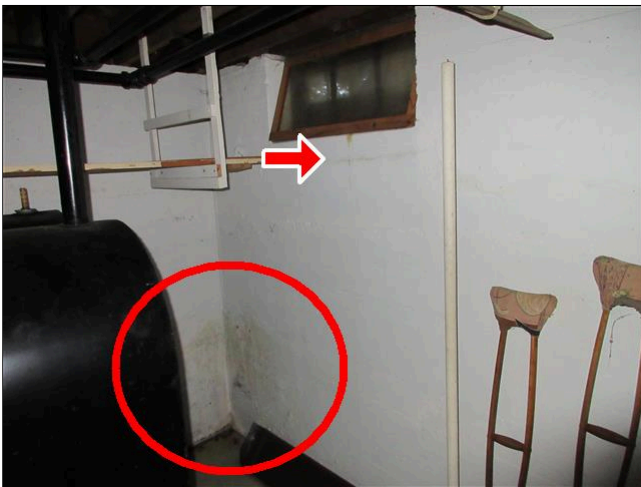
1.9 Item 5(Picture) Staining and Efflorescence

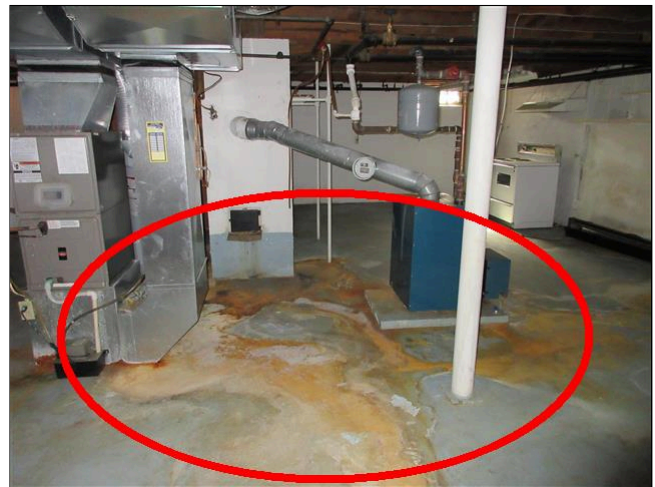
1.9 Item 6(Picture) Staining

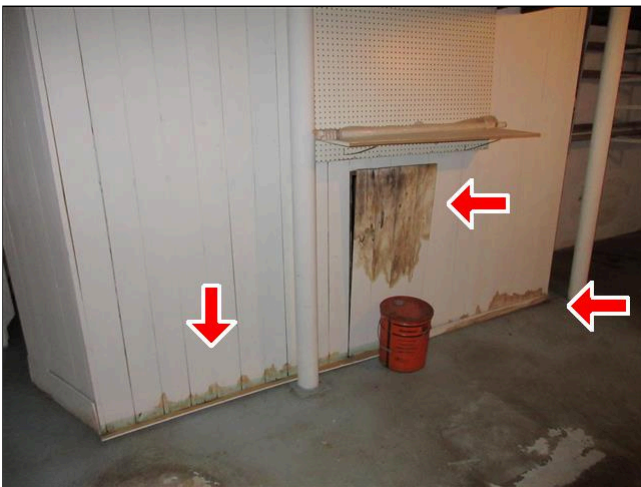
1.9 Item 7(Picture) Staining and Organic Growth

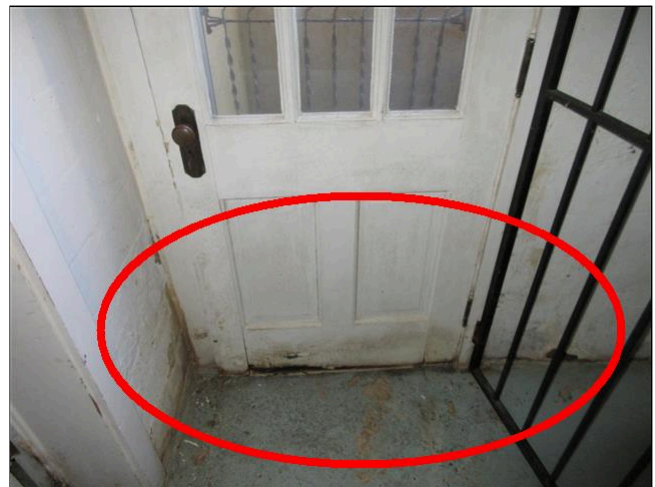
1.9 Item 8(Picture) Staining and Deterioration (Around Basement Entrance)

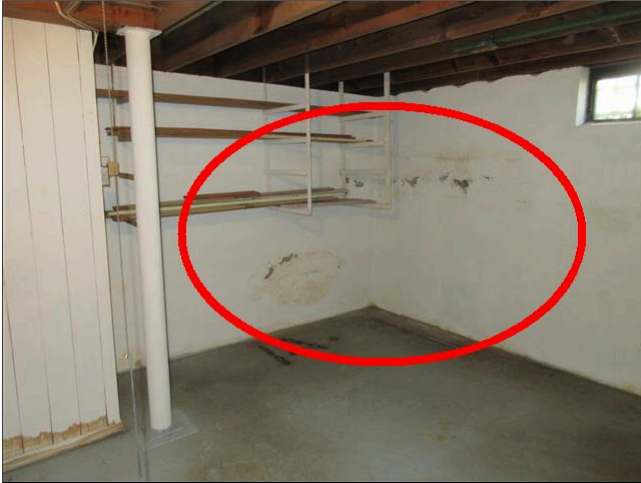
1.9 Item 9(Picture) Staining and Efflorescence

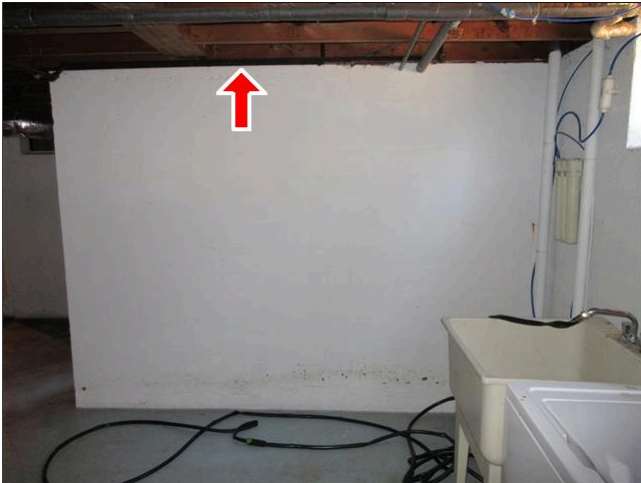
1.9 Item 10(Picture) Location (Near Washing Machine)

🔍 (2) What appeared to be insect damage was observed in a section of the rim joist. No active insects were observed at the time of the inspection. Suggest having a qualified contractor inspect and advise if any insect treatment is necessary. If active insects are found, suggest having a qualified contractor further inspect the framing and repair any damaged areas as needed.

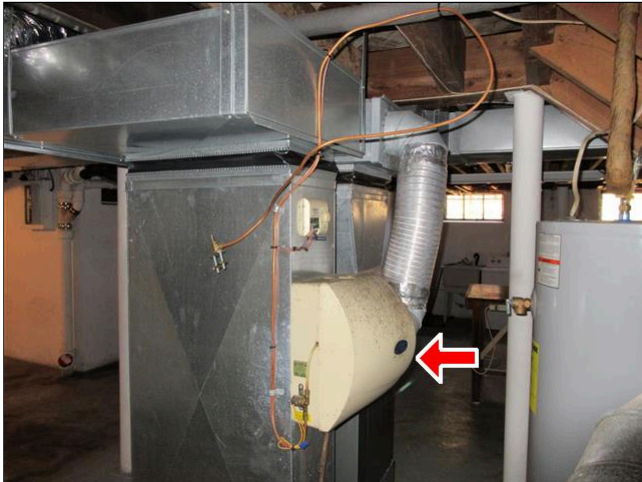
(1) A humidifier was observed but has been disconnected. Operation of this component is outside the scope of the home inspection. Typically these units are not maintained per manufacturers recommendation and fail to function properly.

2.0 Item 1(Picture) Humidifier

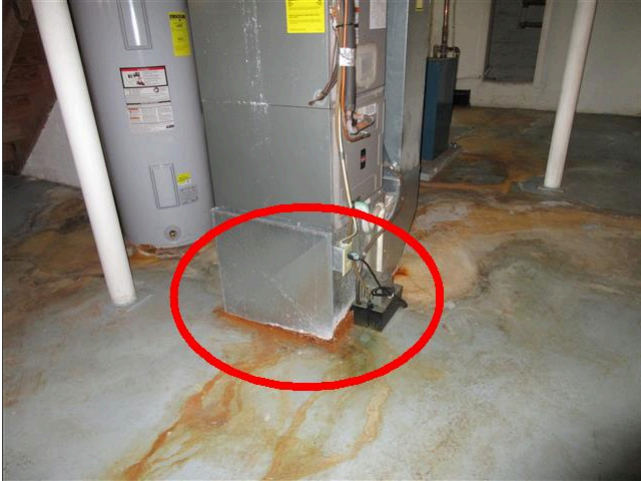
- 🔍 Corrosion was observed around the base of the air handler/ return ducting. This can allow for corrosion to be pulled into the system off the corrosion. Recommend having a licensed HVAC contractor further evaluate and repair.

2.2 Item 1(Picture) Corrosion

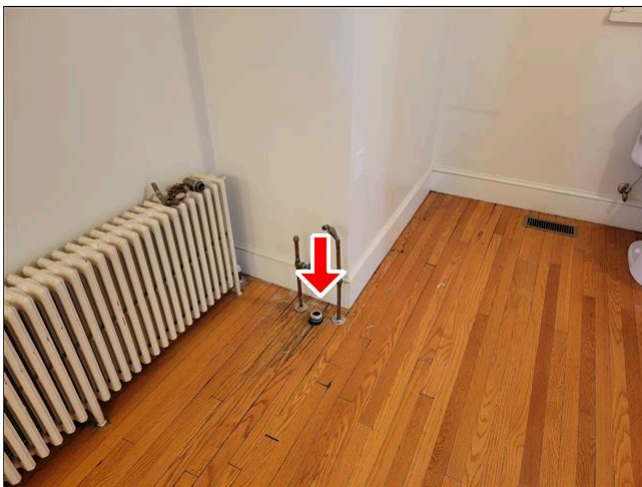
- 🔍 (1) The noted primary bathroom drain was observed uncapped. Uncapped drains can allow unpleasant sewer gasses to enter the home. This can also allow accidental leaks in the event of a clog. Suggest capping or installation of a drain plug.

3.0 Item 1(Picture) Uncapped Drain (Primary Bathroom)

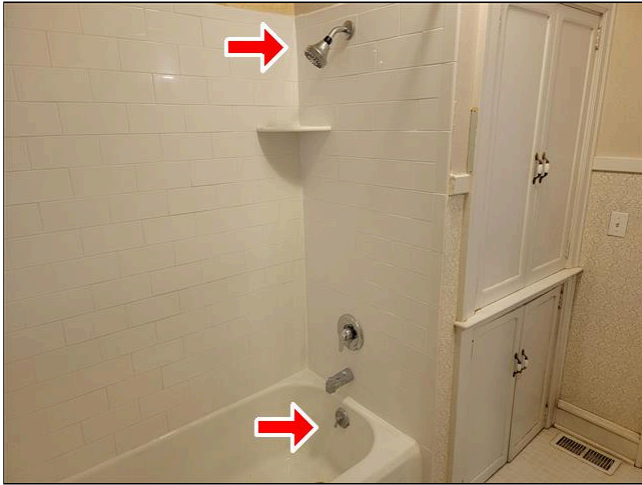
- (1) The noted shower arm mounts behind the wall cavity were observed loose, a sink fixture was constantly dripping, and a tub stopper did not function. Although no leaking was observed at the mounts, repeated head adjustments can lead to connection leaks. Suggest securing shower arm mounts and repairing dripping fixture.

3.2 Item 1(Picture) Loose Shower Head Mount and Faulty Stopper (Main Bathroom)

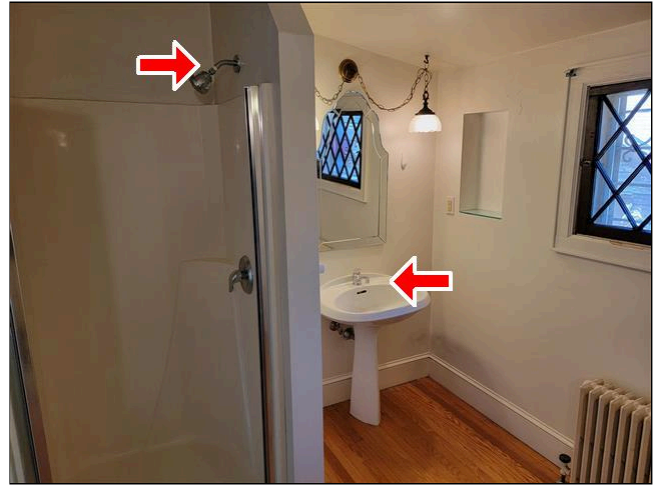
3.2 Item 2(Picture) Constant Drip and Loose Shower Mount (Primary Bathroom Sink and Shower)

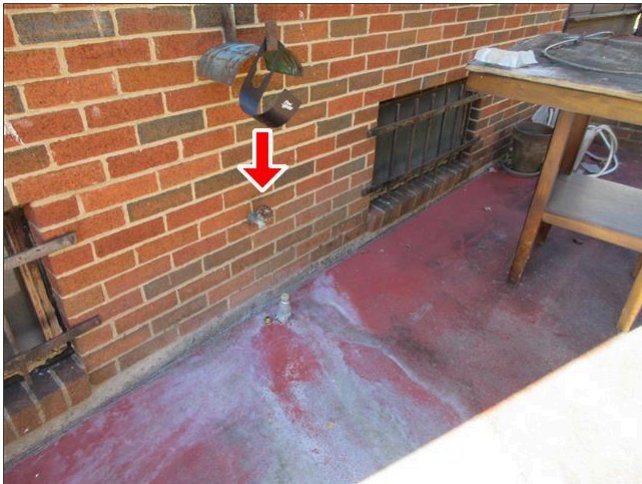
- (2) The rear hose bibb was seized and would not turn on. Suggest repair to restore normal use and to identify any leaks.

3.2 Item 3(Picture) Seized (Rear Hose Bibb)

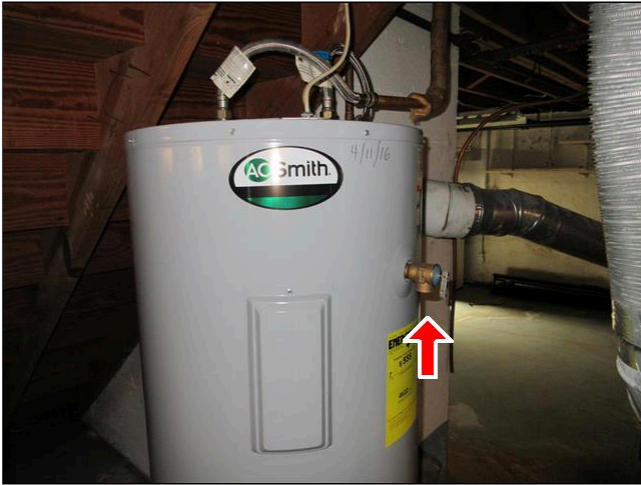
- 🔍 (1) No temperature / pressure (T&P) relief valve discharge pipe was observed attached to the water heater at the time of inspection. The T&P relief valve on the water heater is designed to safely discharge hot water in the event of a water heater failure. A 3/4" discharge pipe is required to safely direct the discharging hot water to within 6" of the floor. Suggest installation of a discharge pipe.

3.3 Item 1(Picture) No Discharge Tube

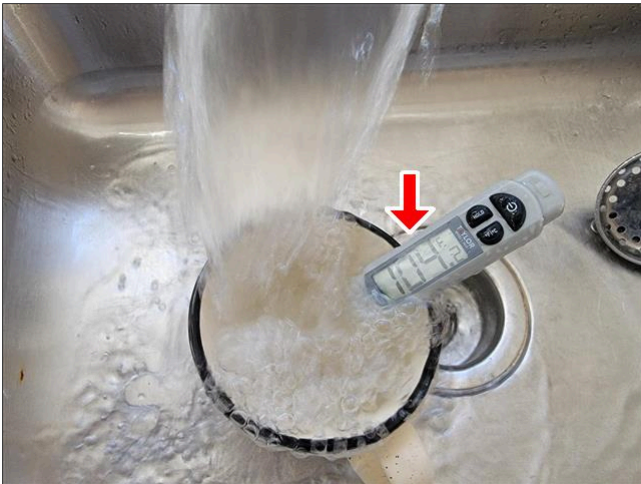
- (2) The water heater output temperature measured low (Below 115 degrees). Typical output temperature is 120-125 degrees. Low temperatures can impact water potability. The thermostats may be set low and need adjusting. Suggest removing the thermostat covers on the water heater and adjusting thermostats. If no adjustment is necessary, recommend having a licensed plumber evaluate and repair as necessary.

3.3 Item 2(Picture) 104.2 Degrees

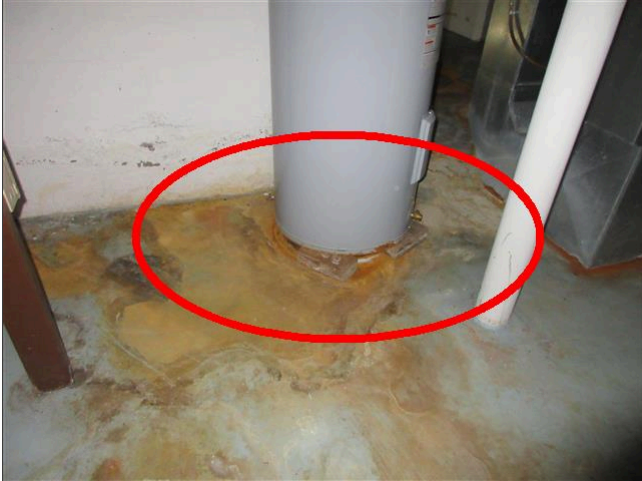
(3) Although no leaking was observed at the time of the inspection, corrosion was around the base of the water heater. This may be from past water intrusion events. Suggest monitoring for leaks once normal use has been restored as repairs may require replacement.

3.3 Item 3(Picture) Corrosion

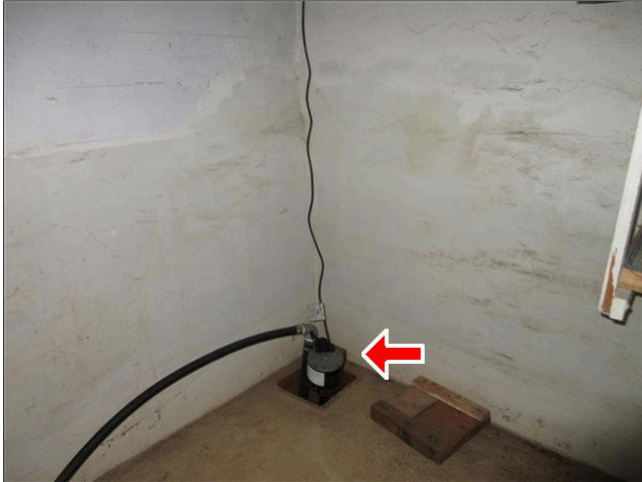
A sump pump was observed in the front basement storage area but the sump well was dry. The unit was inspected for operation but not for pumping function. Suggest monitoring.

3.5 Item 1(Picture) Sump Pump

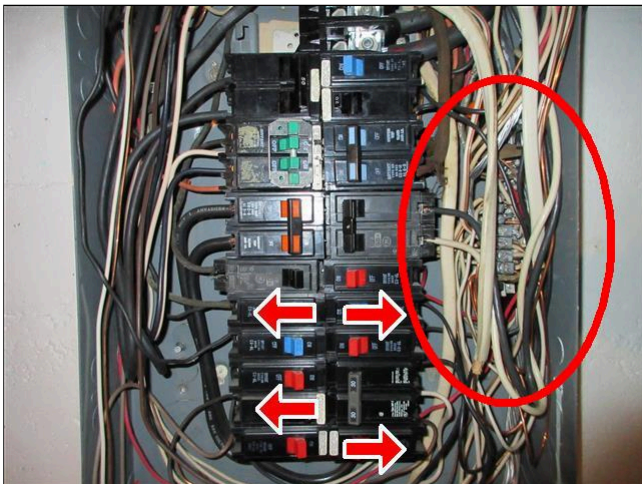
**What appeared to be breaker over-sizing was observed in the electrical panel. This is improper and does pose a safety concern as the wire can overheat before the breaker will trip. Also breaker double tapping (two or more wires under one breaker terminal) was observed. Many breaker manufacturers do not allow double tapping and consider it a safety issue. Additionally, the interior panel is a sub panel off the exterior panel. Typically special requirements are required for sub panels such as the ground and neutrals being isolated and independent on separate bars. Currently the grounds and neutrals are combined. Recommend having a licensed electrician further evaluate the panel and repair any concerns as necessary.**

4.3 Item 1(Picture) Observations

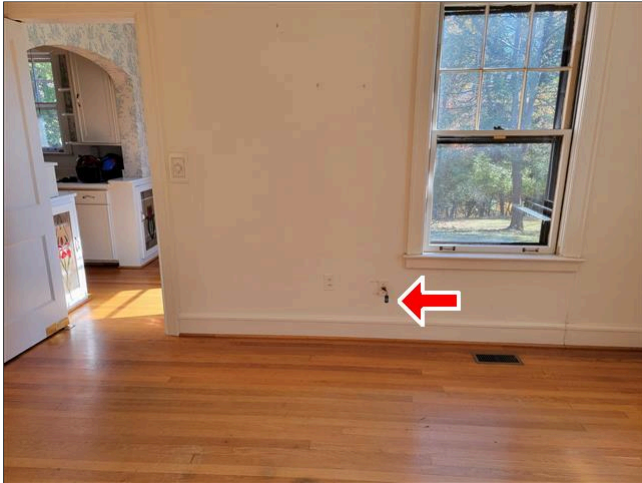
🔍 (1) The noted dining room outlet, and primary bathroom fixtures were inactive. The dining room outlet is 220 for a window ac unit. Additionally, the doorbell chime did not function. Suggest asking the sellers about this or having a licensed electrician evaluate and correct as necessary.

4.4 Item 1(Picture) Inactive 220 Outlet (Dining Room)

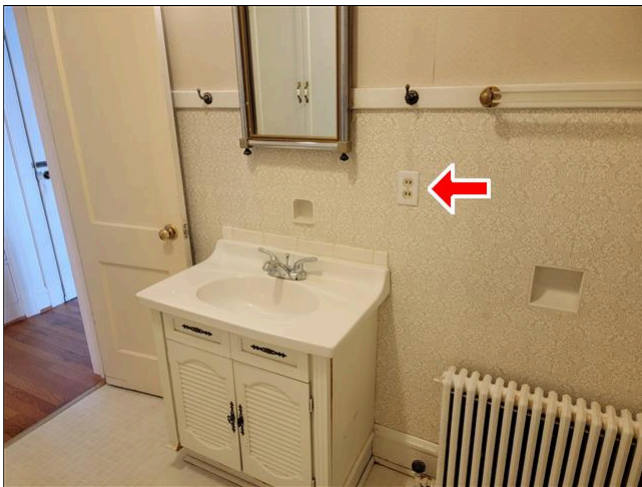
🔍 (1) The main bathroom outlet was observed ungrounded. Ungrounded outlets near water sources pose an increased shock concern. GFCI devices provide additional electrical safety in these locations. Recommend having a licensed electrician upgrade the noted outlets/circuits to improve electrical safety.

4.5 Item 1(Picture) Ungrounded (Main Bathroom)

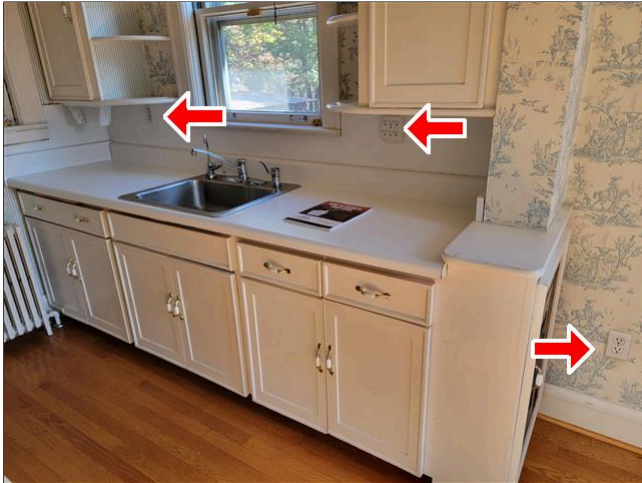
🔍 (2) Although the noted outlet(s) are grounded, outlets near water sources pose an increased shock concern. GFCI devices provide additional electrical safety in these locations. Recommend having a licensed electrician upgrade the noted outlets or circuit to improve electrical safety.

4.5 Item 2(Picture) Grounded (Kitchen Outlets)

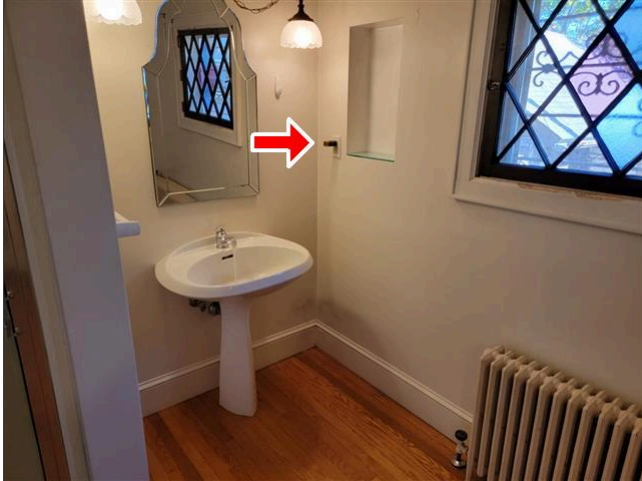
- 🔍 The noted primary bathroom GFCI outlet was observed inactive and failed to reset. This is common with age and infrequent testing. Recommend having a licensed electrician replace the faulty outlet to restore proper safety function.

4.6 Item 1(Picture) Faulty GFCI Outlet (Primary Bathroom)

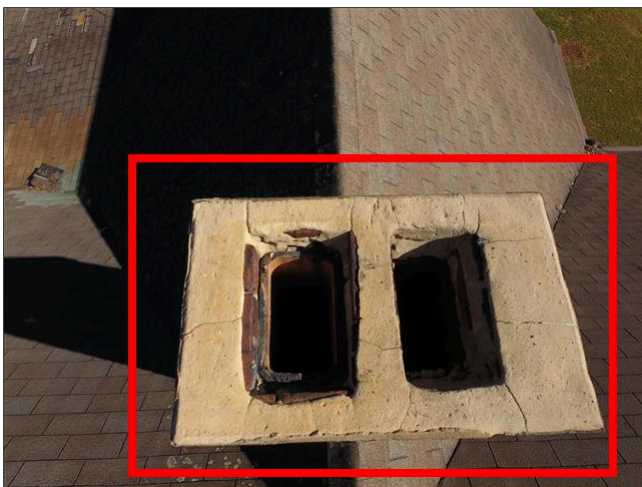
**The chimney crowns were observed intact but cracked and worn from age and weather. Cracking can potentially allow water to enter the chimney chase which increases deterioration especially when the chimney is no longer used or abandoned. Staining was present around the middle chimney in the basement. The installation of a rain cap over the top of the chimney would be an improvement over the current configuration. Recommend having a licensed contractor further evaluate and repair as necessary.**

6.6 Item 1(Picture) Cracking (Middle Chimney)

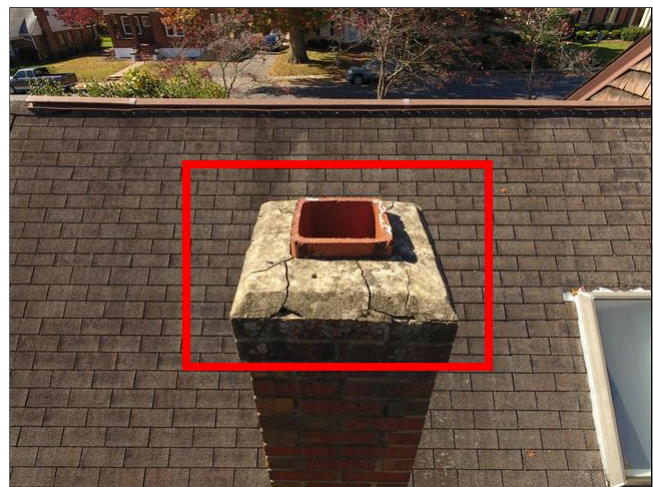
6.6 Item 2(Picture) Cracking (Right Rear Chimney)

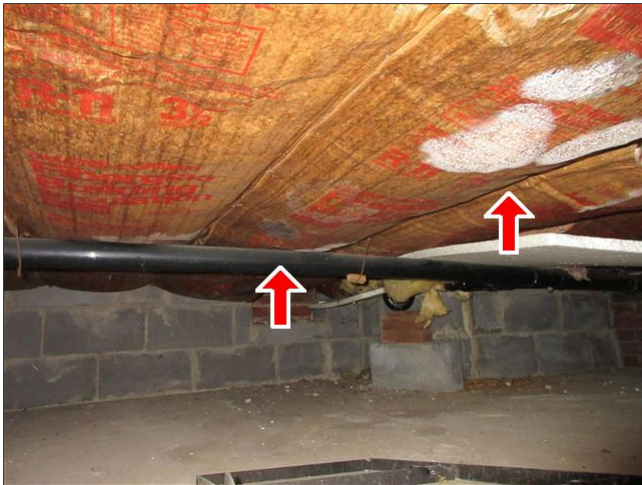
- What appeared to be organic growth was visible on areas of the floor insulation under the primary bathroom. Recommend replacing the affected insulation.

7.1 Item 1(Picture) Organic Growth

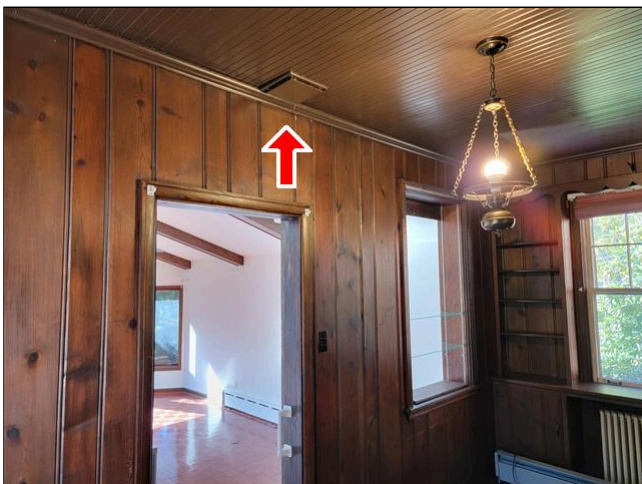
(1) The vent fan located between the right den appears to have been removed and the cover has been left behind. Suggest removing cover and sealing to reduce heat loss and drafts. Identified for reference only.

7.4 Item 1(Picture) Removed Vent Fan

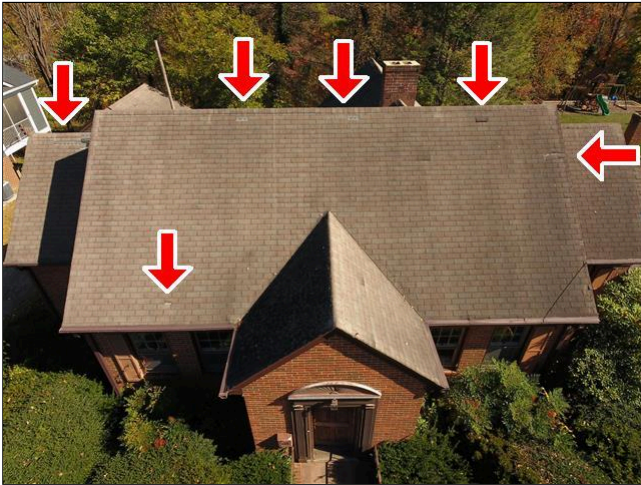
The shingles were observed in worn condition. The edges have thinned, the corners are beginning to curl, wind lift damage was noted in multiple areas leaving exposed nail heads and substantial granular loss is visible. As the shingles appear to be at the end of their typical life expectancy, suggest having a licensed roofing contractor further evaluate and advise on replacement cost/repairs.

8.0 Item 1(Picture) Wind Lift, Missing Tabs, and Nail Pops

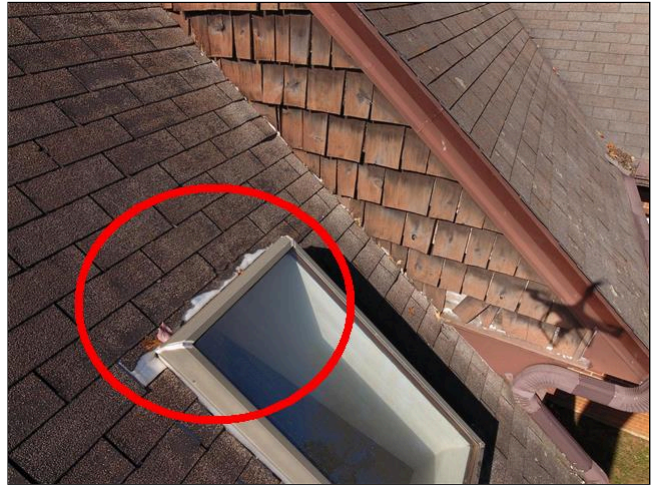
8.0 Item 2(Picture) Damaged Shingles (Around Skylights)

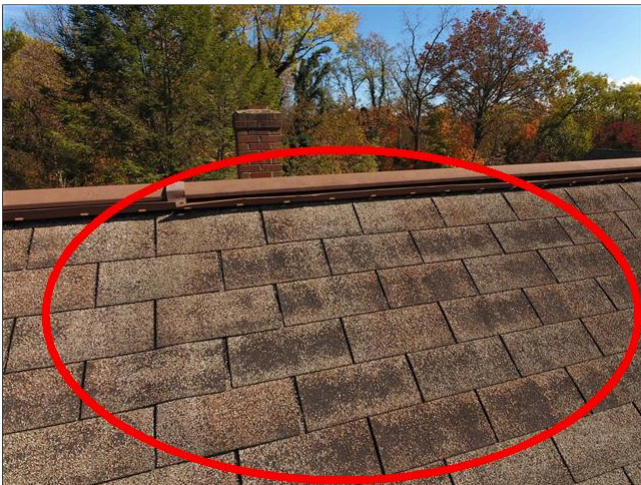
8.0 Item 3(Picture) Substantial Granular Loss

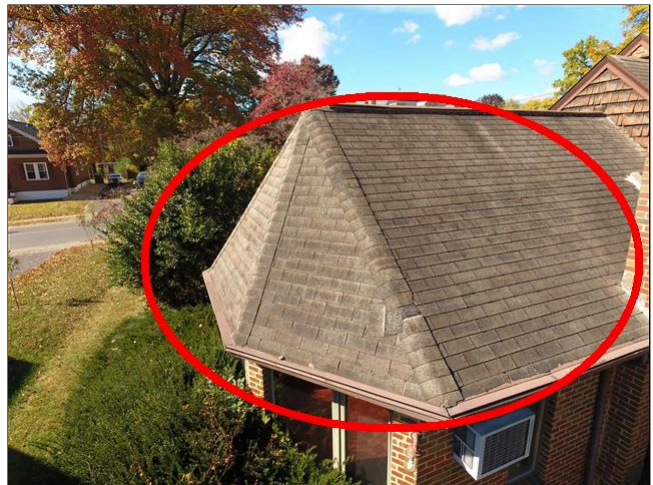
8.0 Item 4(Picture) Substantial Granular Loss, and Damaged Shingles

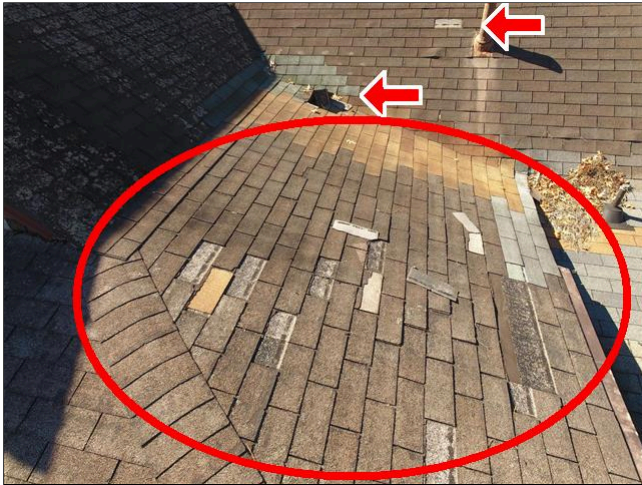
8.0 Item 5(Picture) Missing Shingles and Exposed Nail Heads

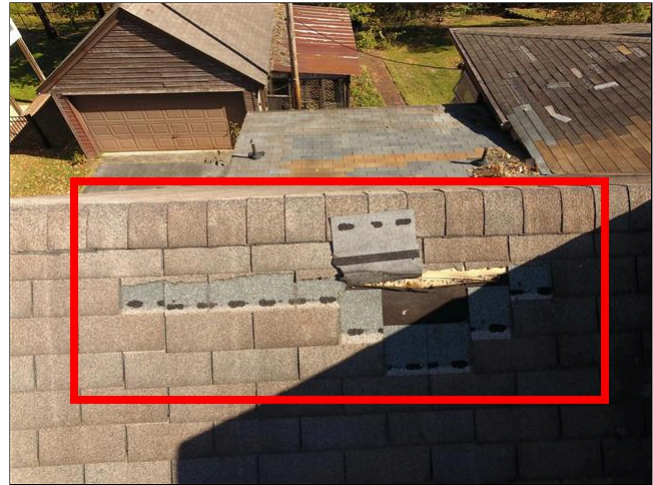
8.0 Item 6(Picture) Missing Shingles and Exposed Nail Heads

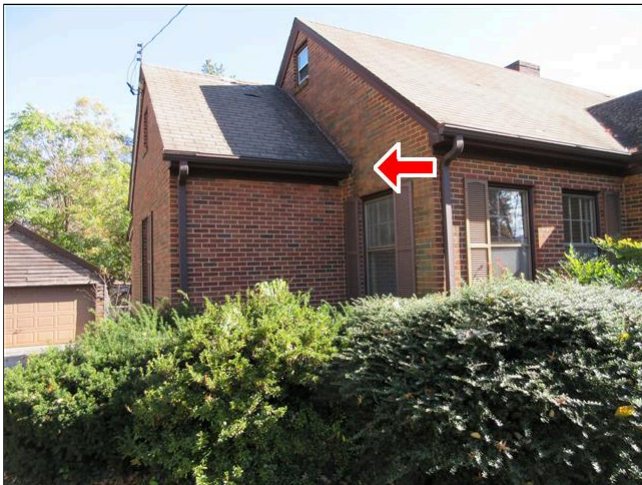
8.1 Item 1(Picture) Front Left

- 🔍 (1) Multiple openings were observed around the chimney flashing. This is common with the age of the roof. Suggest repair to the flashing to eliminate the potential of moisture intrusion when the roof is repaired.
- (2) Although not required, no kick out flashing or diverter was observed at the roof to side wall transition. Kick out flashing diverts roof water into the gutter and prevents large volumes of water from running down the siding. Suggest installation of kick out flashing to improve rain water management and reduce the potential for water intrusion.

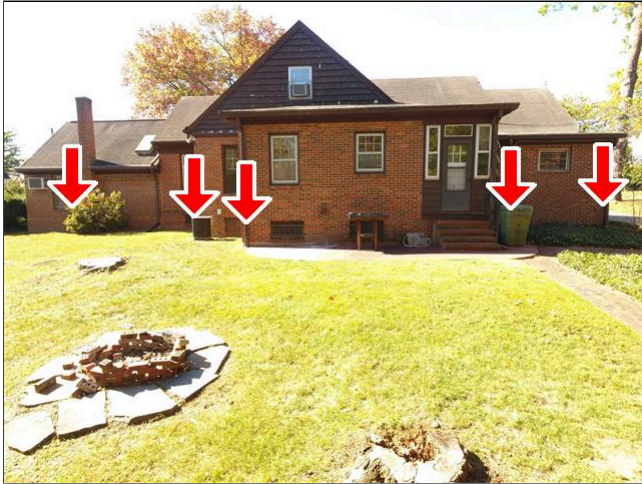
Although the gutters appear intact and complete, they were observed discharging at the foundation. Downspouts should discharge water 4'-6' away from the foundation. Due to the lack of rain during the inspection, gutter functionality was not determined. Suggest installation of downspout leaders, and monitoring gutter function during a moderate rain event to identify if any sections need slope adjustments.

8.3 Item 1(Picture) Discharge (Multiple Locations Around the Exterior Front and Rear)

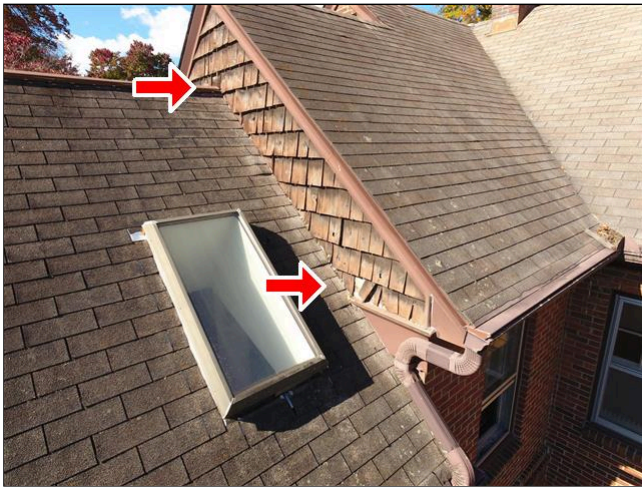
Although typically maintenance related and/or cosmetic issues, open joints, and un-painted or peeling painted surfaces on the exterior of the home can lead to premature decay. Exterior paint is liquid siding that protects the wood from weather. Suggest sealing any open joints (around windows, doors, thresholds, and trim/siding), repairing any damaged areas, and painting any exposed surfaces as needed to reduce the decay potential.

9.0 Item 1(Picture) Damaged Wood Siding and Openings

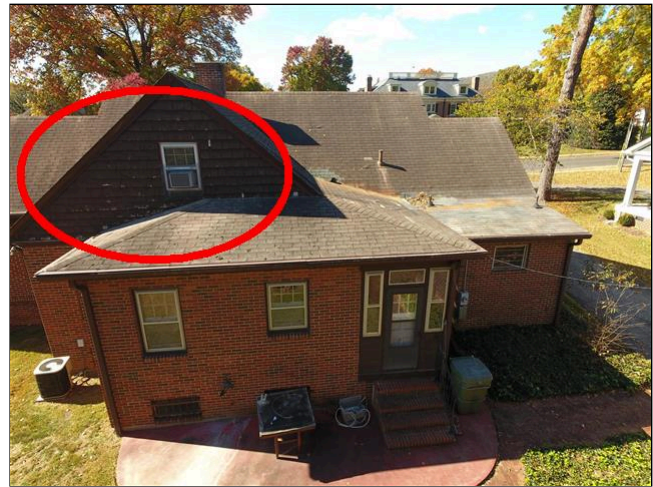
9.0 Item 2(Picture) Damaged Wood Siding and Openings

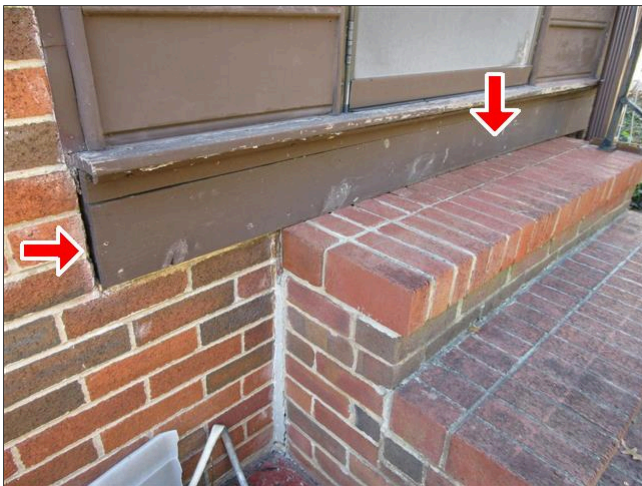
9.0 Item 3(Picture) Openings (Around Rear Door)
