Home Inspection Report

Property Address:
528 N Market Street
Salem VA 24153

Bateman Home Inspections, LLC

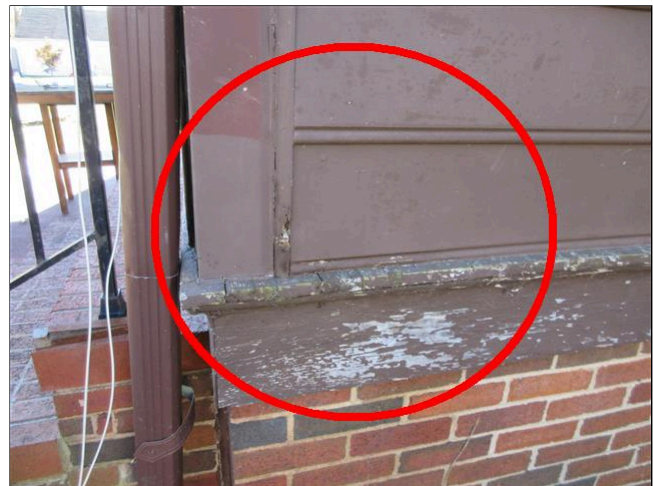
Although typically maintenance related and/or cosmetic issues, open joints, and un-painted or peeling painted surfaces on the exterior of the home can lead to premature decay. Exterior paint is liquid siding that protects the wood from weather. Suggest sealing any open joints (around windows, doors, thresholds, and trim/siding), repairing any damaged areas, and painting any exposed surfaces as needed to reduce the decay potential.

9.0 Item 4(Picture) Deterioration and Peeling Paint

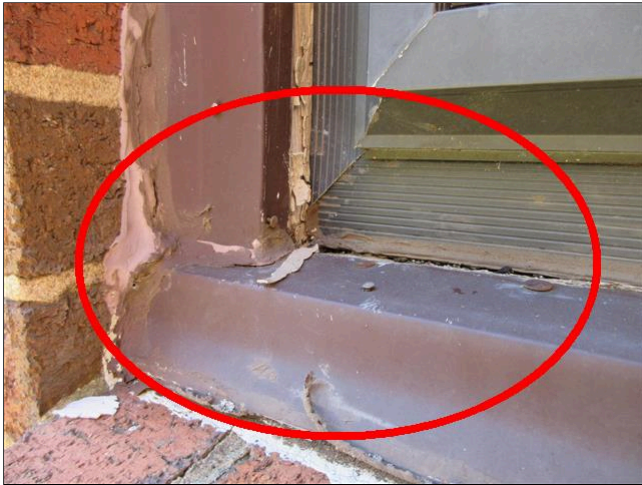
9.0 Item 5(Picture) Openings and Failing Sealant (Around Windows)

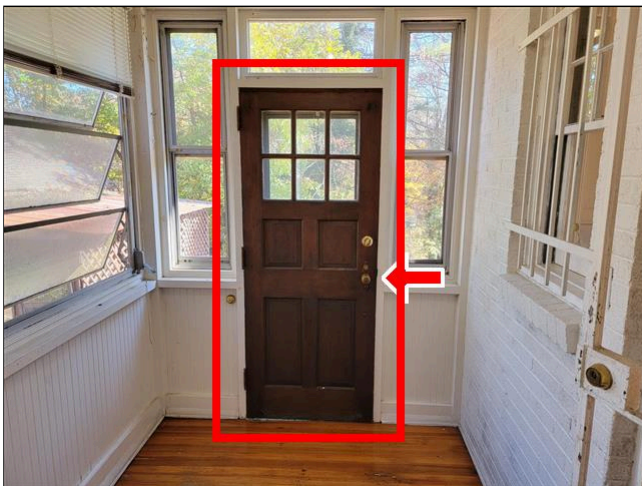
The rear and basement exterior doors were observed not adequately sealed resulting in excessive air leakage, and the door knob was missing components at the rear. The basement door would not close which also creates a safety concern. This can also allow potential pest and moisture intrusion. Suggest repair to reduce the concerns.

9.1 Item 1(Picture) No Weather Stripping and Faulty Door Knob (Rear)

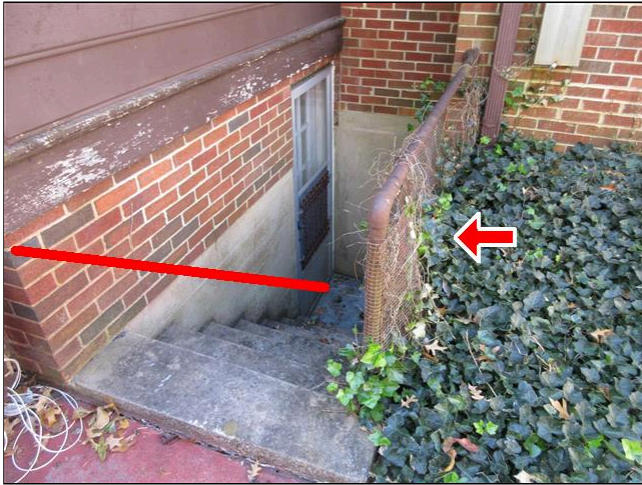
9.3 Item 1(Picture) Basement Stairs

🔍 Railing requirements have changed over time. Although not required to, the lack of a graspable handrail and balusters does not meet current safety specifications. Typically stairs over three risers tall have a hand rail and vertical balusters for safety. This is a fall safety concern especially for toddlers and small children.
