# Pre-Listing Inspection Report

**Property Address:**  
516 N Market Street  
Salem VA 24153

<b>Date:</b> 7/9/2024	<b>Time:</b> 09:00 AM	<b>Report ID:</b> 0724516
<b>Property:</b> 516 N Market Street Salem VA 24153	<b>Customer:</b> Catherine Potter	<b>Real Estate Professional:</b>

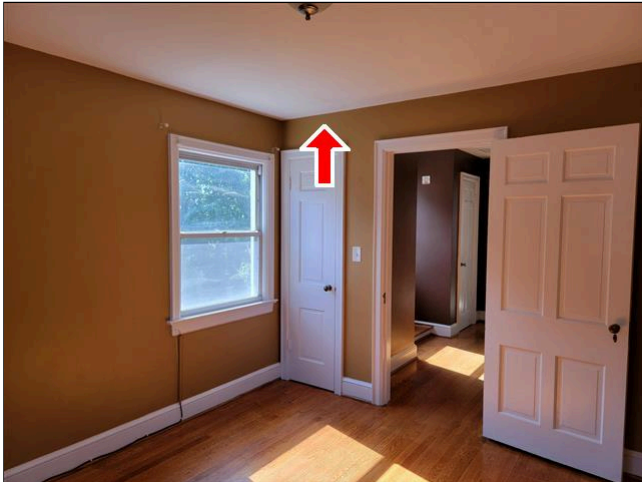
(1) Noted ceiling staining was observed. Elevated levels of moisture were measured and appears to be roof related (see sections 8.0 and 8.2 for roof related references). Recommend having a qualified contractor further evaluate and repair roofing or flashing elements as necessary.

1.0 Item 1(Picture) Staining (Upstairs Left Rear Bedroom)

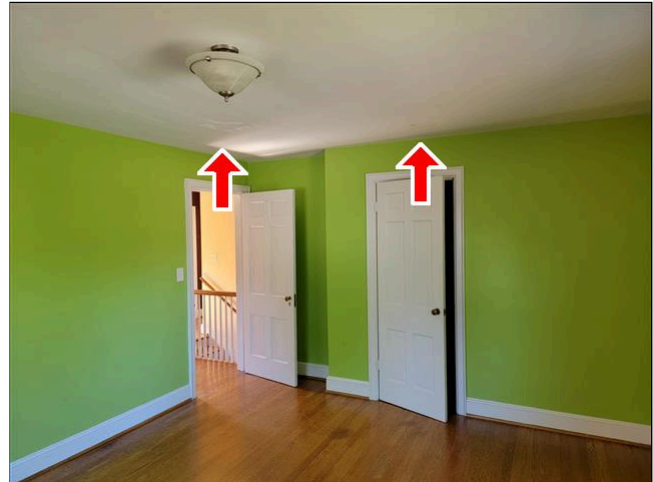
1.0 Item 2(Picture) Wet Staining (Upstairs Front Left Bedroom)

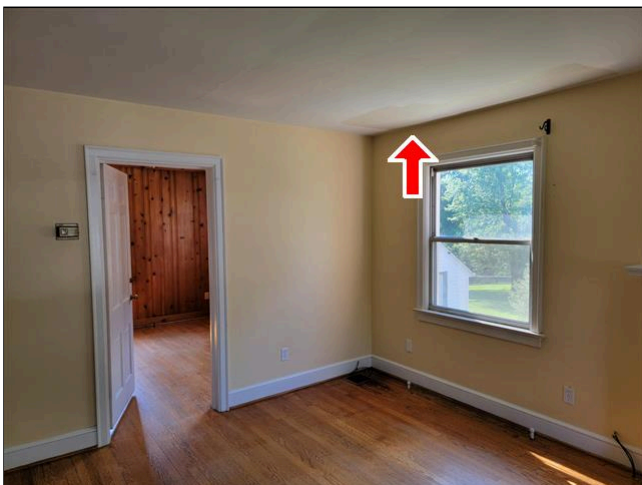
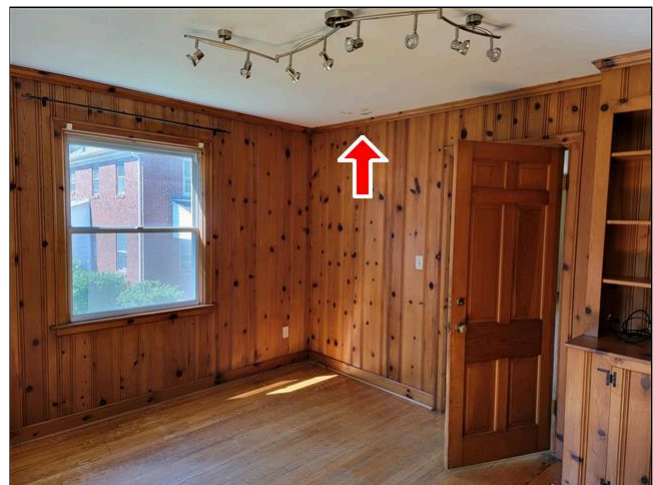
(2) Noted ceiling staining was observed. This may be from past leaks at the shower/jet tub, and the open joints around the jet tub (see section 1.1 for additional reference). Suggest monitoring for leaks once normal use of the home has been restored.

1.0 Item 3(Picture) Living Room (Under the Bathroom)

1.0 Item 4(Picture) Main Level Right Rear Bedroom (Under the Bathroom)

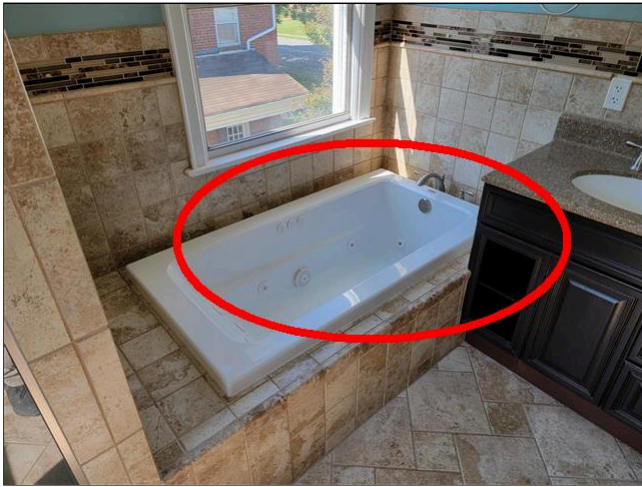
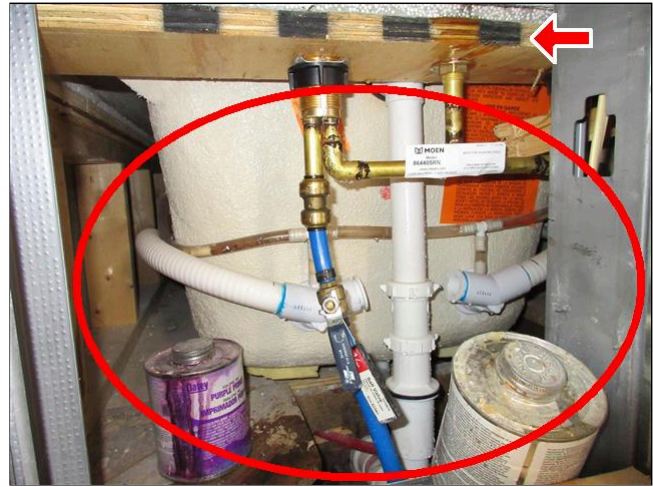
Although typically a maintenance/cosmetic issue, open grout lines and/or open joints were observed around the upstairs bathroom jet tub. When the jet tub was turned on the jets sprayed water out of the tub and exposed where several openings were on the backside of the wall. Due to the water that was dripping from the joints an exact identification could not be determined of any potential plumbing leaks. These areas should be sealed upon moving in to reduce the potential of water intrusion behind surfaces and monitoring for connection leaks.

1.1 Item 1(Picture) Open Joints (Around Jet Tub)

1.1 Item 2(Picture) Behind Wall Cavity

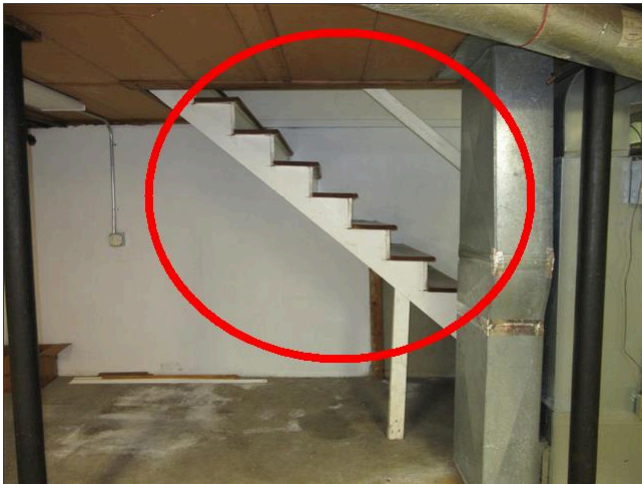
1.3 Item 1(Picture) Basement Stairwell

Railing requirements have changed over time. Although not required to, the lack of balusters does not meet current safety specifications. This poses a fall safety concern for toddlers and small children.

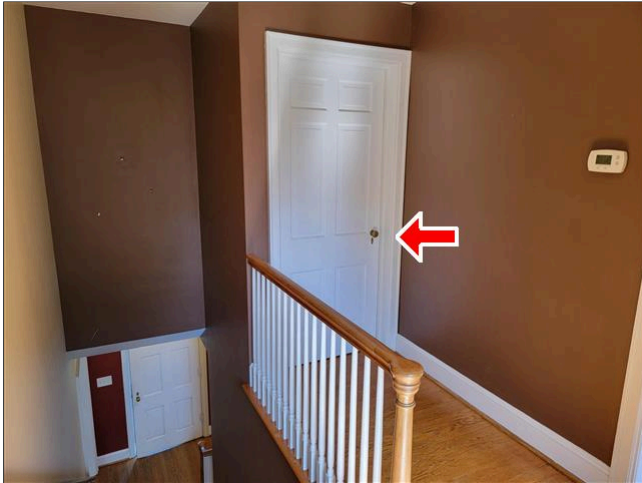
The noted door was observed not to latch when shut. This is common with age and may be corrected with a minor position adjustment to the strike plate or possibly tightening of the door hinge screws. Identified for reference.

1.5 Item 1(Picture) Upstairs Front Left Bedroom (Not Latching)

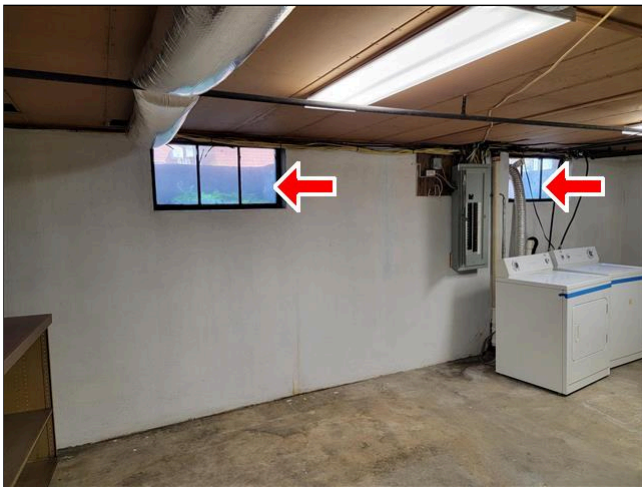
1.6 Item 1(Picture) Basement (Left Wall)

(1) Broken/cracked glass was observed at the noted window(s). Recommend repair to reduce the safety concern and/or restore sealing capacity.

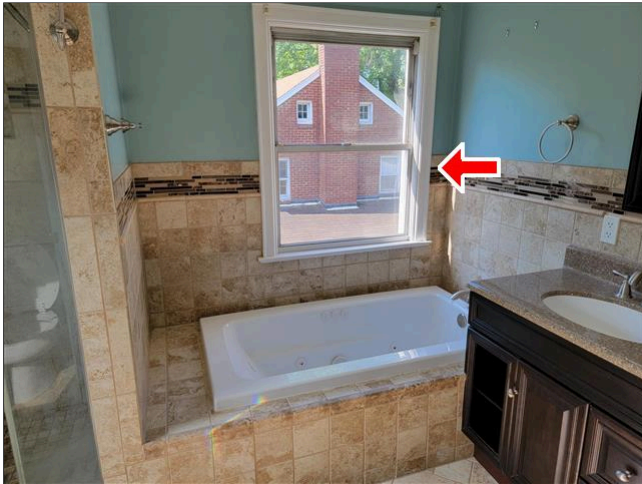
1.6 Item 2(Picture) Upstairs Bathroom

- 🔍 (2) Safety glass was not observed in the noted window. Although replacement windows are not required to meet current safety specifications, the lack of safety glass poses a safety concern if fallen into.

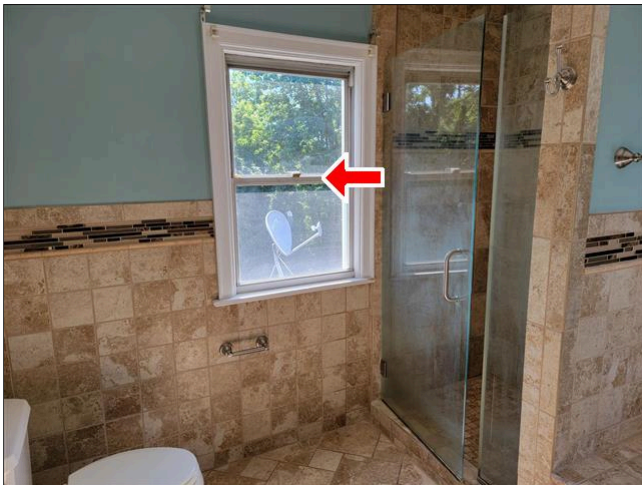
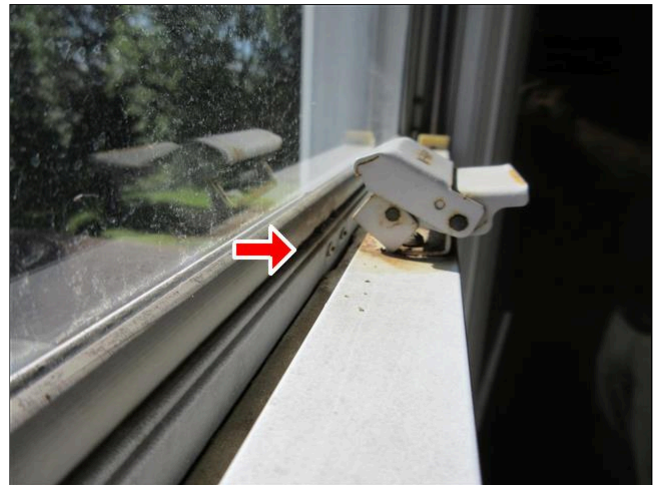
- 🔍 (3) The upstairs bathroom window was missing lock hardware. Suggest installing additional hardware to restore normal locking function.

1.6 Item 3(Picture) Missing Hardware (Upstairs Bathroom)

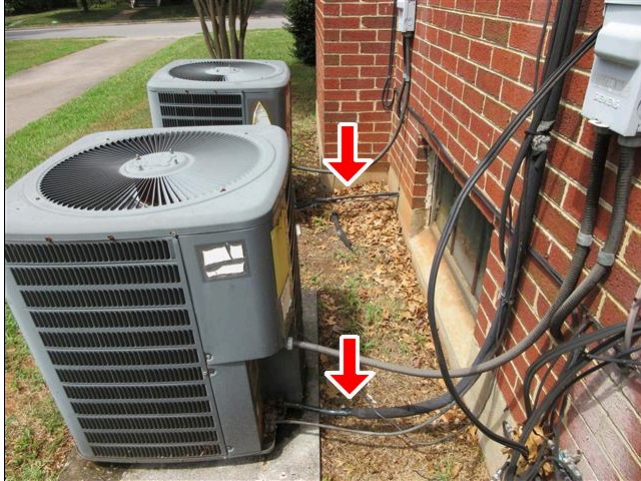
- 🔍 The foam insulation sleeve on the outdoor unit suction line is deteriorated for both units (upstairs and downstairs). Missing/deteriorated foam can cause energy loss and condensation. Suggest installing new foam at both units to reduce the concerns.

2.8.A Item 1(Picture) Suction Lines

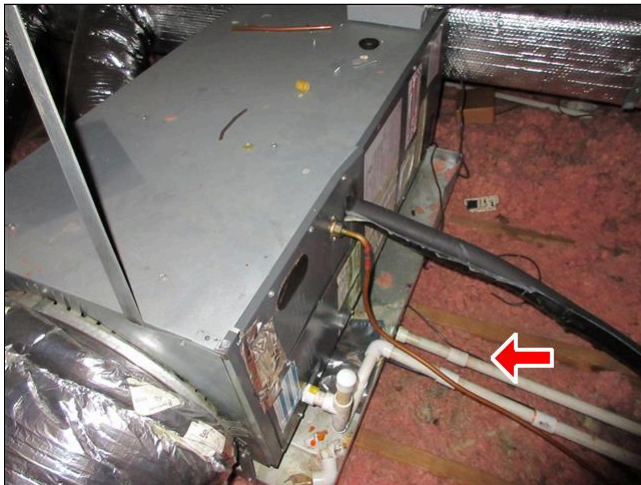
Attic mounted air handlers require special consideration for condensate overflow protection to prevent accidental damage to finished surfaces. Traps, independent drains, trap switches and float switches are just a few of the ways to prevent or warn of overflow conditions. Drains were observed. Although not required, the installation of electronic water detection safety controls would improve the current configuration and reduce the potential of condensate water overflow related damage.

2.9.A Item 1(Picture) Drains Only (Attic Air Handler)

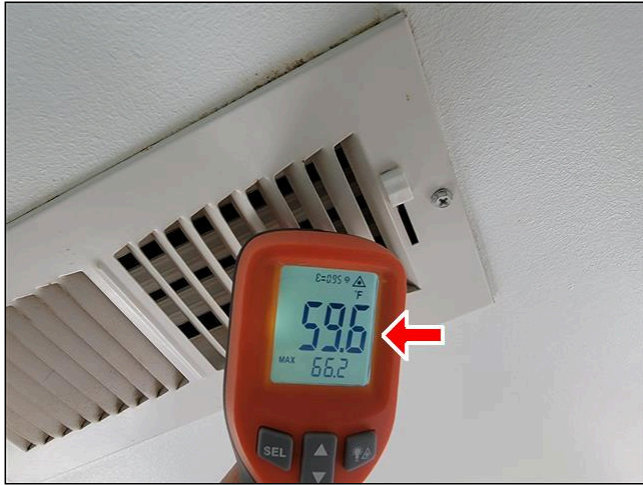
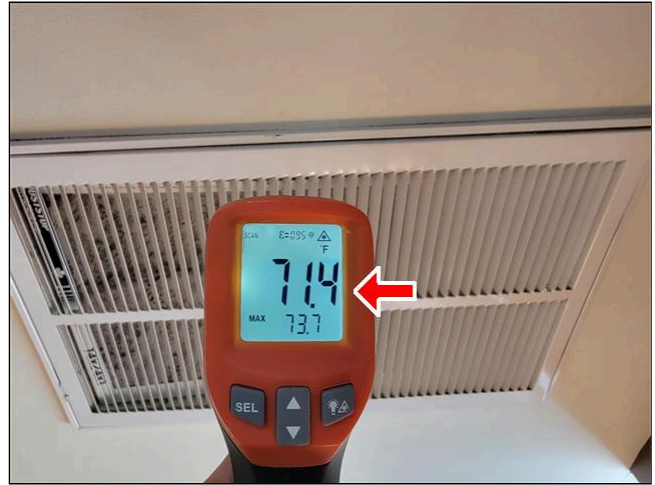
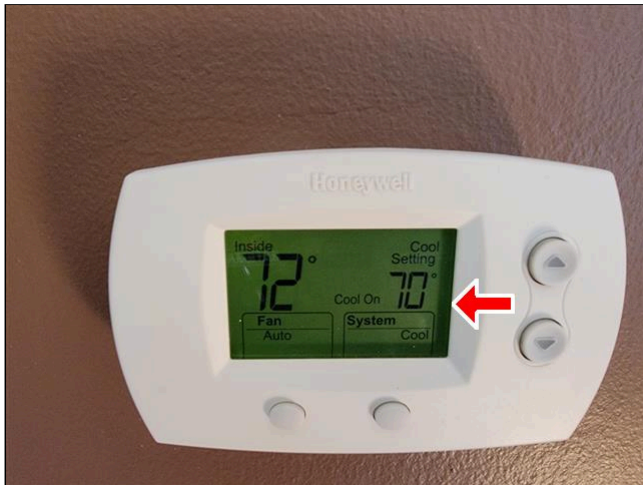
The cooling system was operational but the output was below expected output for a properly operating system. As the system components were functioning, this typically indicates it may be low on refrigerant or other concern. Recommend having a qualified contractor further evaluate the system and repair the unit as necessary.

2.10.A Item 1(Picture) 59.6 Degrees (Supply Temperature)

2.10.A Item 2(Picture) 71.4 Degrees (Return Temperature)

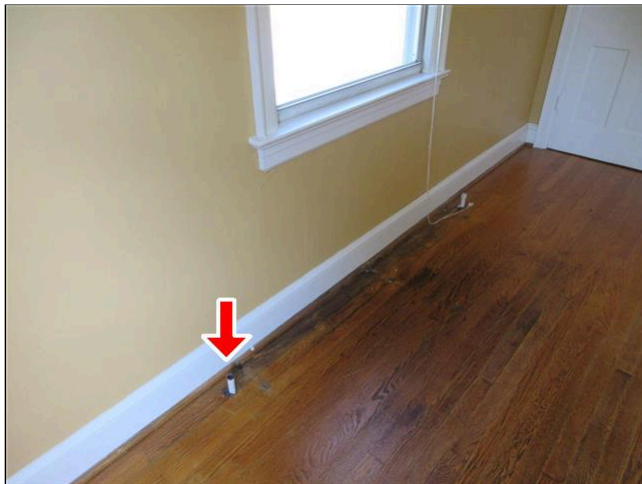
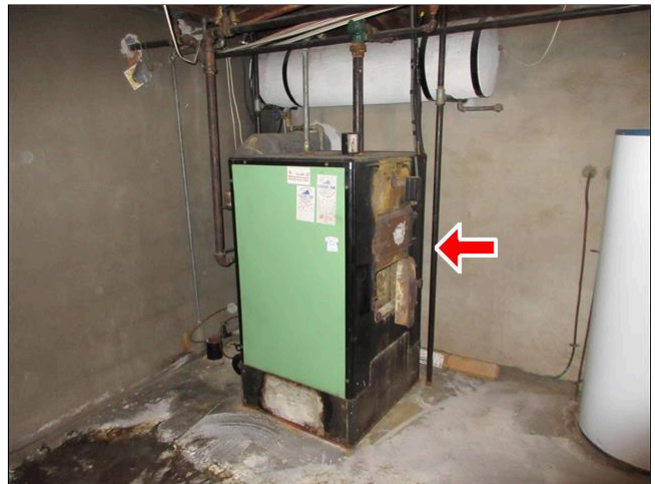
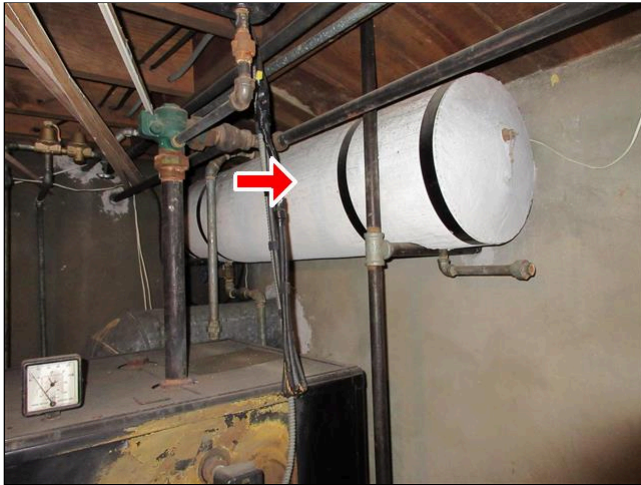
🔍 An old oil fired boiler was still present in the basement. The radiators have been removed but several of the water supply lines have been left behind and uncapped. Suggest removing the lines or capping as needed. Additionally, the tank for the water storage to the boiler is wrapped in a material that may contain asbestos fibers. If left alone, it does not pose a concern. The wrap should not be removed by any means other than trained contractors.

2.0.B Item 1(Picture) Uncapped Radiator Line (Multiple Locations)

2.0.B Item 2(Picture) Old Abandoned Boiler

2.0.B Item 3(Picture) Potential Asbestos Material

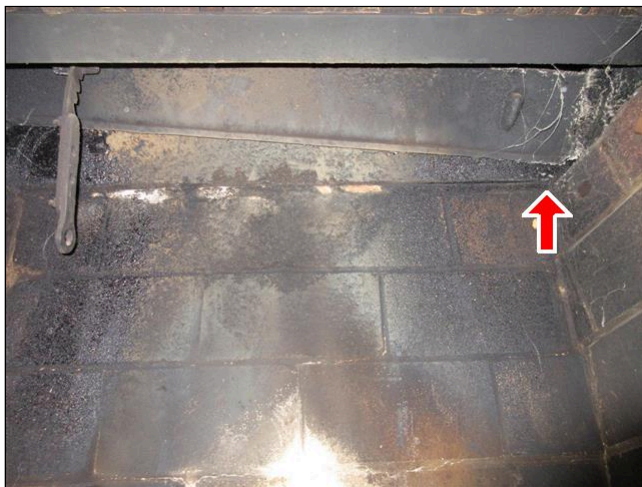
- 🔍 The damper was observed non-functional (seized/not properly positioned) and would not fully open. Suggest having a qualified contractor perform a Level 1 chimney inspection prior to any use to ensure safe and proper operation.

2.5.B Item 1(Picture) View of Damper

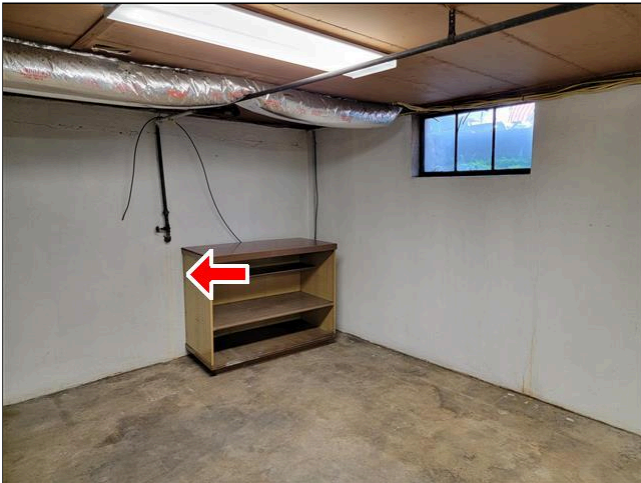
(1) Although no active leaking or elevated levels of moisture were measured at the time of the inspection, staining was present on the foundation wall below the main water line entrance in the basement. Suggest monitoring as future leaks may require additional sealant, or a qualified contractor.

3.1 Item 1(Picture) Staining

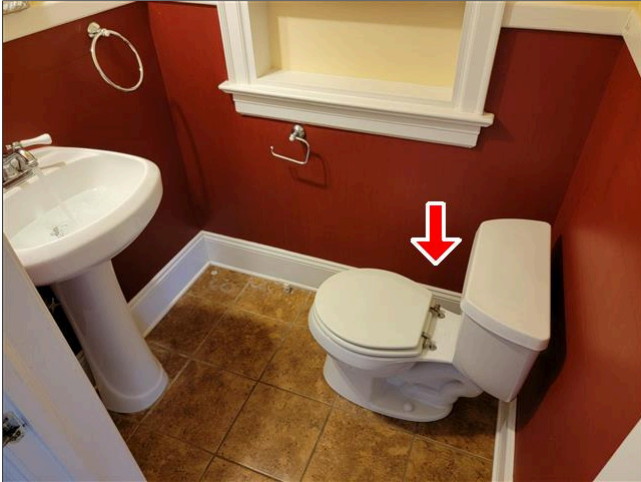
(1) The main level half bath toilet fixture connection to floor was observed loose. This can allow potential leaks and seal damage. Suggest lightly tightening bolts upon moving in and monitoring.

3.2 Item 1(Picture) Loose Toilet (Main Level Half Bath)

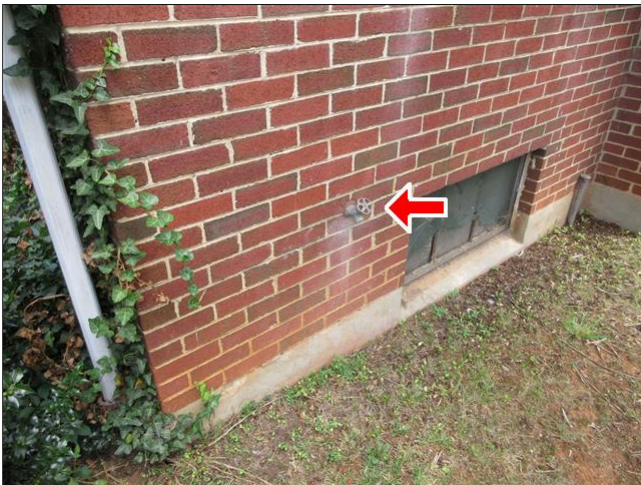
(2) The right side hose bibb was seized and not functional. Suggest repair to restore normal use.

3.2 Item 2(Picture) Seized Handle

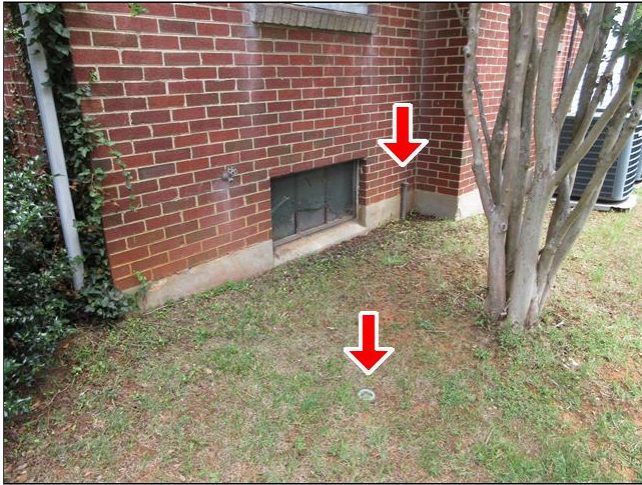
🔍 A fuel oil tank vent and/or fill neck was observed indicating that the fuel oil tank may still be in the the ground. The lines are still routed through the basement wall to the boiler. No soil sampling was performed. Suggest ensuring that the tank has been emptied. It may need to be removed or back filled since the boiler will no longer be utilized, and a tree is growing in this location.

3.4 Item 1(Picture) Fill Neck and Vent (Right Side)

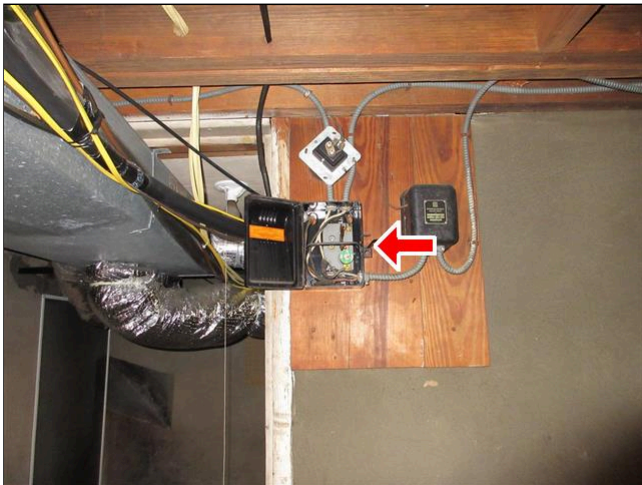
🔍 What appeared to be fuse over-sizing was observed in the boiler fuse box. 12 ga circuit(s) are typically connected to 20 amp breakers, not larger. This is improper and does pose a safety concern as the wire can overheat before the breaker will trip. Suggest removing circuit since the boiler will no longer be utilized.

4.3 Item 1(Picture) 12 gauge wire on 30 amp fuse

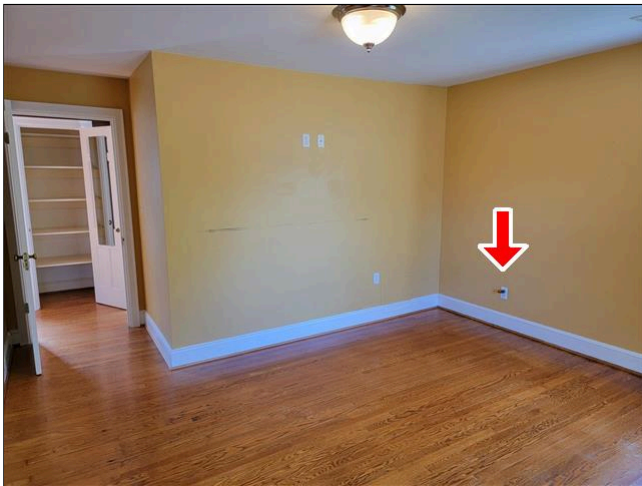
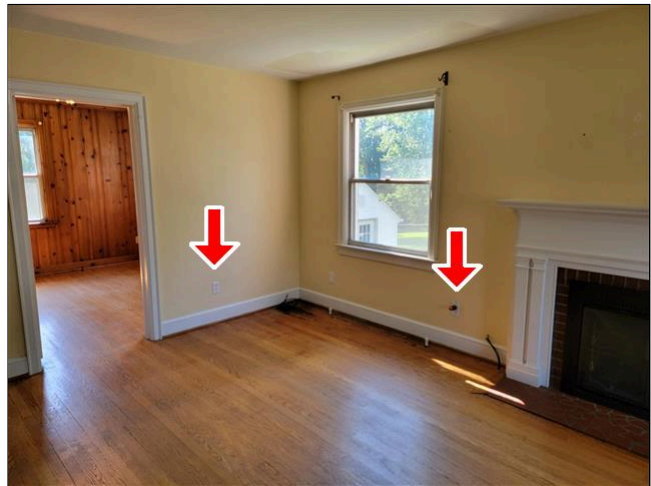
1. The noted outlet(s) were observed with reverse polarity. Although electronic equipment will still function properly, this creates a potential shock hazard. This typically means the hot and neutral wires are reversed. Suggest repair to reduce the concerns.

4.4 Item 1(Picture) Reversed Polarity (Upstairs Front Right Bedroom)

4.4 Item 2(Picture) Reversed Polarity (Living Room)

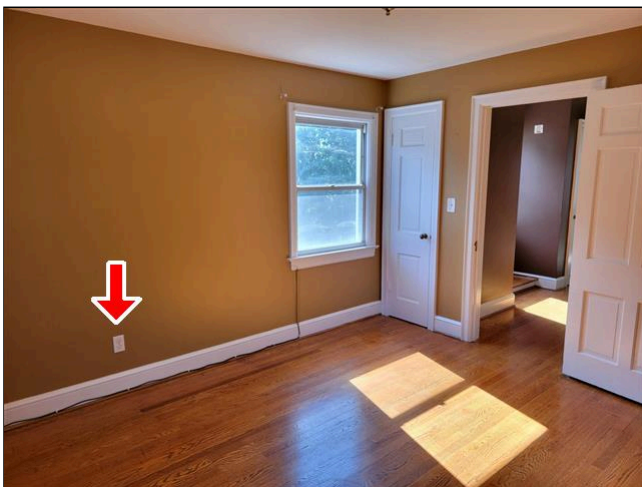
2. Although 3-prong outlets were observed throughout the home, the noted 3-prong outlet was not grounded. Suggest labeling any ungrounded 3-prong outlets as non-grounded or replacing with 2-prong outlets to represent the correct ground configuration.

4.4 Item 3(Picture) Ungrounded (Upstairs Left Rear Bedroom)

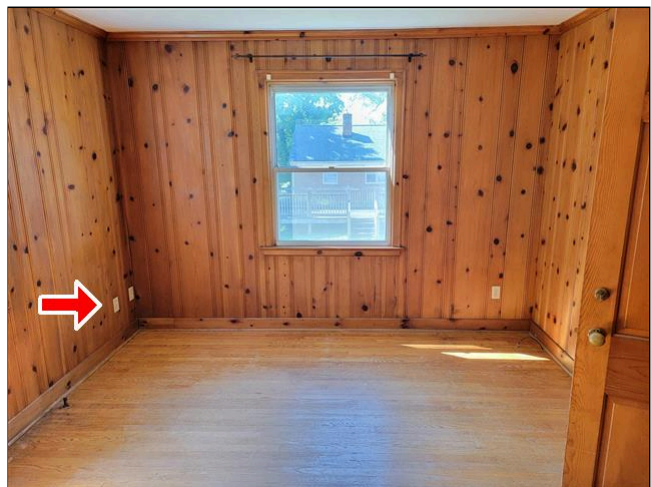
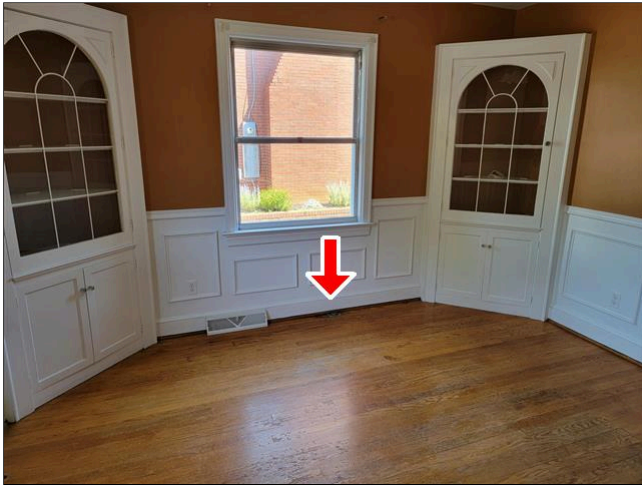
3. The noted outlet(s) were inactive and no switch was located to provide power. They may be disconnected as the plugs were older 220.
4. The doorbell chime did not function.

4.4 Item 4(Picture) Inactive Outlet (Main Level Right Rear Bedroom)

4.4 Item 5(Picture) Inactive Outlet (Dining Room)

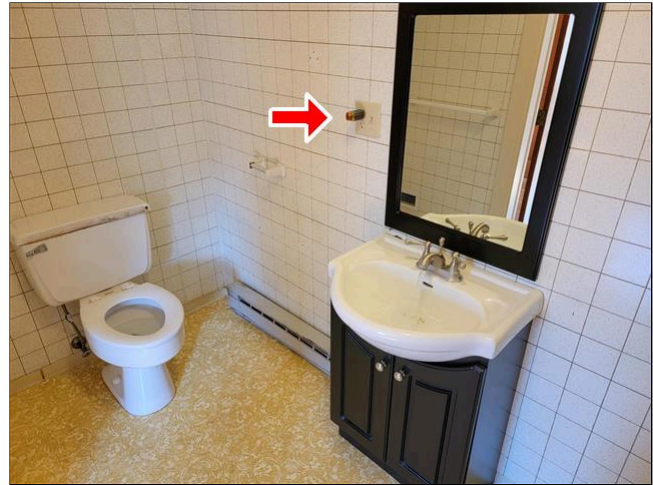
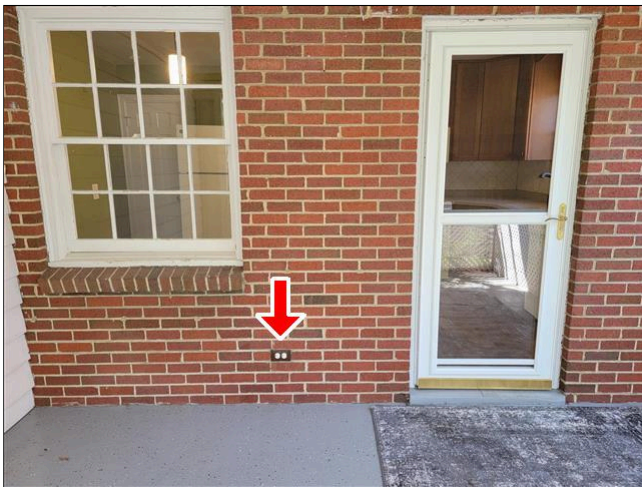
5. The noted wet location outlet(s) were observed ungrounded. Ungrounded outlets near water sources pose an increased shock concern. GFCI devices provide additional electrical safety in these locations. Recommend upgrading noted outlets/circuits to improve electrical safety.

4.4 Item 6(Picture) Ungrounded Wet Location 3 Prong (Main Level Rear Bathroom)

4.4 Item 7(Picture) Ungrounded Wet Location 3 Prong (Screened in Patio)

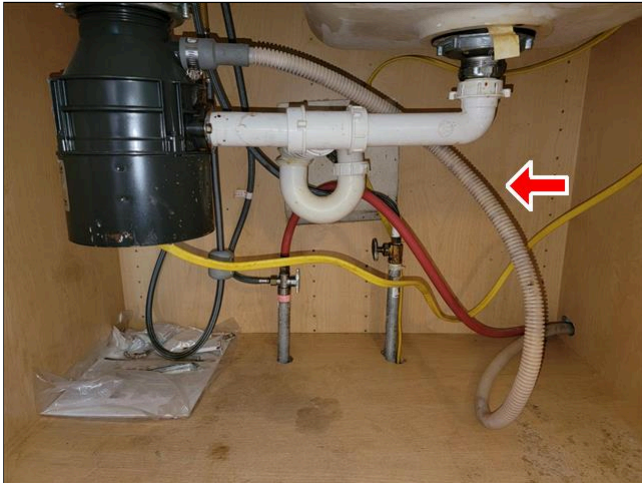
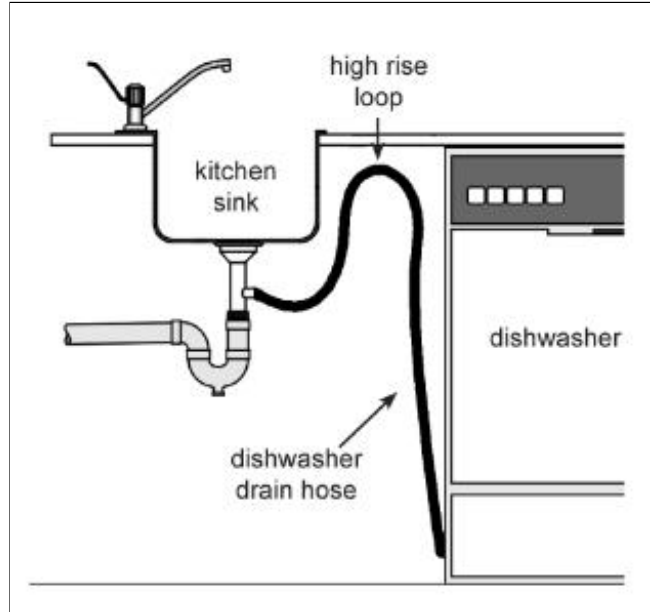
A "High Loop" mount was not observed for the dishwasher drain. A high loop prevents a sink backup from flowing into the dishwasher and is recommended by most manufacturers. Some of which have begun providing high loops built into the back of the dishwasher. Suggest installation of a drain high loop upon moving in (per the sketch) if it cannot be determined if one exists.

5.0 Item 1(Picture) Dishwasher Drain

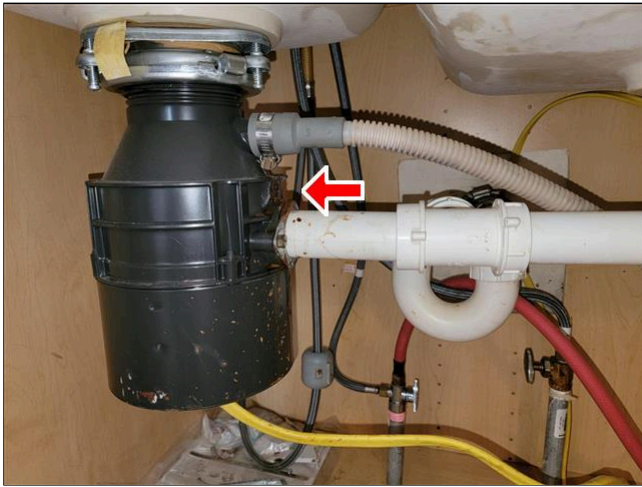
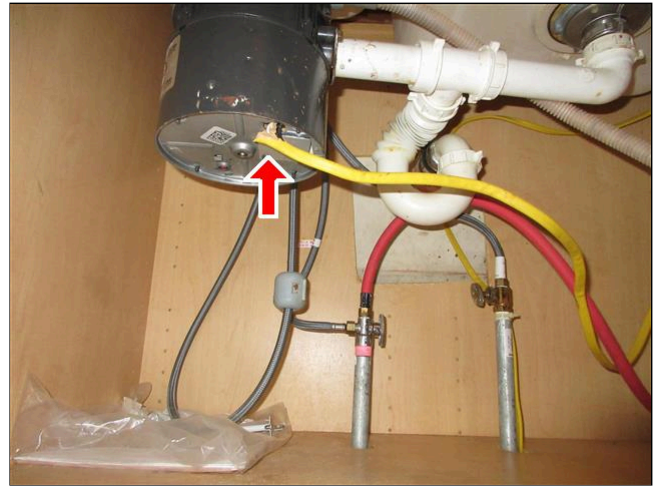
- Although functional, the housing of the disposal unit appears cracked with evidence of a minor leak.
- Suggest replacement of the unit. Additionally, the electrical circuit to the disposal is wired with Non-Metallic Sheathed Wire (Romex). Although once a common practice, this is a soft jacket, solid core wire that can loosen or break due to motor induced vibration or repeated under sink movement. Typically the wiring is incased in secured, flexible conduit or connected with a multi-conductor stranded cord. Additionally the food disposer cord was observed missing the anti-strain device. Installation of an anti-strain device would reduce the potential of cord and disposer damage.

5.3 Item 1(Picture) Cracked Housing and Leaking

5.3 Item 2(Picture) No Anti Strain Device and Exposed Romex

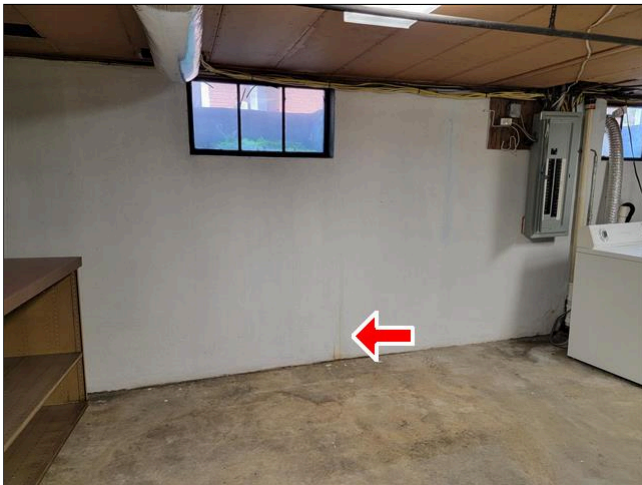
- Minor vertical foundation cracking, and staining was observed. 1/16" and less cracks are common. No observations indicate any current or on going structural concern but due to the staining, water intrusion may occur during a moderate rain event. Suggest sealing any open joints as needed with an approved foundation epoxy/sealer and monitoring. If cracking changes in shape or grows to a gap in excess of 3/16", further evaluation is then recommended by a qualified contractor.

6.0 Item 1(Picture) Staining and Crack (Left Wall)

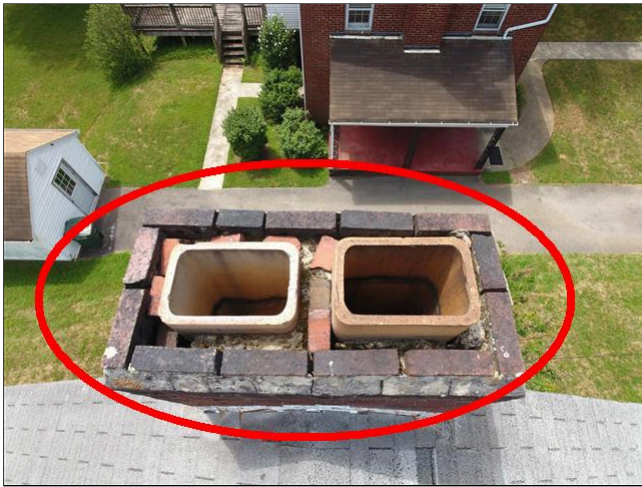
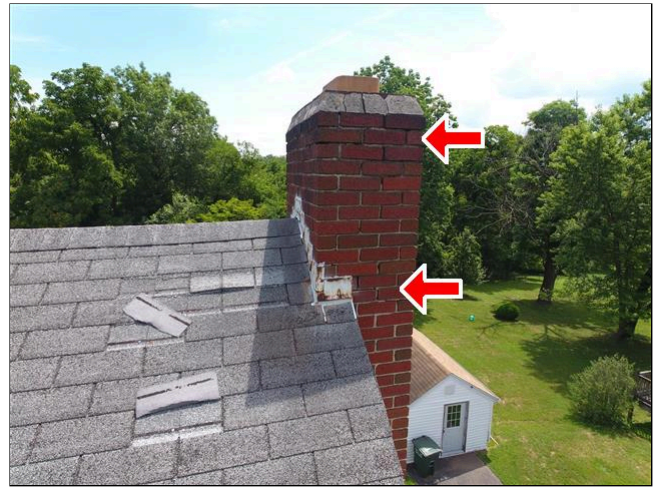
- The crown was observed worn from age and weather with openings, plus mortar joint deterioration was observed in areas. Cracking and open mortar joints can potentially allow water to enter the chimney chase which increases deterioration, especially when the chimney is no longer used or abandoned. The installation of a rain cap over the top of the chimney would be an improvement over the current configuration. Suggest repair to the crown, and re-pointing any mortar joints as needed to reduce future

6.6 Item 1(Picture) Crown Deterioration, and Openings

6.6 Item 2(Picture) Open Mortar Joints (Multiple Locations)

concerns. Recommend having a qualified contractor further evaluate and repair as necessary.

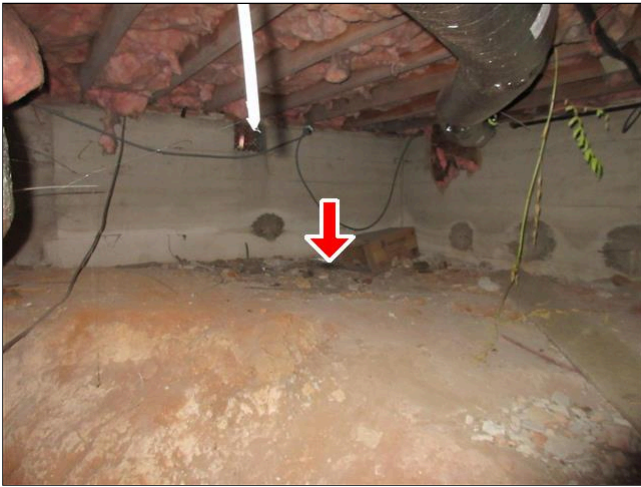
- 🔍 No vapor barrier was observed in the crawl space. A vapor barrier reduces moisture transfer from the ground to the framing and insulation, reduces corrosion and improves the overall condition of the space.

7.2 Item 1(Picture) Exposed Soil

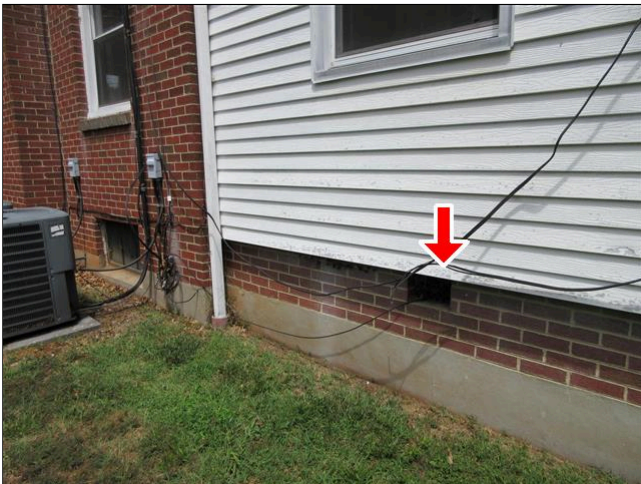
- (1) The crawl space vents were missing screen that can allow for pest intrusion. Suggest installing vent screens to reduce the nesting potential.

7.3 Item 1(Picture) Crawl Space Vents (Both Sides)

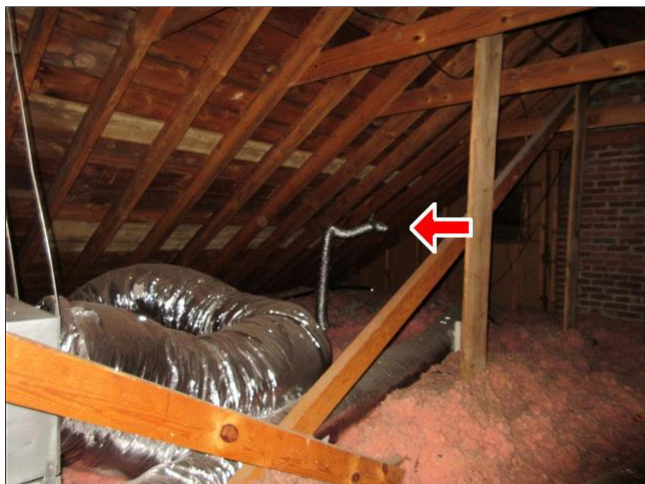
🔍 The upstairs bathroom exhaust fan/ducting was observed discharging directly into the attic space. Although once a common practice, warm and moist air can damage building materials over time. Suggest venting the exhaust to the exterior, or through the roof.

7.4 Item 1(Picture) Upstairs Bathroom Vent Discharge

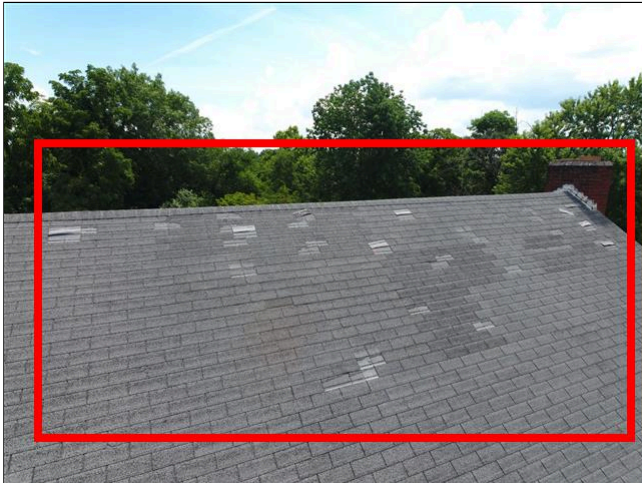
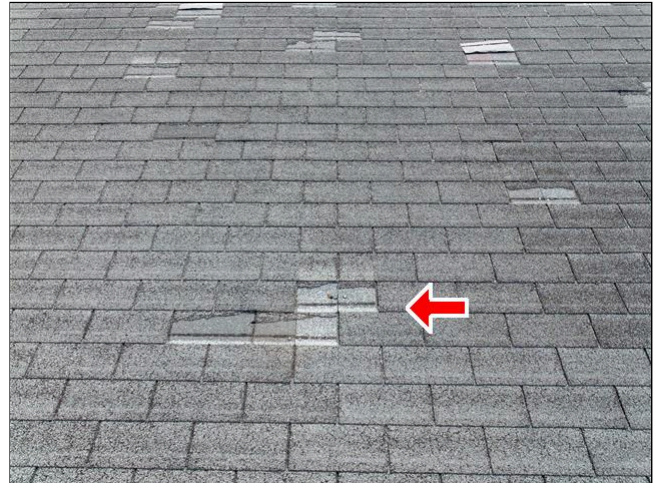
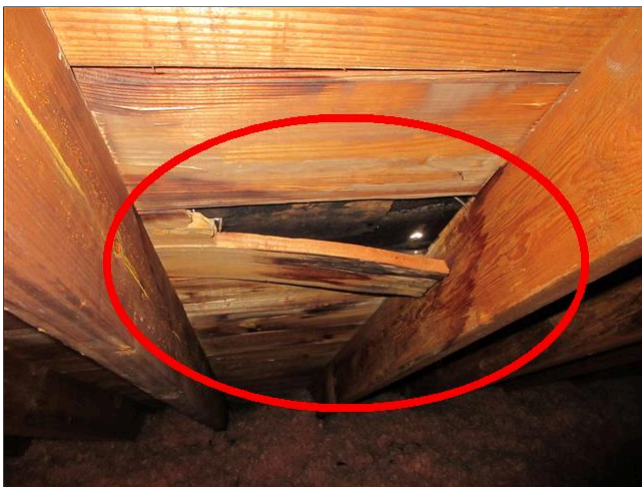
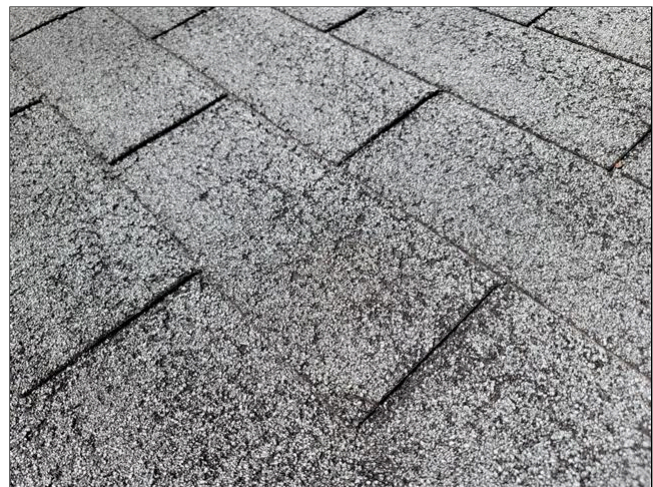
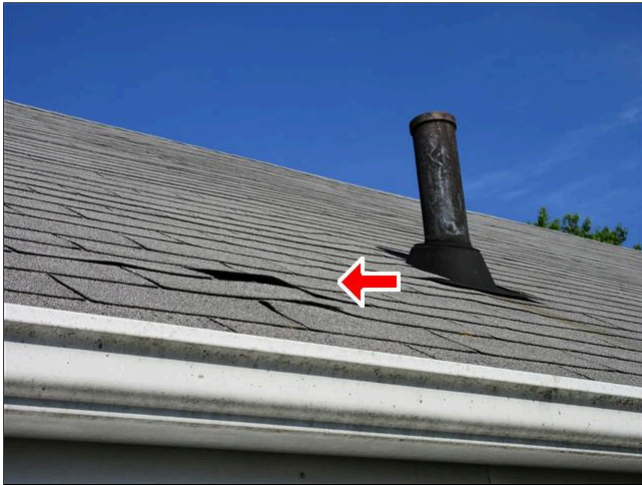
The shingles were observed in worn condition (brittle, granular loss, wind lift, holes, exposed nail heads and nail pops). Observations were made indicating active leaking is occurring. As the shingles appear to be at the end of their typical life expectancy, suggest having a qualified contractor further evaluate and advise on replacement cost/repairs.

8.0 Item 1(Picture) Wind Lift, Exposed Nail Heads, and Openings (Front View)

8.0 Item 3(Picture) Hole and Staining (Multiple Attic Locations)

8.0 Item 4(Picture) Blistering, Brittle and Thinning Edges

8.0 Item 5(Picture) Nail Pops (Rear)

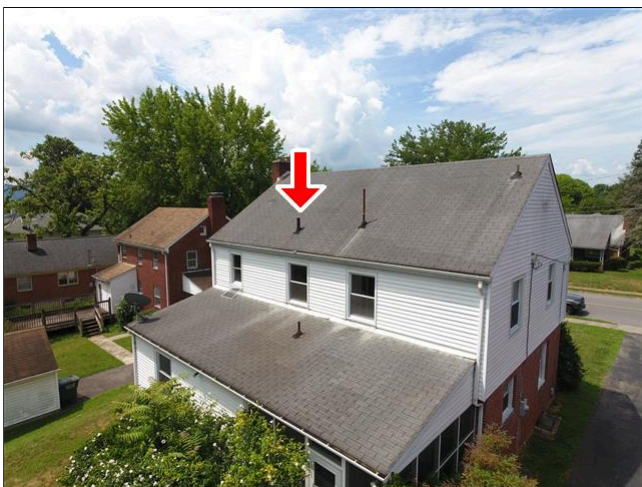
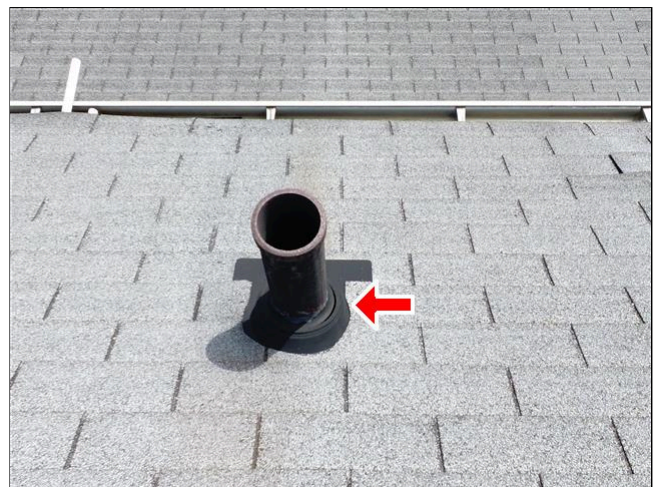
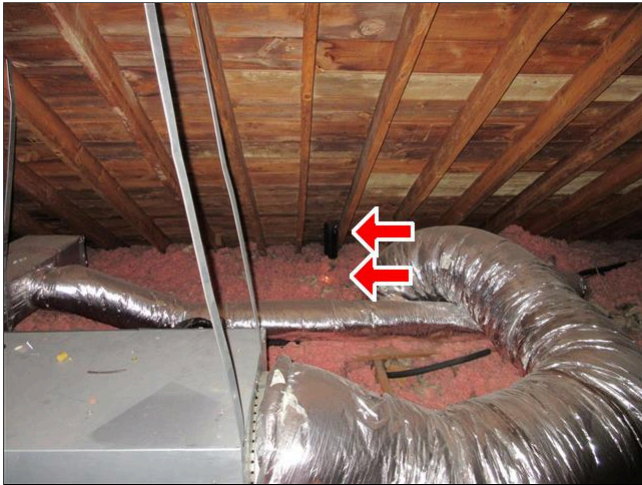
The plumbing vent pipe flange seal has failed with age and exposure. This is common with the age of the roof. Ceiling staining or water intrusion into the attic was observed. Recommend having a qualified contractor evaluate and replace or repair seal as necessary. Caulking is not recommended.

8.2 Item 1(Picture) Failed Seal

8.2 Item 3(Picture) Daylight (Attic View)

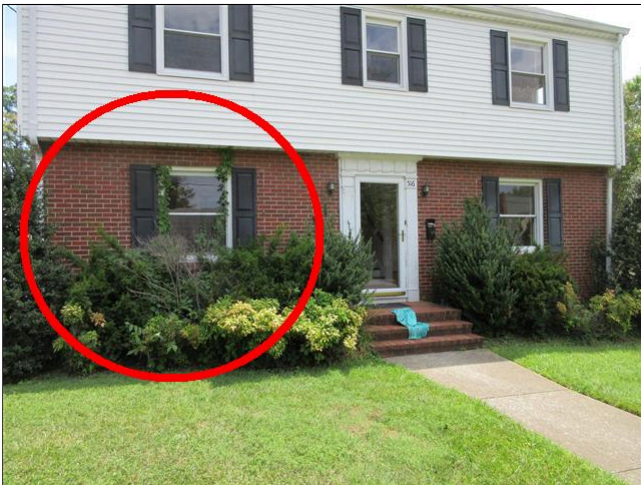
(1) Vegetation was observed in contact with the home at multiple locations. Suggest trimming upon moving in to reduce the potential of contact related material damage.

9.4 Item 1(Picture) Overgrowth (Multiple Locations)
