Pre-Listing Inspection Report

Property Address:
432 N Market Street
Salem VA 24153

Date: 7/2/2024	Time: 09:00 AM	Report ID: 0724432
Property: 432 N Market Street Salem VA 24153	Customer: Catherine Potter	Real Estate Professional:

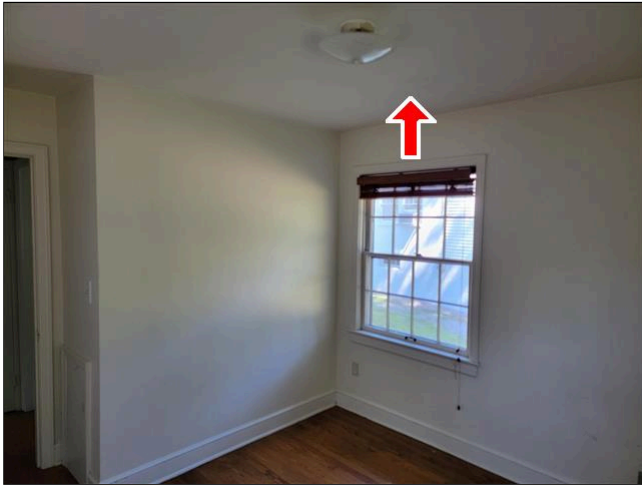
Ceiling staining and disruptions were observed in several areas of the home. No elevated levels of moisture was measured at the time of the inspection. The staining on the main level may be prior to the existing roof or flashing elements. The staining in the basement may be from condensation forming on the non-insulated ducting and dripping on the ceiling materials. Identified for reference.

1.0 Item 1(Picture) Staining (Left Rear Bedroom)

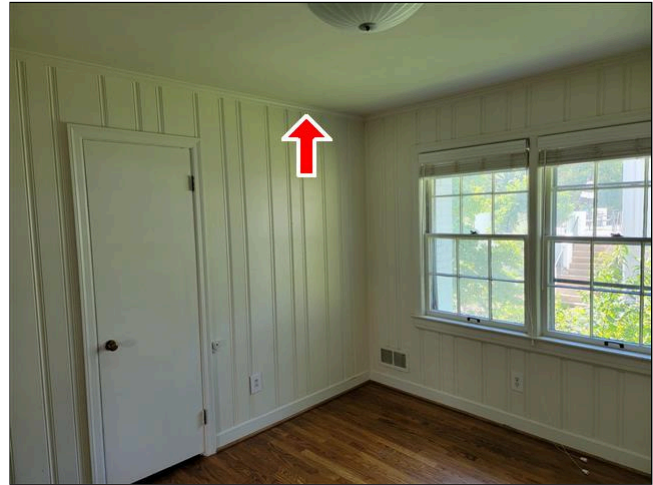
1.0 Item 2(Picture) Staining (Front Right Bedroom)

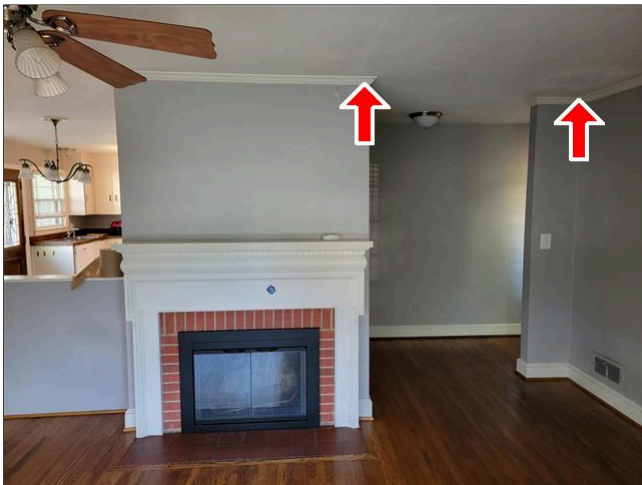
1.0 Item 3(Picture) Staining and Repairs (Living Room)

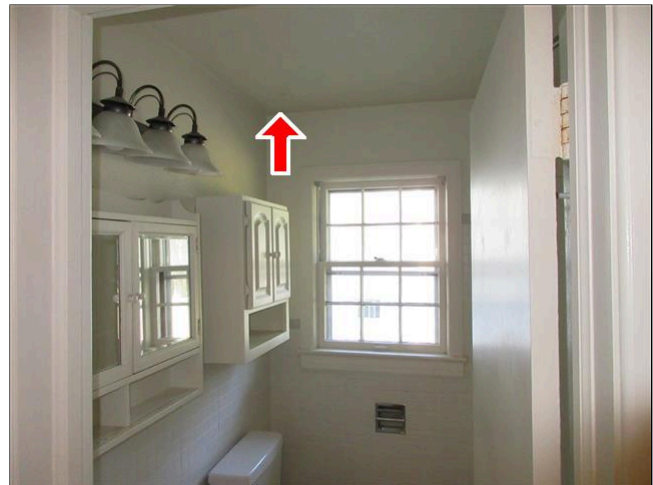
1.0 Item 4(Picture) Disruptions (Main Bathroom Ceiling)

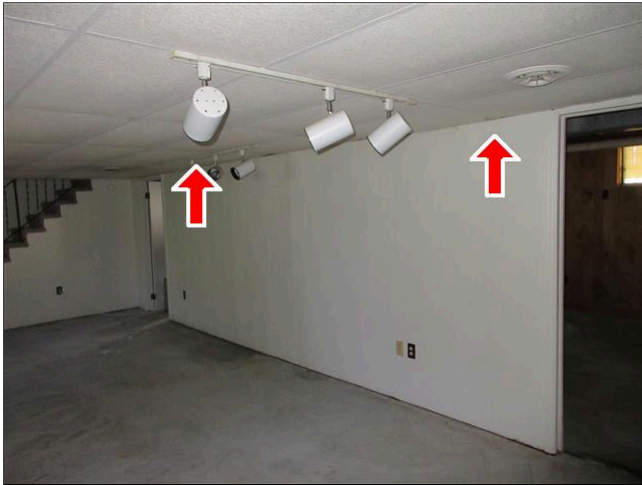
1.0 Item 5(Picture) Staining (Basement Den - Multiple Locations)

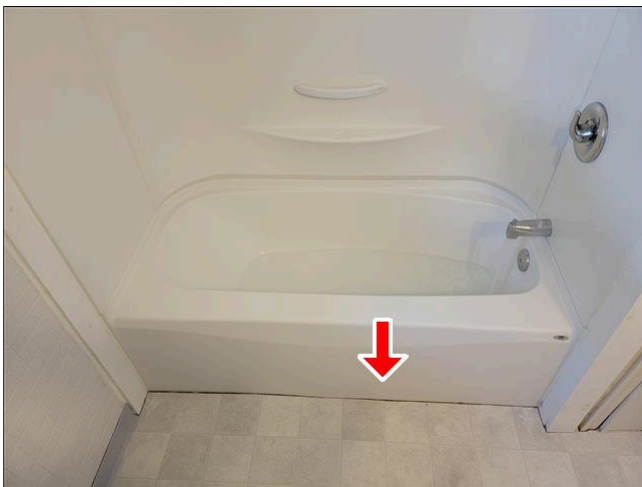
Although typically a cosmetic issue, an open joint was observed around the front of the main bathroom tub. These areas should be sealed upon moving in to reduce the potential of water intrusion behind surfaces.

1.2 Item 1(Picture) Open Joint (Around Main Bathroom Tub)

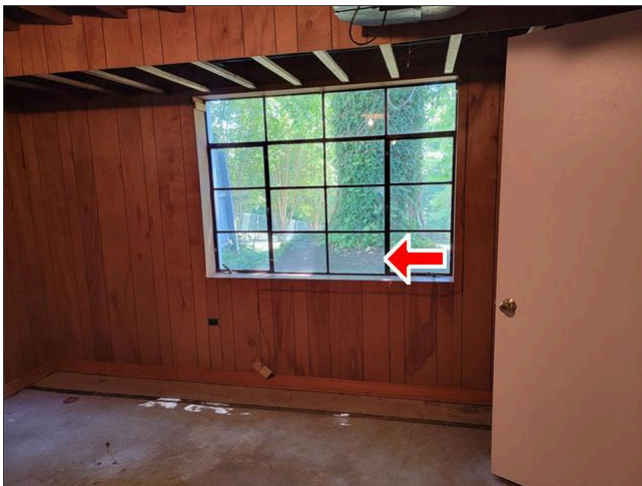
1. Cracked glass was observed at the noted basement bedroom window. Recommend repair to reduce the safety concern and/or restore sealing capacity.
2. The noted window sashes were observed disconnected from the balance. The sash balances are the devices that assists in lifting the weight of the sash and holds the sash in the up position. Window sashes are equipped with one on each side. Suggest caution when lifting the window as property damage and/or personal injury can result from the falling sash. Recommend repair to reduce the concerns.
3. Most basement windows were observed stuck shut due to paint and/or lack of use, plus from the wall framing restricting the windows from opening. This creates a safety concern as it can impede an emergency exit. Suggest repair to restore normal use and to restore normal use.

1.6 Item 1(Picture) Cracked Glass and Seized Windows (Left Rear Basement Bedroom)

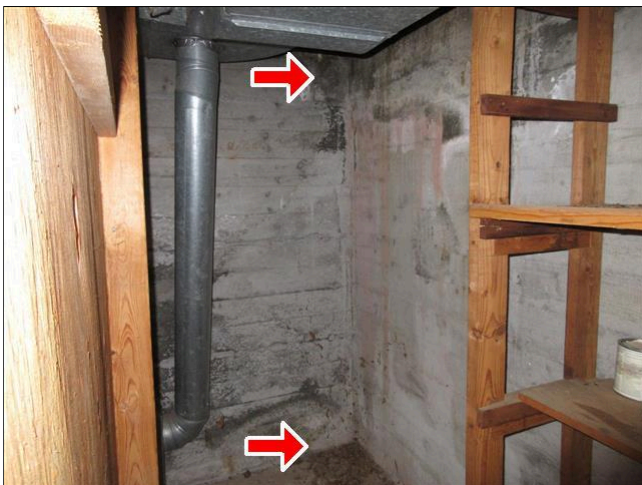
🔍 (1) Although no active water was observed in the basement at the time of inspection, historical indications of water intrusion were noted (staining, repairs, elevated levels of moisture, and potential organic surface growth). It is not uncommon for older basements to leak under certain rain event conditions. If this occurs, improper exterior grading against the home and clogged or improperly discharging gutters are almost always the cause. Poor exterior siding conditions (openings and cracks) can also allow water intrusion at above grade locations. The sill plate has been repaired under the front entrance, but openings are still present on the exterior, and moisture was measured below this area in the basement. Signs of organic surface growth was also observed on the floor joists behind the ceiling panels in the basement den and may be related to past water intrusion events, plus the dampness in the basement. No sampling was performed. Organic growths are typically a result of reduced air circulation, poor climate control, and moisture. Suggest spraying and wiping surfaces that have the organic growths with an approved disinfectant. Constant use of a dehumidifier will significantly reduce surface contamination. Suggest sealing any openings to reduce water intrusion. If leaking occurs, recommend having a qualified contractor further evaluate and advise corrective actions.

1.9 Item 1(Picture) Staining and Elevated Moisture (Below Front Entrance)

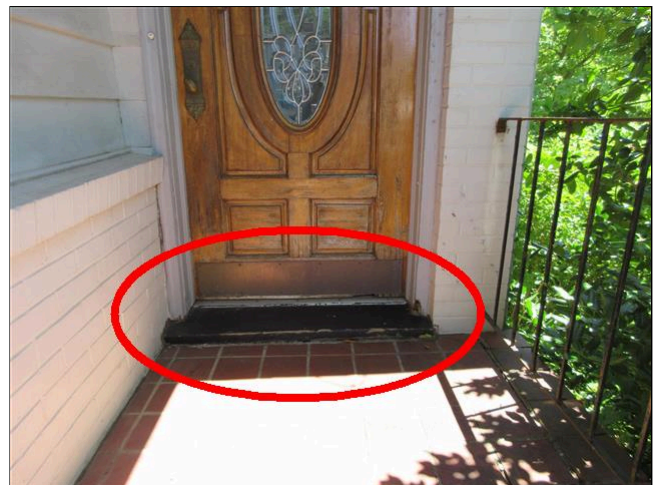
1.9 Item 2(Picture) Openings and Deterioration (Around Front Entrance)

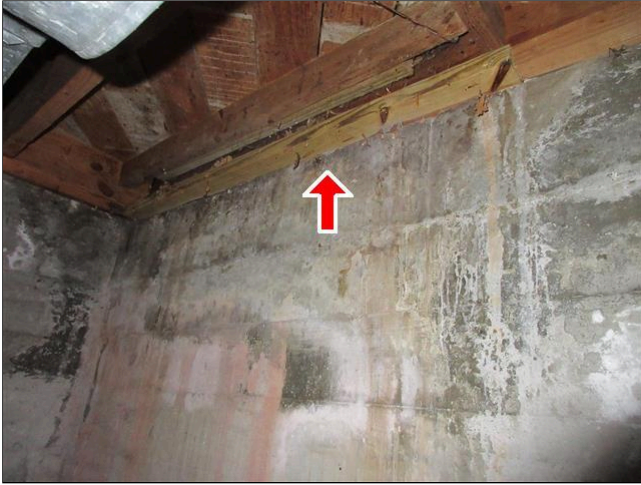
1.9 Item 3(Picture) Sill Plate Repairs

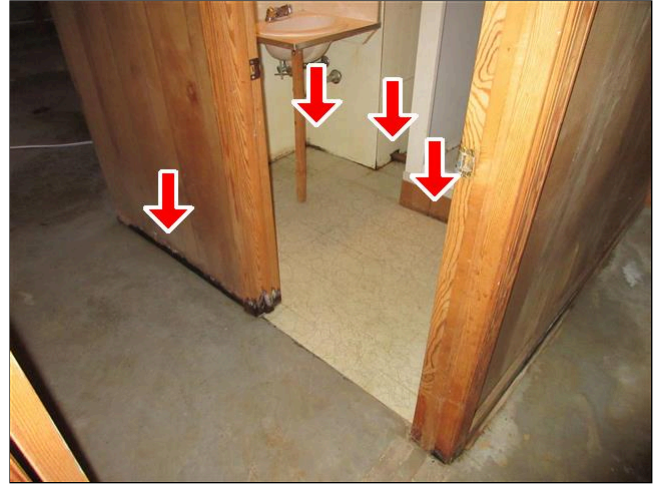
1.9 Item 4(Picture) Staining (Multiple Locations Around the Basement Bathroom)

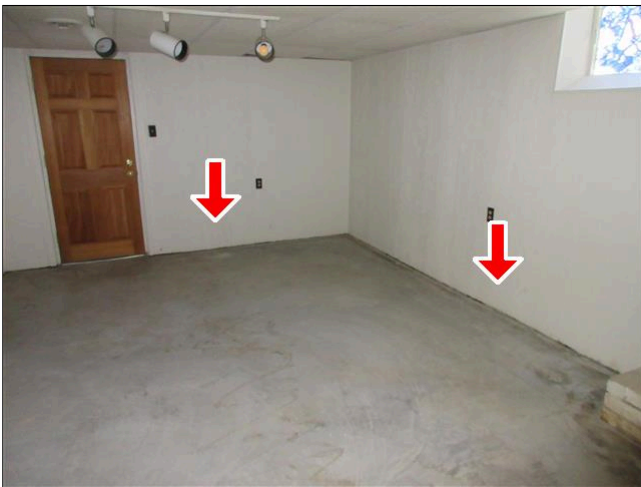
1.9 Item 5(Picture) Staining and Moisture (Basement Den)

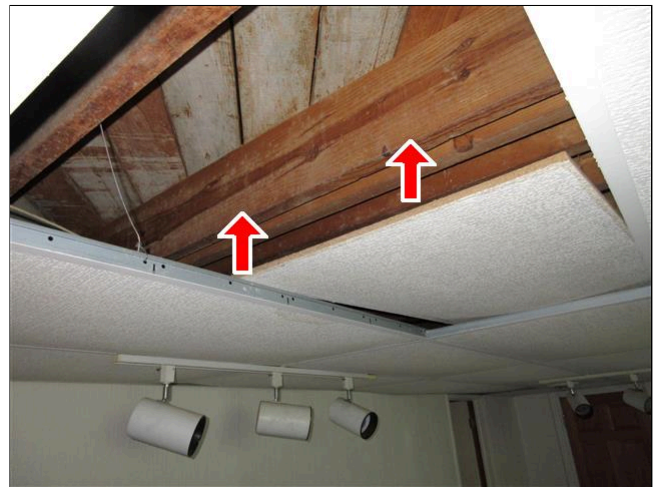
1.9 Item 6(Picture) Organic Growth (Behind Basement Ceiling Panels)

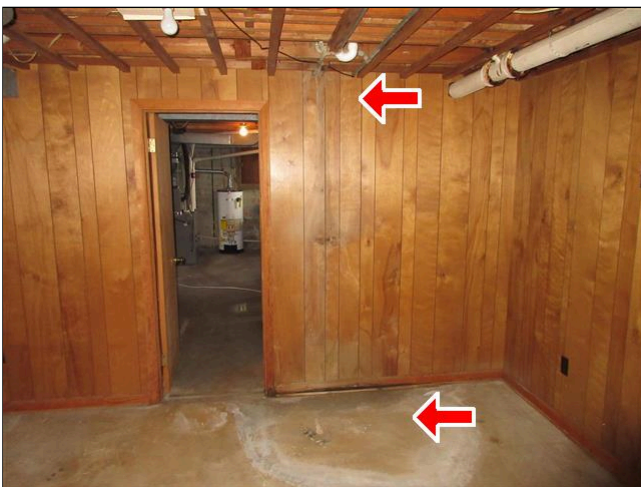
(2) Staining was observed in the rear basement bedroom wall and floor. This appears to be from past leaks in the shower above that has been repaired as no elevated levels of moisture was measured at the time of the inspection, and newer plumbing materials has been installed. Identified for reference.

1.9 Item 7(Picture) Staining

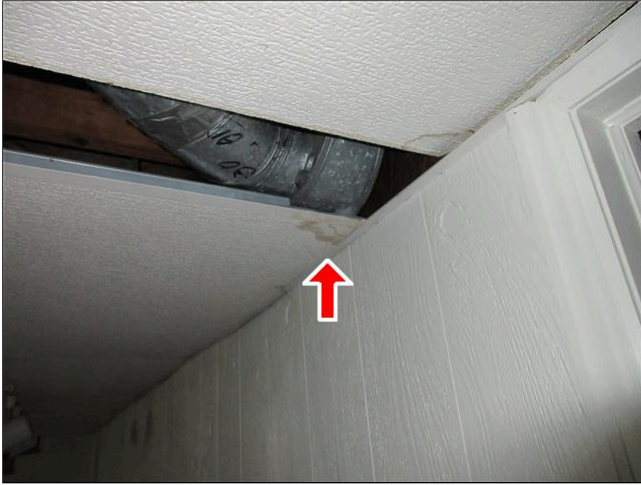
2.3 Item 3(Picture) Condensation Causing Ceiling Staining

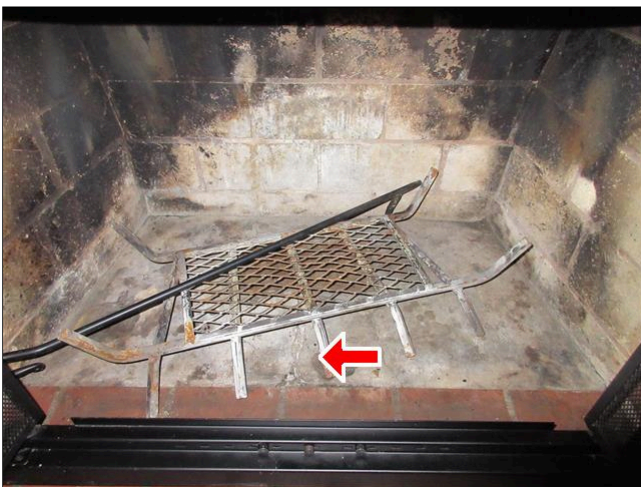
- 🔍 Minor mortar deterioration was observed in the living room fireplace firebox. These areas should be repaired to reduce embers falling in the openings. Suggest having a qualified contractor fully inspect and repair as necessary the firebox prior to any use as a wood burning unit to ensure safe and proper operation.

2.6 Item 1(Picture) Cracking (Living Room Fireplace)

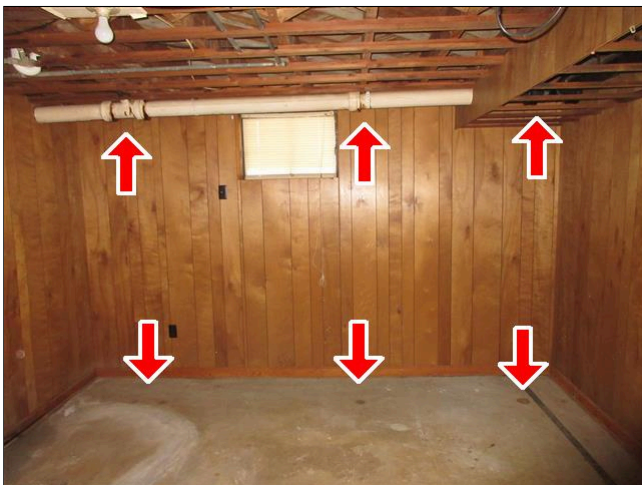
- (1) Staining and drips were observed in areas of the cast iron connections, and at a small section of the galvanized waste line was deteriorated. The drips have caused staining on the floors. This may be from old plumbers putty, or waste line leaks from age. Recommend having a qualified contractor further evaluate these observations and repair any concerns as necessary.

3.0 Item 1(Picture) Staining and Drips (Multiple Locations)

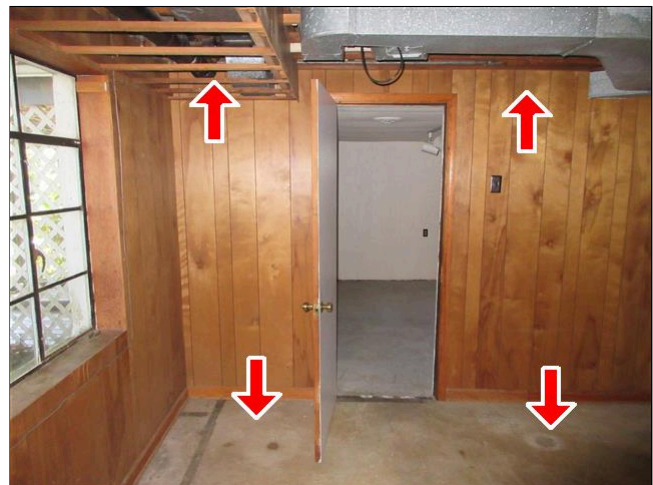
3.0 Item 2(Picture) Staining and Drips (Multiple Locations)

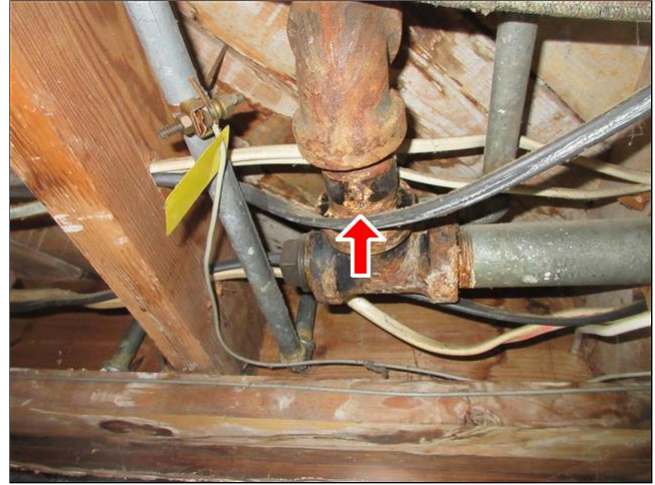
3.0 Item 4(Picture) Additional View of the Corrosion

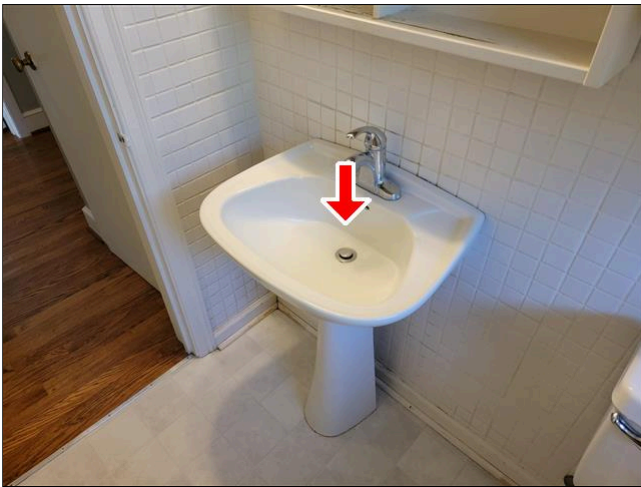
🔍 (2) The main bathroom sink drain was observed draining slowly suggesting that the potential of a near term clog is elevated. Suggest ensuring drains are clear and flowing freely.

3.0 Item 5(Picture) Slow Drain (Main Bathroom Sink)

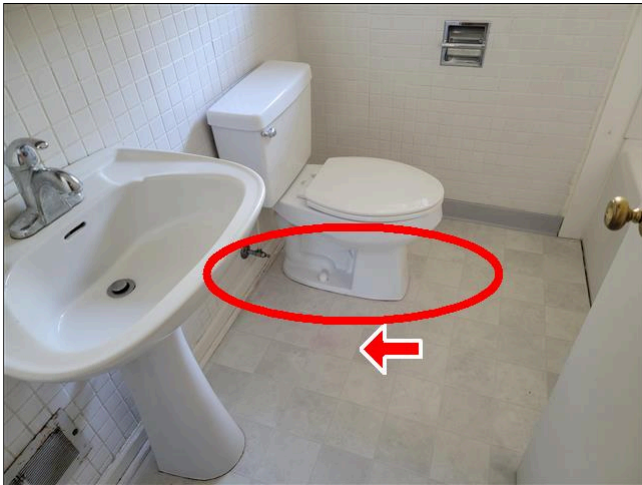
1. Staining was observed on the vinyl flooring materials under/around the main bathroom toilet. The vinyl has changed colors which is typically the indication of a leak. Staining and moisture was present on the flooring materials below in the basement. This is typical of a faulty wax seal. Recommend having a qualified contractor evaluate and repair as necessary.

3.2 Item 1(Picture) Staining and Elevated Moisture (Main Bathroom Toilet)

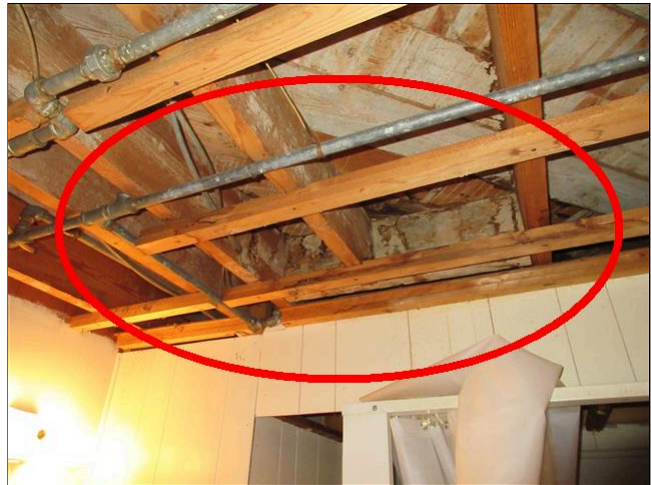
3.2 Item 2(Picture) Staining and Moisture (Below Main Bathroom Toilet)

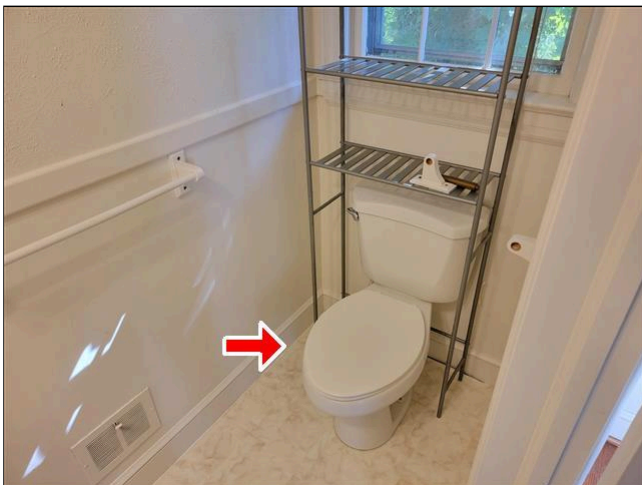
2. The primary bedroom half bath toilet fixture connection to the floor was observed loose (rocking back and forth). This can allow potential leaks and seal damage. Suggest lightly tightening bolts upon moving in and monitoring.

3.2 Item 3(Picture) Loose Toilet (Primary Bedroom Half Bath)

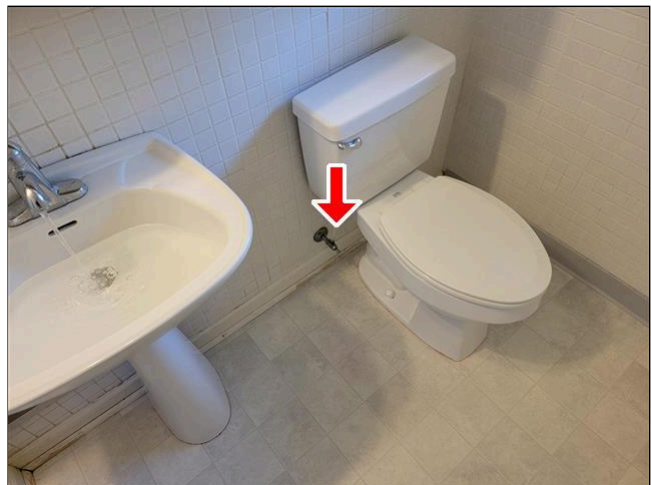
3. Several service valves were missing handles. Suggest installing handles to turn the water off in the event of an emergency.
4. The basement bathroom shower fixture was rusting and deteriorating which can allow for leaks around the fixture. Staining was present in this area. Suggest repair/replacing to reduce the concerns.

3.2 Item 4(Picture) Missing Handle (Main Bathroom Toilet)

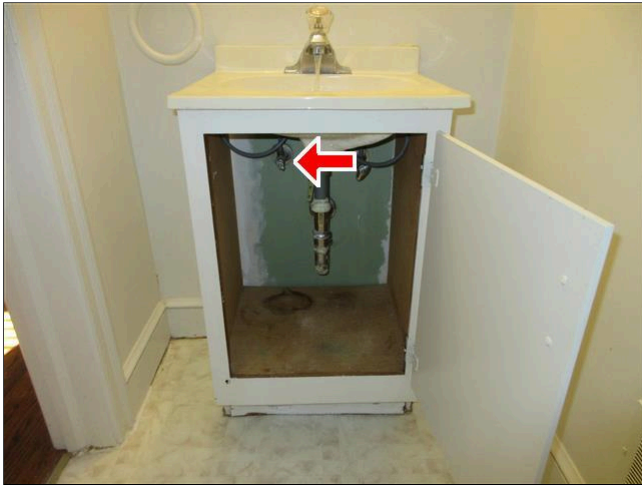
3.2 Item 5(Picture) Missing Handle (Primary Bedroom Half Bath Sink)

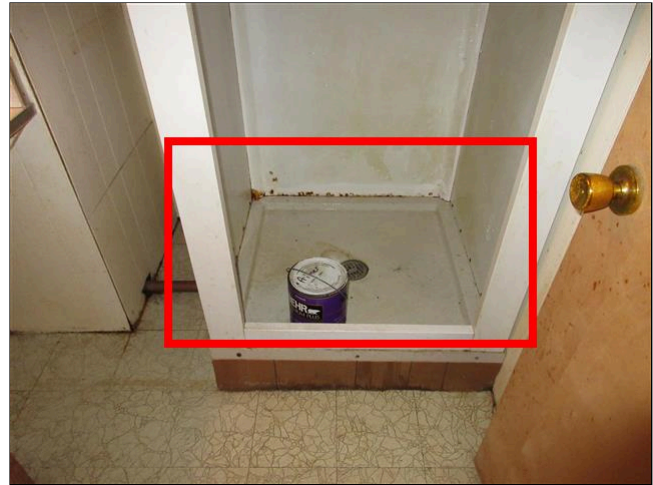
3.2 Item 6(Picture) Rust/Corrosion (Basement Bathroom Shower)

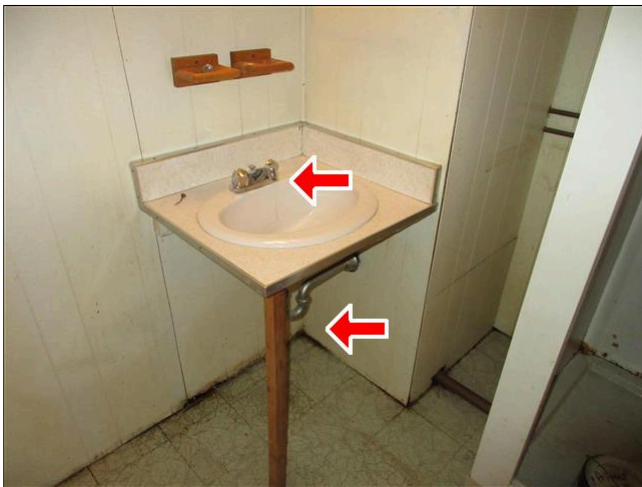
5. The basement bathroom sink was constantly dripping from the faucet, and a leak was observed at the connections below the sink when the trap was flooded. Recommend repair/replacing to correct.

3.2 Item 7(Picture) Constant Drip and Leaking Connections (Basement Bathroom Sink)

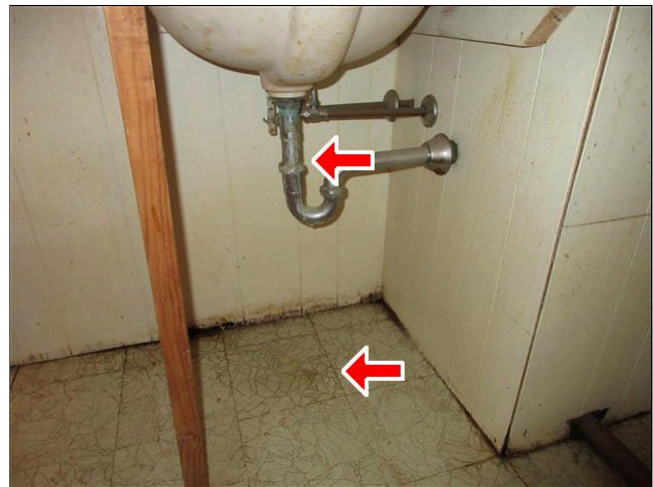
3.2 Item 8(Picture) Additional View of Leak (Below Basement Bathroom Sink)

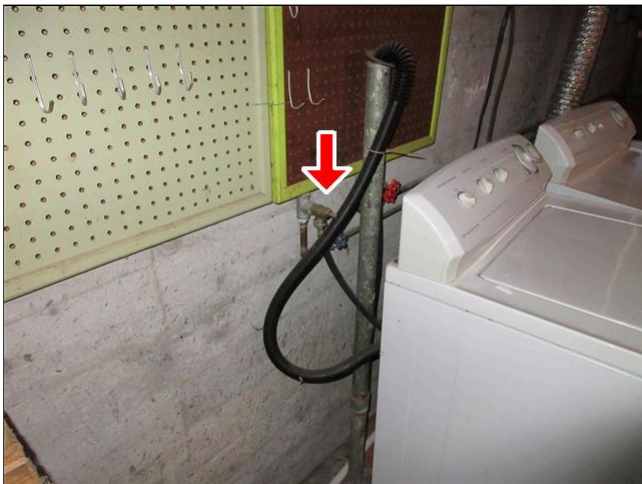
3.2 Item 9(Picture) Missing Handle (Basement Washing Machine)

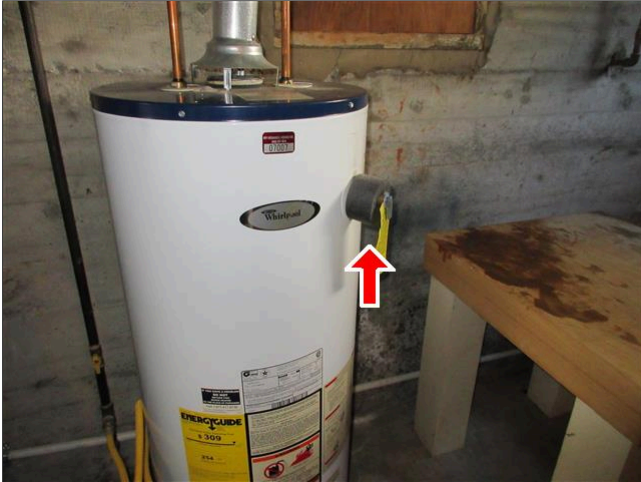
- (1) No temperature / pressure (T&P) relief valve discharge pipe was observed attached to the water heater at the time of inspection. The T&P relief valve on the water heater is designed to safely discharge

hot water in the event of a water heater failure. A 3/4" discharge pipe is required to safely direct the discharging hot water to within 6" of the floor. Suggest installation of a discharge pipe.

3.3 Item 1(Picture) No Discharge Tube

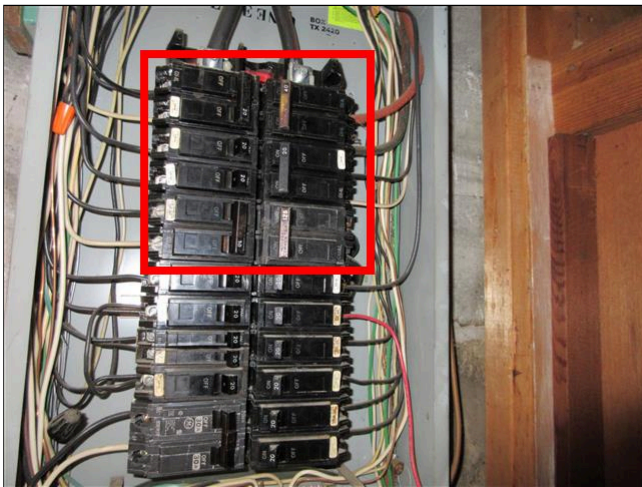
- 🔍 (1) More than 6 hand movements were observed necessary to remove all power from the home. An excessive number of main breakers creates a potential accidental shock hazard. The panel was also not labeled correctly. Recommend having a qualified contractor evaluate and correct as necessary.

4.2 Item 1(Picture) 7 Hand Movements

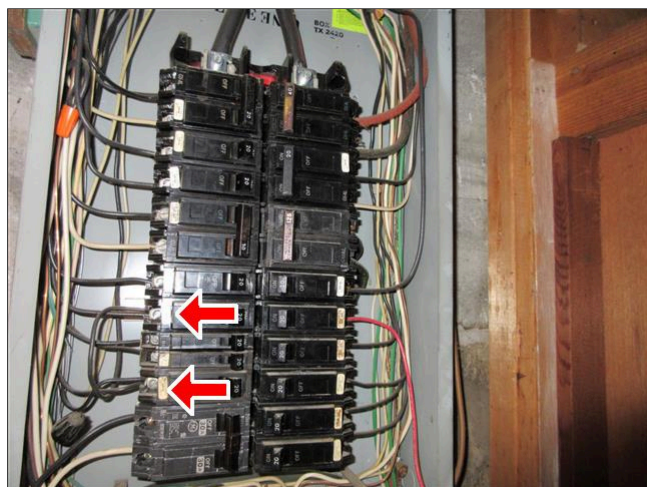
- 🔍 Breaker double tapping (two or more wires under one breaker terminal) was observed in the electrical panel. Many breaker manufacturers do not allow double tapping and consider it a safety issue. Suggest

installation of additional breakers or "pigtail" the existing circuits to correct the concern.

4.3 Item 1(Picture) Double Taps

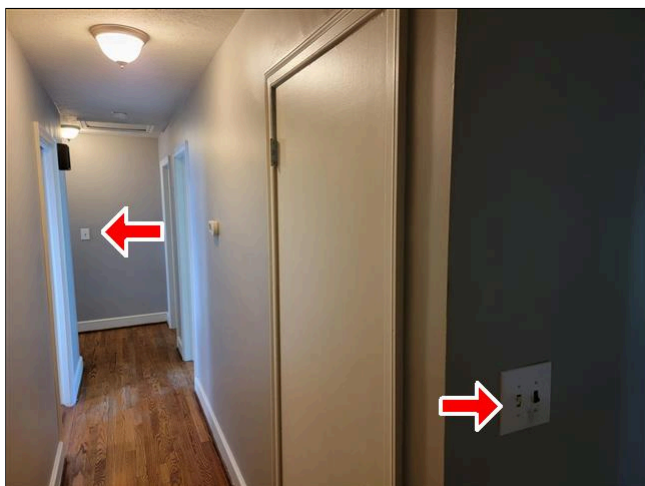
1. Although functional, the noted light switch combinations appear to be improperly configured. Suggest repair to restore normal use. Recommend having a qualified contractor evaluate and repair as necessary.

4.4 Item 1(Picture) Hall Light Switch Combination

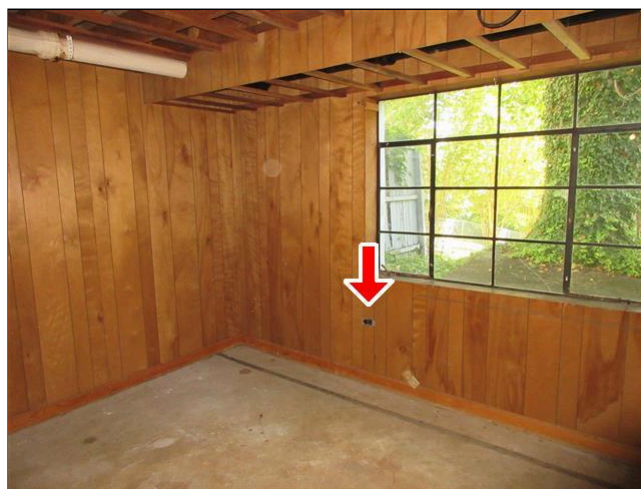
3. A broken outlet was observed in the rear basement bedroom. This is an increase for electrical shock. Suggest replacing the outlet to reduce the concern.

4.4 Item 4(Picture) Broken Outlet (Rear Basement Bedroom)

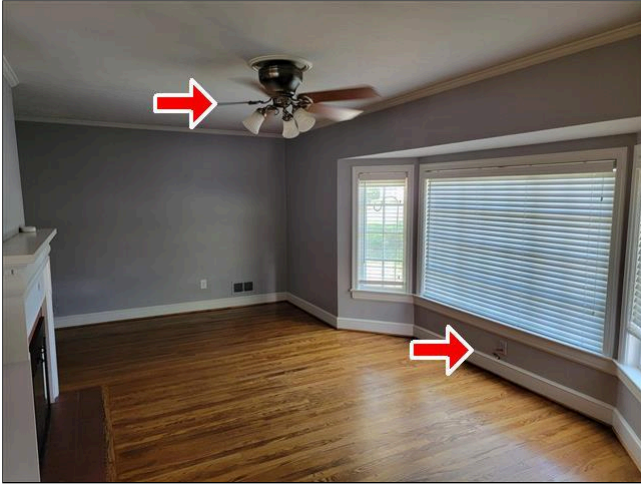
5. The living room ceiling fan and front wall outlet both operate by a wall switch. Identified for reference.

4.4 Item 5(Picture) Same Circuit (Living Room Ceiling Fan and Outlet)

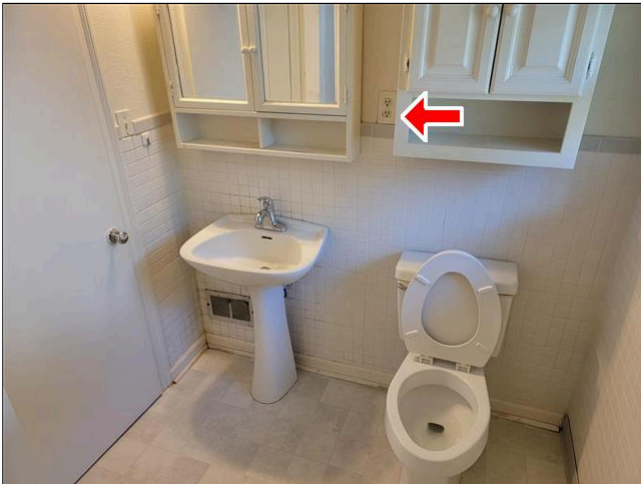
- 🔍 (1) The noted wet location outlet(s) were observed without GFCI protection. Ungrounded outlets near water sources pose an increased shock concern. GFCI devices provide additional electrical safety in these locations. Recommend upgrading noted outlets/circuits to improve electrical safety.

4.5 Item 1(Picture) Ungrounded 3 Prong (Main Bathroom)

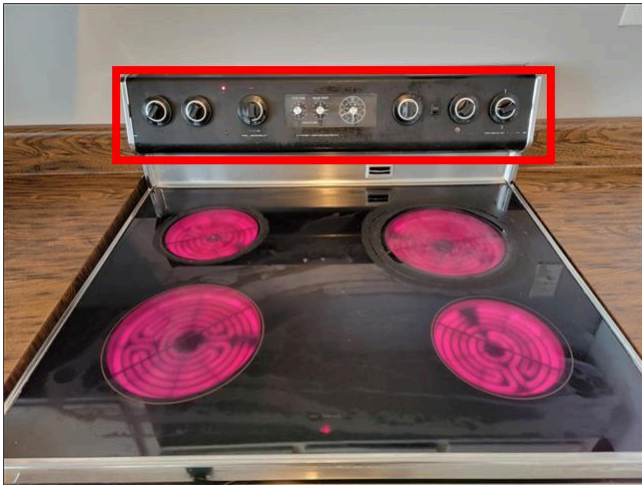
(1) Although functional, the range lettering was worn off on the control panel reducing the ability to identify the setting for the burners, and oven controls. Suggest labeling to identify settings or replacing.

5.1 Item 1(Picture) No Control Panel Lettering Indicators

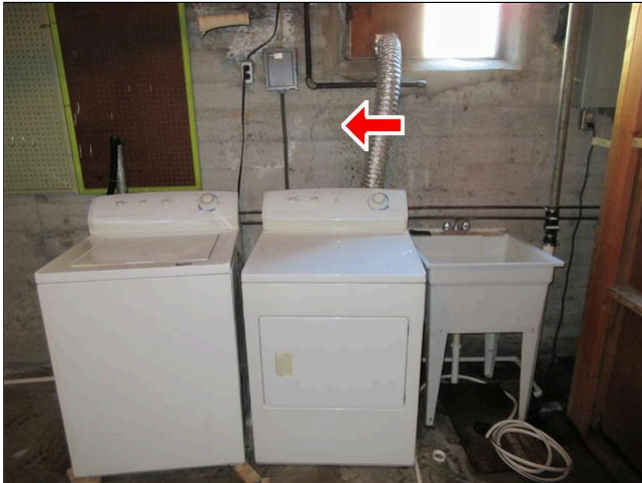
- 🔍 Vertical foundation cracking and staining was observed. No observations indicate any current or on going structural concern. Suggest sealing any open joints with an approved foundation epoxy/sealer and monitoring. If cracking changes in shape or grows to a gap in excess of 3/16", further evaluation is then recommended by a qualified contractor.

6.0 Item 1(Picture) Crack and Staining (Basement Left Wall)

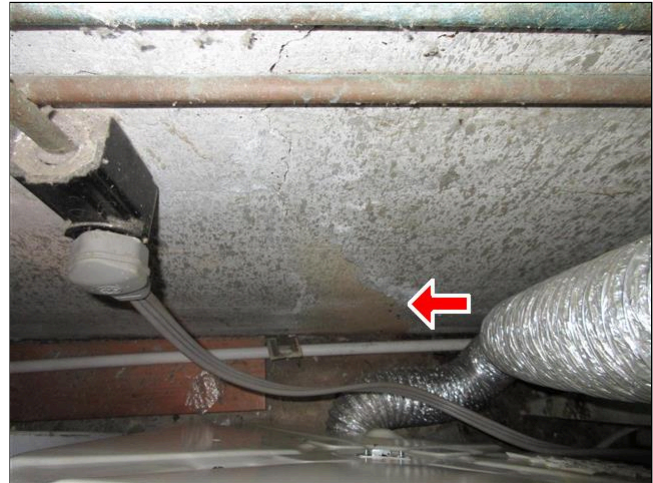
6.0 Item 2(Picture) Staining (Bottom of the Crack)

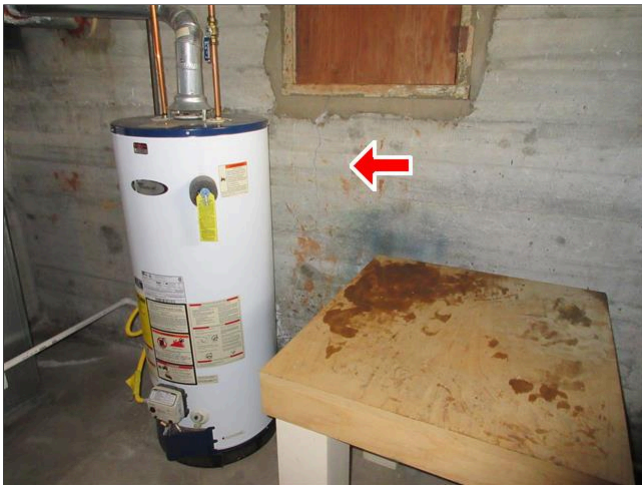
6.0 Item 3(Picture) Crack (Below Crawl Space Entrance)

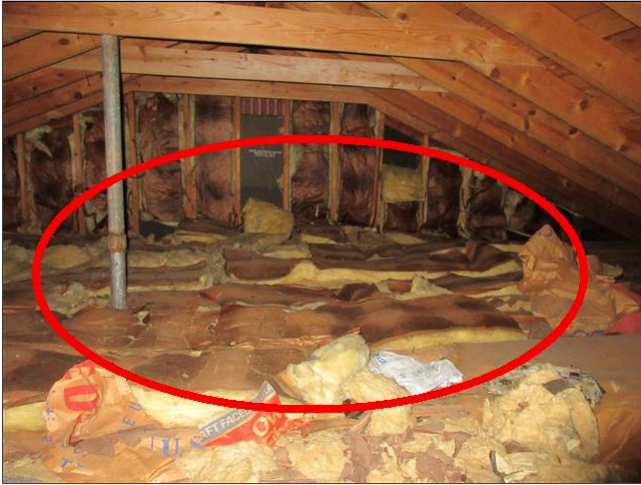
Areas of the insulation were improperly installed in the attic with the paper side facing up. Typically faced insulation is installed with the paper side facing the ceiling materials. Suggest flipping insulation.

7.0 Item 1(Picture) Faced Insulation

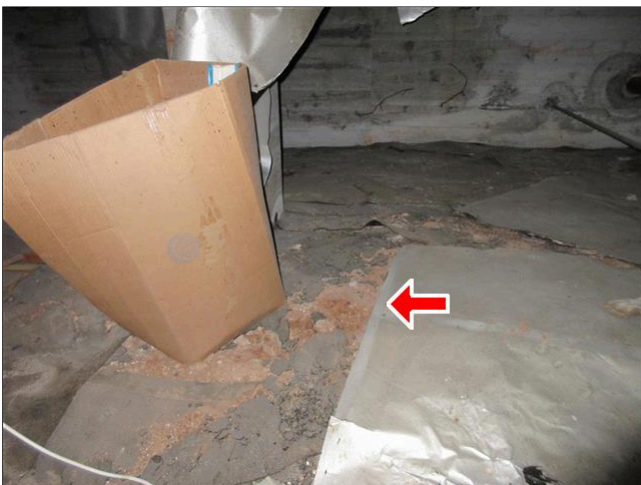
- 🔍 The vapor barrier was deteriorated in areas of the crawl space. A continuous vapor barrier reduces moisture transfer from the ground to the framing and insulation, reduces corrosion and improves the overall condition of the space. Suggest replacing damaged materials.

7.2 Item 1(Picture) Deterioration and Exposed Soil

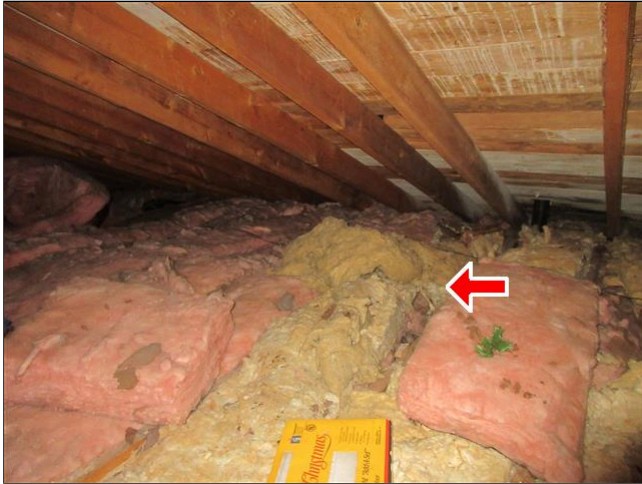
🔍 The kitchen exhaust fan/ducting was observed discharging directly into the attic space. Although once a common practice, warm and moist air can damage building materials over time. Suggest venting the exhaust to the exterior, or through the roof.

7.4 Item 1(Picture) Kitchen Exhaust Discharge (Under the Insulation)

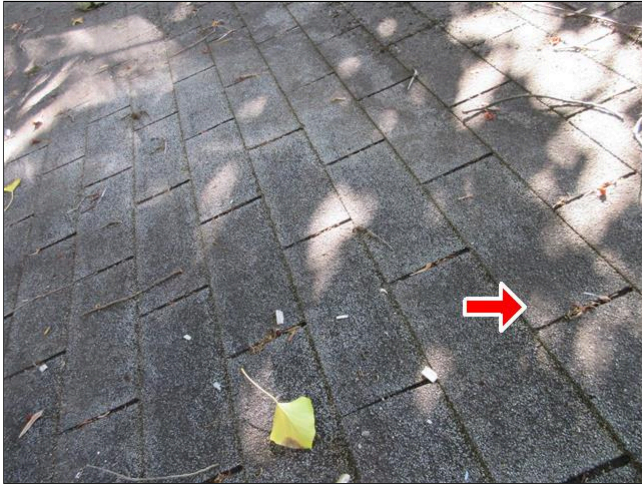
The shingles were observed in worn condition (granular loss at the rear, blistering over the home, and what appeared to be areas of hail impact). No active leaking was observed and the shingles over the home were not brittle. The blistering may be from inadequate attic ventilation. Suggest having a qualified contractor further evaluate and advise on replacement for the rear, and advise if corrective actions are necessary due to the blistering and potential hail impact on the shingles over the home.

8.0 Item 1(Picture) Granular Loss and Brittle Shingles (Rear Patio Roof Shingles)

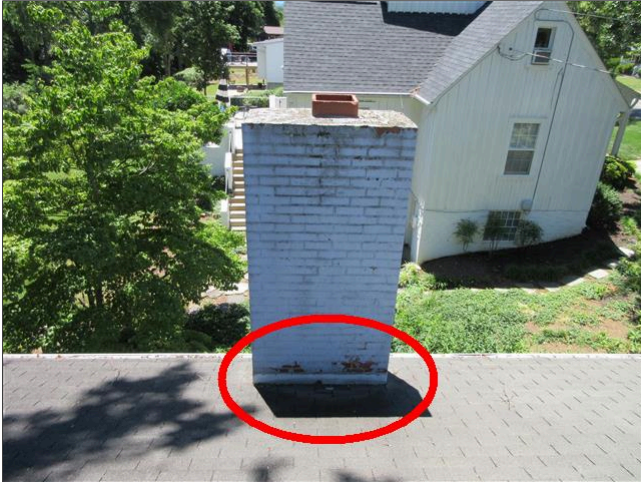
- (1) Multiple openings were observed around the right side chimney flashing. Suggest sealing to eliminate the potential of moisture intrusion.

8.1 Item 1(Picture) Flashing Openings (Right Side Chimney)

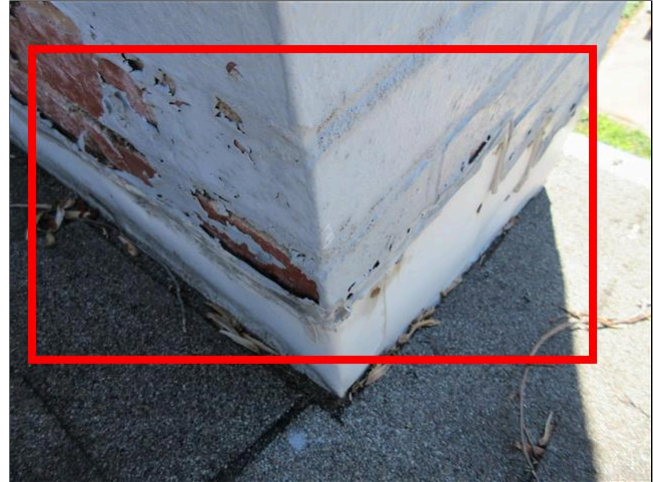
8.1 Item 2(Picture) Additional View of the Openings

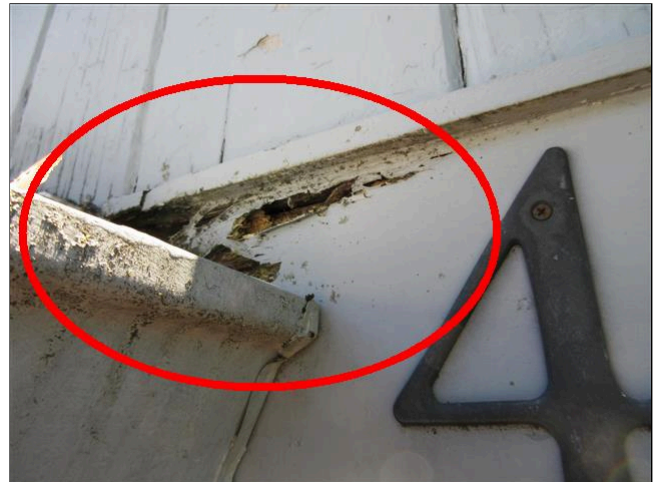
8.1 Item 4(Picture) View of the Deterioration

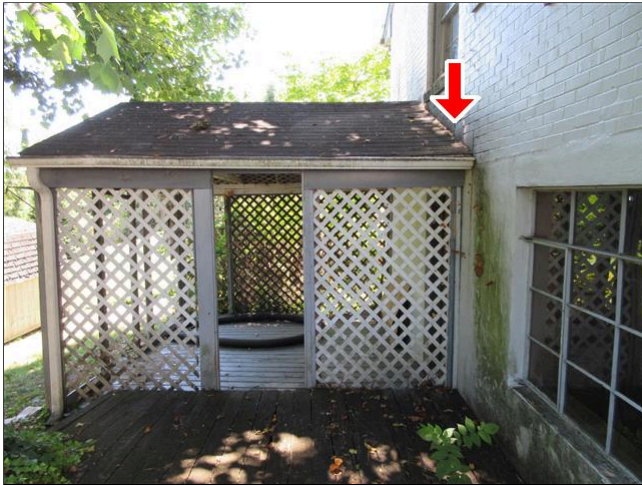
8.3 Item 3(Picture) Improperly Sloped (Rear)

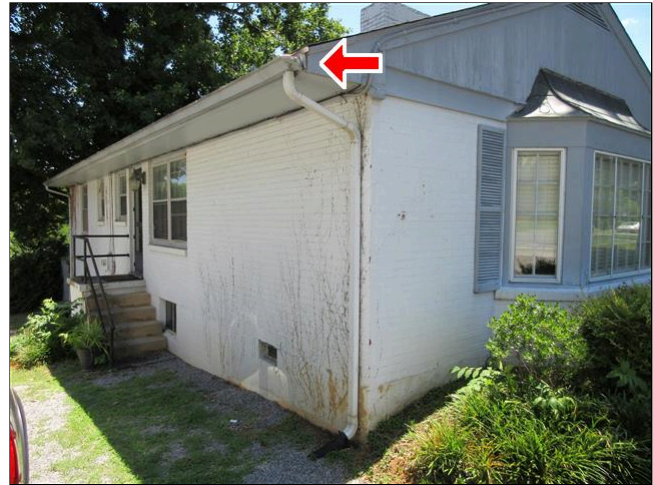
8.3 Item 4(Picture) Bent (Front Left)

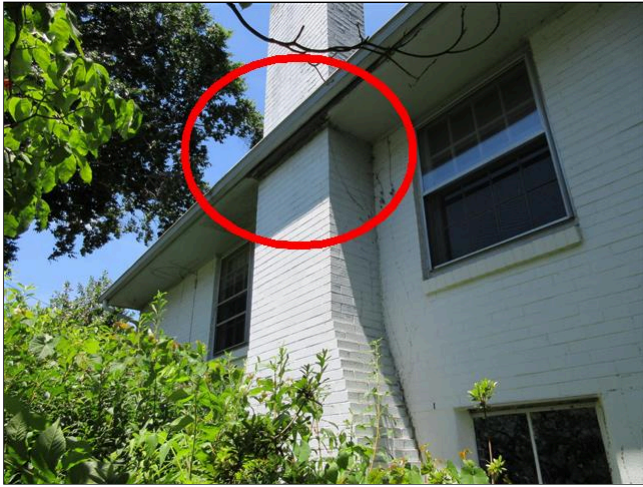
Although typically maintenance related and/or cosmetic issues, open joints, and un-painted or peeling painted surfaces on the exterior of the home can lead to premature decay. Exterior paint is liquid siding that protects the wood from weather. Suggest sealing any open joints (around windows, doors, thresholds, and trim/siding), repairing any damaged areas, and painting any exposed surfaces as needed to reduce the decay potential.

9.0 Item 1(Picture) Openings (Around Right Side Chimney)

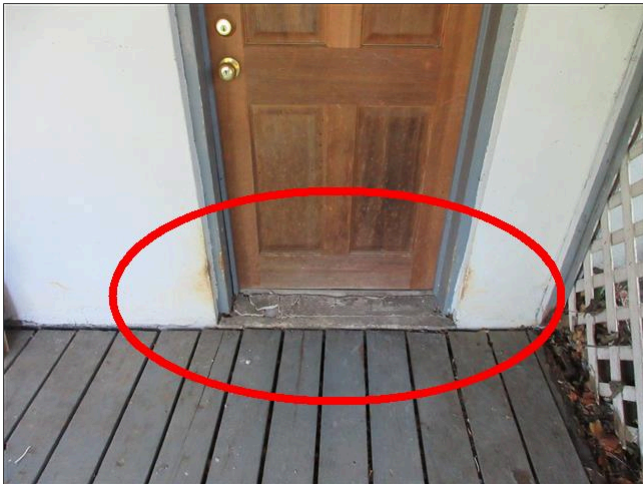
9.0 Item 3(Picture) Deterioration and Openings (Around Basement Entrance)

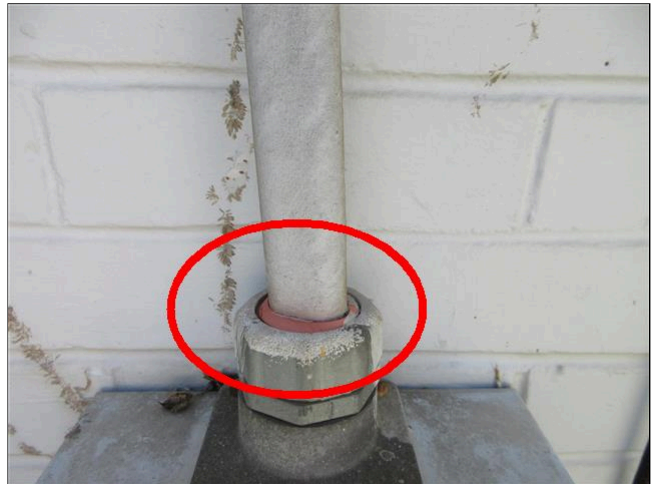
9.0 Item 4(Picture) Opening (Top of Meter Base)

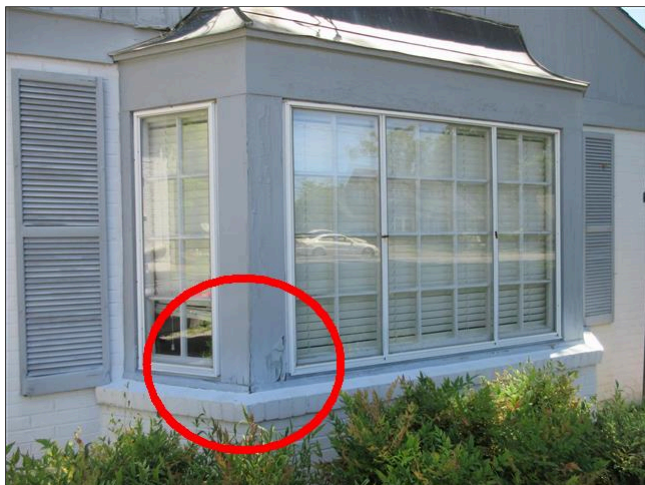
9.0 Item 5(Picture) Deterioration (Front)

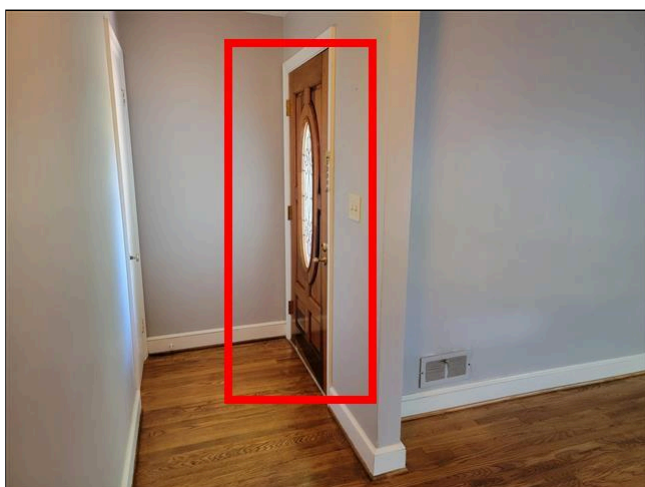
- (1) The noted exterior doors were observed not adequately sealed resulting in excessive air leakage. This can also allow potential pest and moisture intrusion. Additionally, the left side storm door latch was broken. Suggest repair to reduce the concerns, and to restore normal use.

9.1 Item 1(Picture) Openings and Deterioration (Front Entrance)

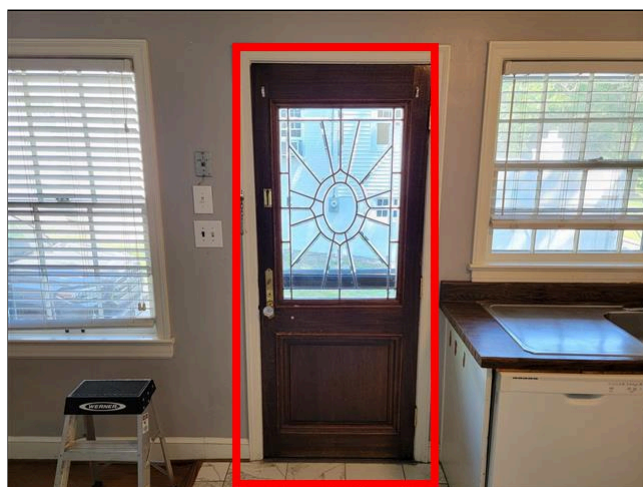
9.1 Item 2(Picture) Openings (Left Side Entrance)

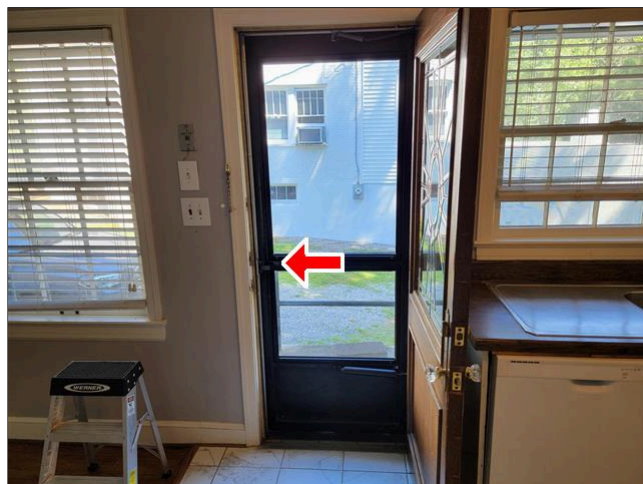
9.1 Item 4(Picture) Broken Latch (Left Side Storm Door)

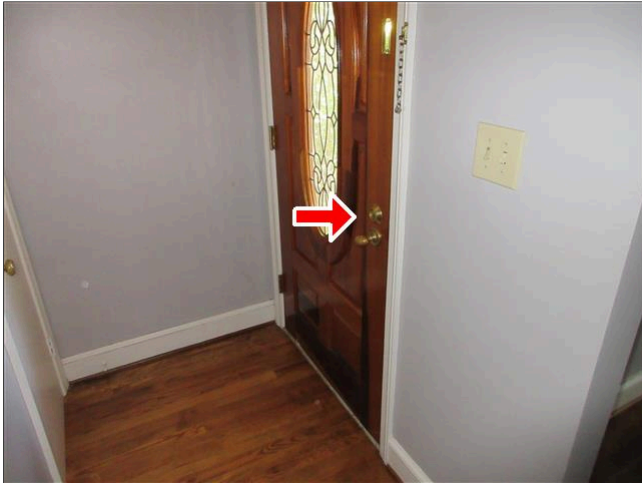
(2) A double cylinder (keyed both sides) lock was observed on the front exterior entry door. This is a potential safety concern as it can impede an emergency exit. Although not required, suggest replacing double cylinder locks with single cylinder lock as needed.

9.1 Item 5(Picture) Double Cylinder Lock (Front)

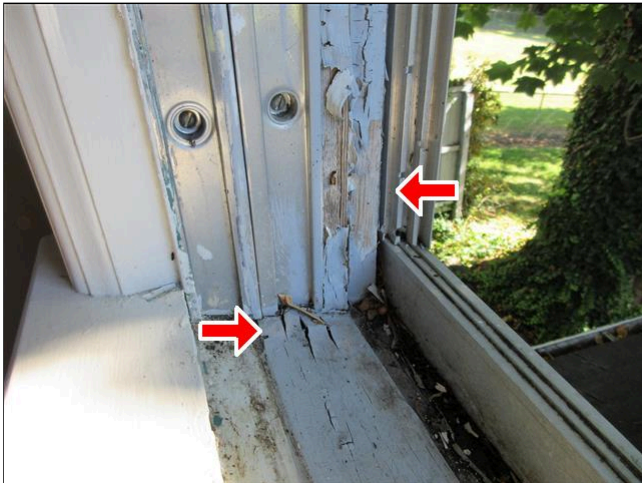
- Although typically a cosmetic issue, the wood trim is peeling paint at most window sills and frames. Further deterioration may occur if not repaired. Suggest removing old paint, plus sealing and painting.

9.2 Item 1(Picture) Bare Wood and Peeling Paint (Most Windows)

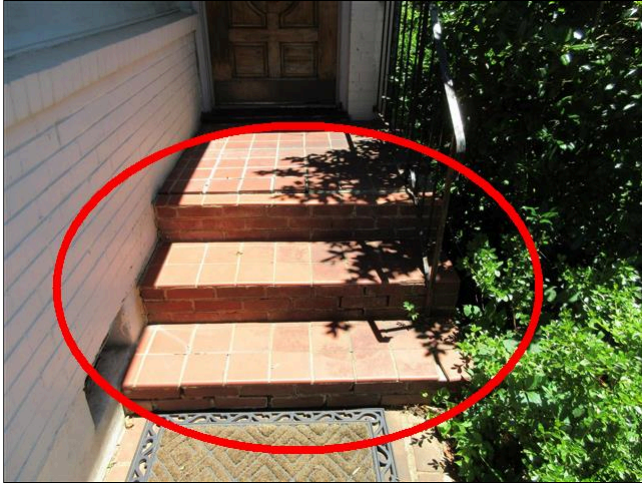
1. The tiles at the front stoop were loose in multiple areas which creates a potential slip fall hazards. Suggest repair to reduce the concerns.
2. The rear decking was deteriorated and not safe to walk on. These materials should be removed.
3. The left side railing was deteriorated at the bottom posts and has horizontal balusters which creates a fall hazard. Recommend repair to reduce the concerns and improve safety.

9.3 Item 1(Picture) Loose Tile (Front Stoop)

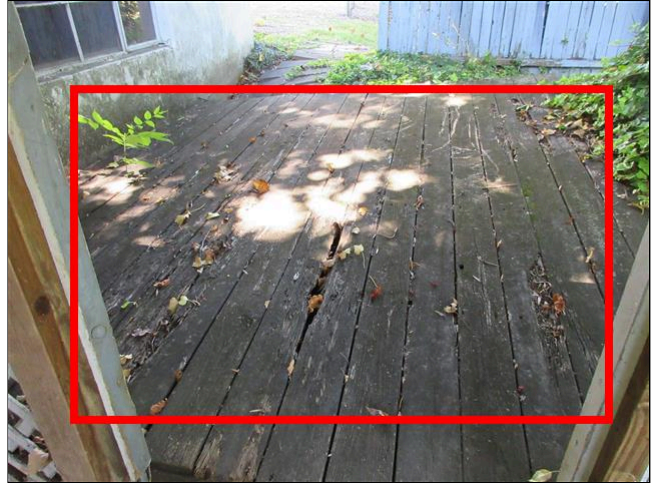
9.3 Item 2(Picture) Deteriorated Deck Boards
