Pre-Listing Inspection Report

Property Address:
432 N Market Street
Salem VA 24153

Date: 7/2/2024	Time: 09:00 AM	Report ID: 0724432
Property: 432 N Market Street Salem VA 24153	Customer: Catherine Potter	Real Estate Professional:

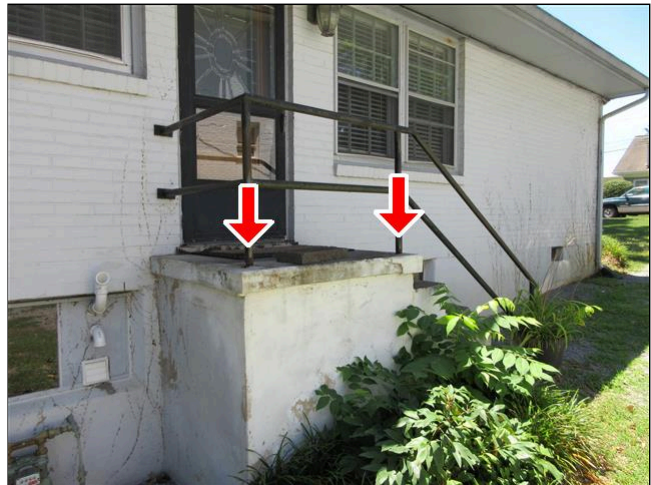
1. The tiles at the front stoop were loose in multiple areas which creates a potential slip fall hazards. Suggest repair to reduce the concerns.
2. The rear decking was deteriorated and not safe to walk on. These materials should be removed.
3. The left side railing was deteriorated at the bottom posts and has horizontal balusters which creates a fall hazard. Recommend repair to reduce the concerns and improve safety.

9.3 Item 4(Picture) Deteriorated Posts and Baluster Spacing (Left Side)

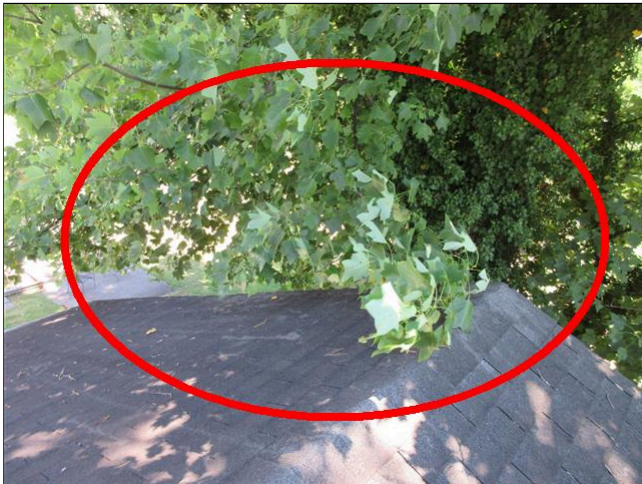
- Vegetation was observed in contact with the home, and the root system for the tree at the rear is causing disruptions to the wooden patio components. Suggest trimming overgrowth upon moving in to reduce the potential of contact related material damage and having a qualified contractor further evaluate and advise removal of the tree and associated costs.

9.4 Item 1(Picture) Overgrowth (Rear)
