# Pre-Listing Inspection Report

**Property Address:**  
502 N Market Street  
Salem VA 24153

**Bateman Home Inspections, LLC**

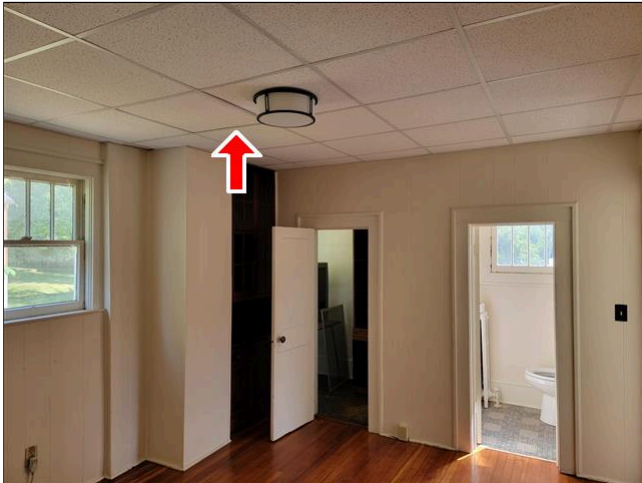
Ceiling staining was observed in the rear den. No elevated levels of moisture were measured and the materials were hard and solid. As the home has been vacant for a period of time and a bathroom is directly above this location, it is not possible to determine if the stains are active or old. Recommend monitoring as leaking may occur once normal use of the home is restored.

1.0 Item 1(Picture) Staining (Den - Bathroom Above)

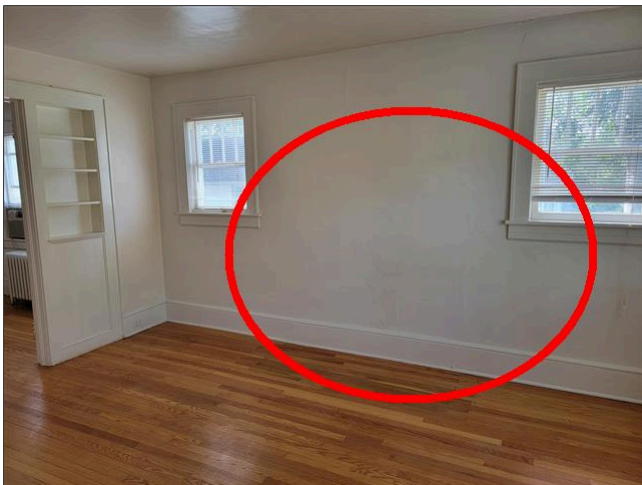
(1) Wall staining was observed in the living room along with elevated moisture levels. The exact cause was not determined but may be openings on the exterior, or condensation in the chimney with openings inside the chimney as this is an active chimney for the boiler flue. Staining and elevated levels of moisture was also measured below the flue in the basement. The chimney is on the adjacent wall, along with wall staining on the exterior. Roof and flashing repairs were observed in the attic of this chimney. Recommend having a qualified contractor further evaluate and advise plus observing during a moderate rain event may also help identifying any leaks.

1.1 Item 1(Picture) Staining and Elevated Moisture (Living Room)

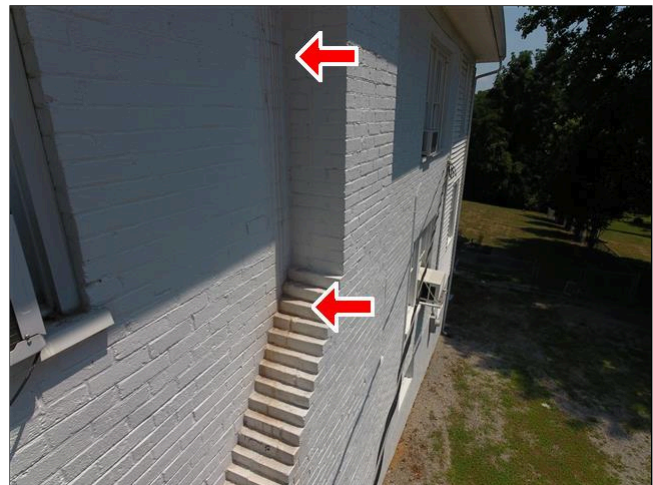
1.1 Item 2(Picture) Staining (Exterior View)

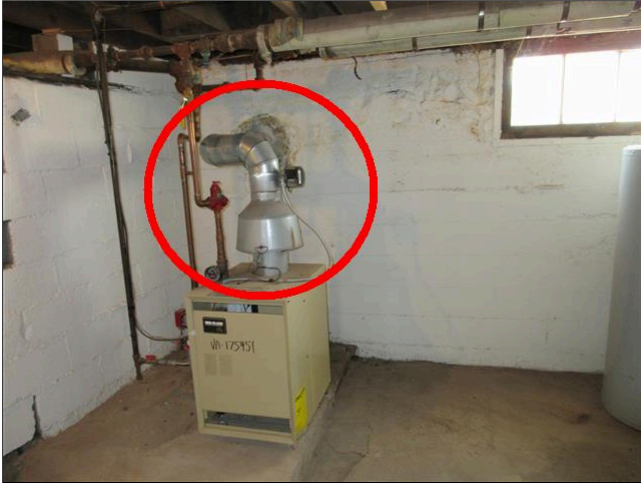
1.1 Item 3(Picture) Wall Staining and Elevated Moisture (Behind Boiler)

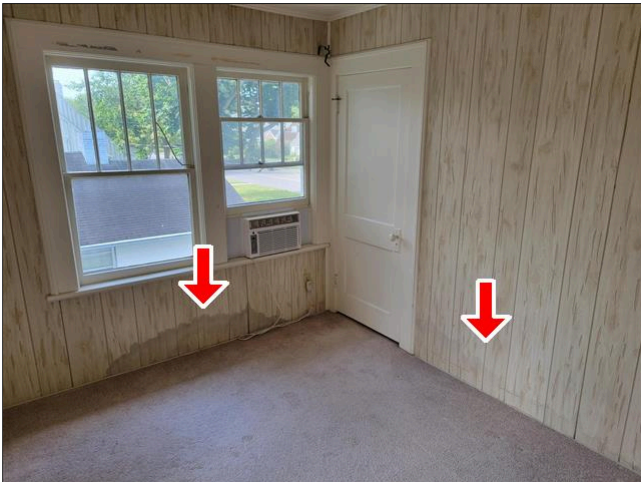
(2) Wall staining was observed in the upstairs right bedroom and the dining room below. No elevated levels of moisture was measured and the materials were hard and solid. This may have been from old condensate water leaks from a window ac unit. Suggest ensuring all window trim and framing is sealed on the exterior.

1.1 Item 4(Picture) Staining (Upstairs Right Side Bedroom)

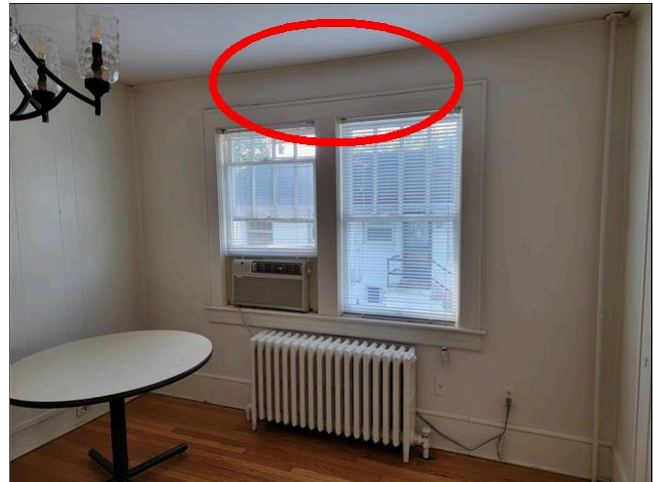
1.1 Item 5(Picture) Staining (Dining Room - Staining Upstairs)

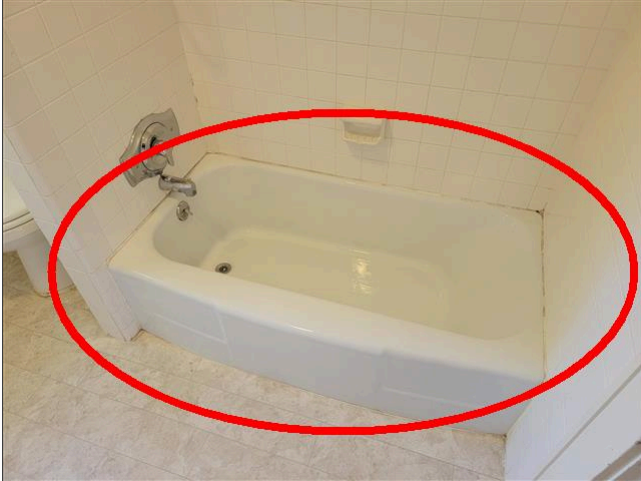
(3) Although typically a maintenance/cosmetic issue, open grout lines and/or open joints were observed around the upstairs bathroom tub. These areas should be sealed to reduce the potential of water intrusion behind surfaces.

1.1 Item 6(Picture) Open Joints (Around Upstairs Bathroom Tub)

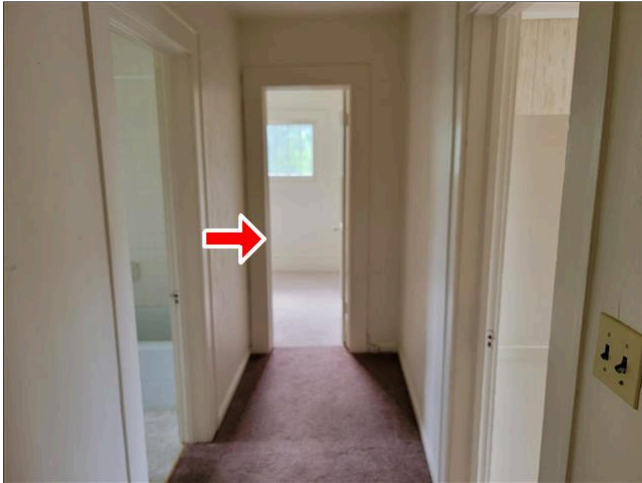
The noted interior doors were observed not to latch when shut. This is common with age and may be corrected with a minor position adjustment to the strike plate, cleaning the paint off the latch, or possibly tightening of the door hinge screws. Identified for reference.

1.5 Item 1(Picture) Not Latching (Upstairs Rear Bedroom and Closet)

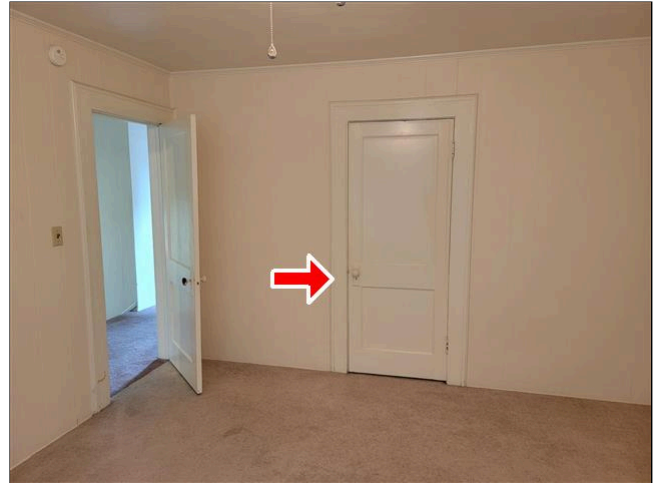
1.5 Item 2(Picture) Not Latching/Painted Latch (Upstairs Front Right Bedroom Closet)

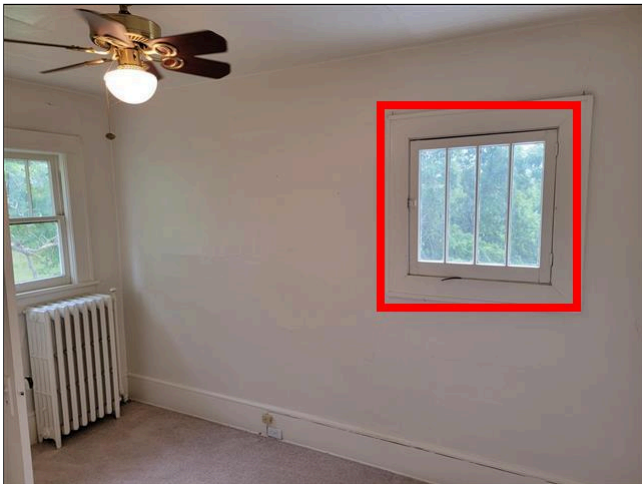
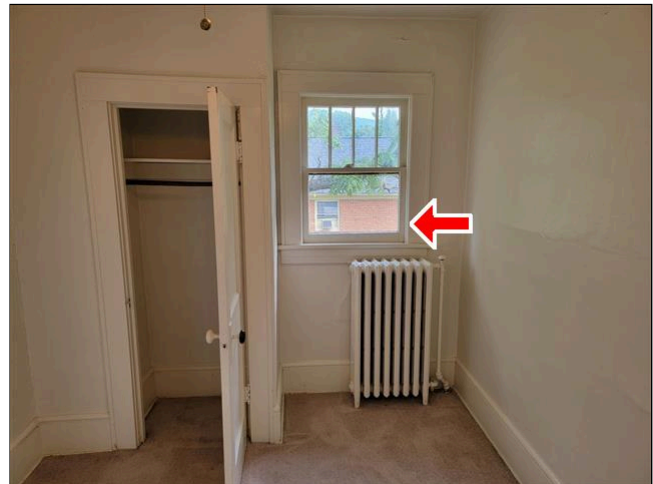
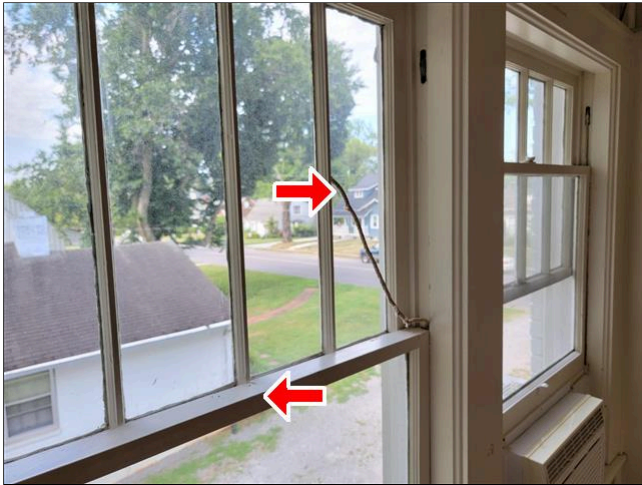
The windows were observed aged and fragile. Most would not open and many of the rope balances were observed missing/broken. The balance is the device that hold the window in the up position. Faulty or missing balances can allow the window to drop resulting in property damage and personal injury. Inoperable windows pose a safety concern as they impede an emergency exit. Additionally, several were with cracked glass and without safety glass. This creates safety hazards. Recommend repair to restore normal use, sealing capacity and to reduce the safety concerns.

1.6 Item 1(Picture) Gaps/Air Leaks (Multiple Locations)

1.6 Item 2(Picture) Not Opening (Multiple Locations)

1.6 Item 3(Picture) Missing Lock and Broken Balance Cord (Multiple Locations)

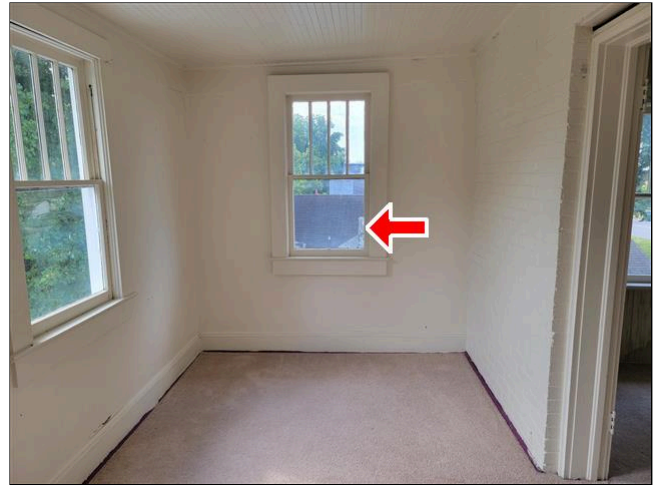
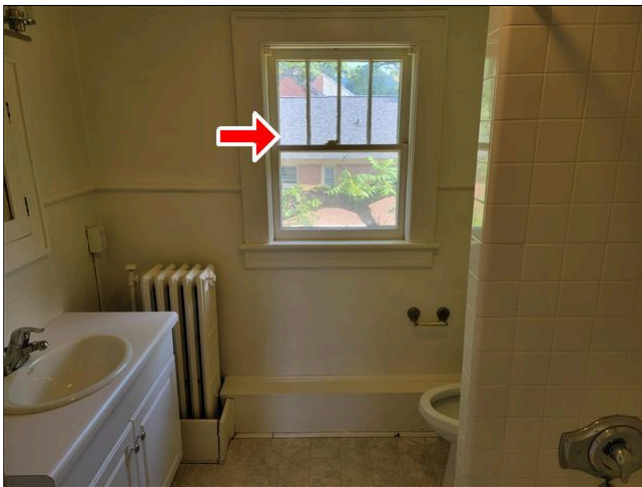
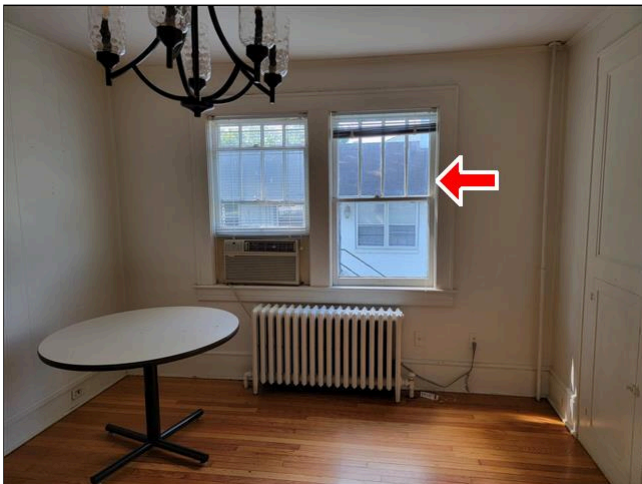
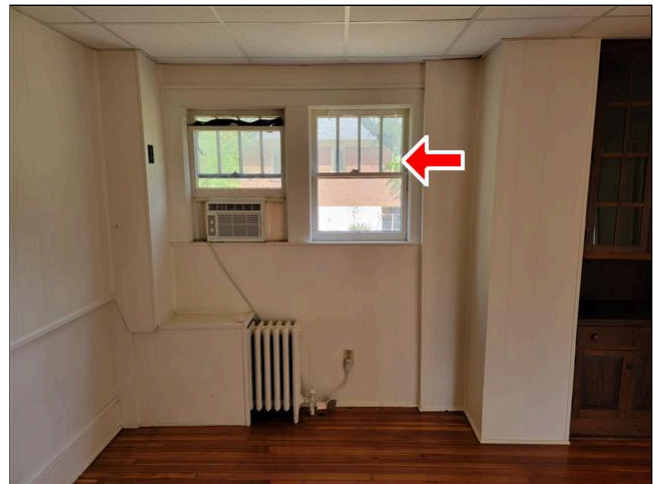
1.6 Item 4(Picture) Cracked Glass (Upstairs Right Rear Bedroom)

1.6 Item 5(Picture) Cracked Glass (Upstairs Bathroom)

1.6 Item 7(Picture) Cracked Glass (Dining Room)

1.6 Item 8(Picture) Cracked Glass (Den)

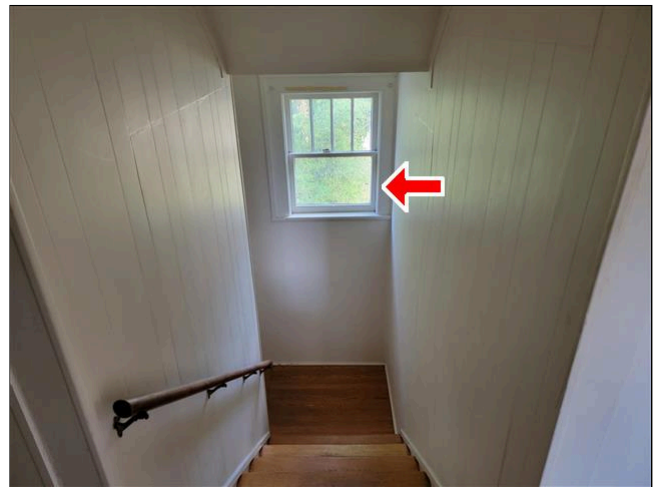
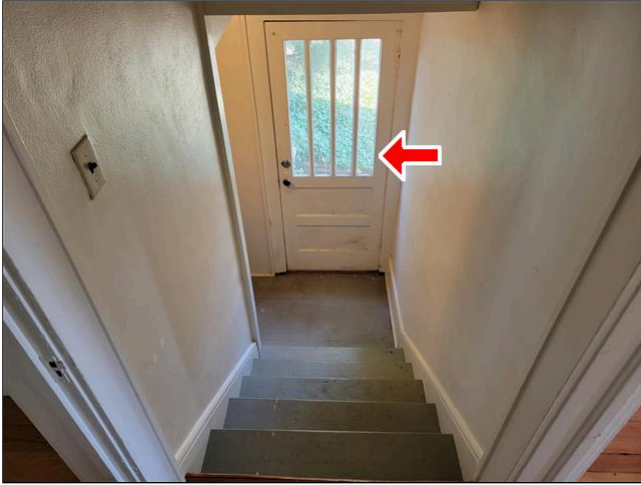
1.6 Item 6(Picture) No Safety Glass (Stairwell Landing)

1.6 Item 9(Picture) No Safety Glass (Stairwell Landing)

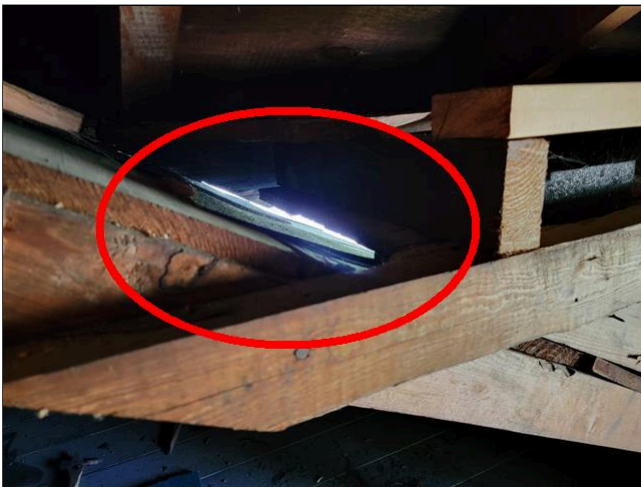
- 🔍 (1) A gap between the fascia and roof sheathing exists in multiple locations which can allow potential insects or bees to enter attic area. Suggest sealing any openings and monitoring to eliminate nesting potential.

1.7 Item 1(Picture) Gaps/Daylight (Multiple Locations)

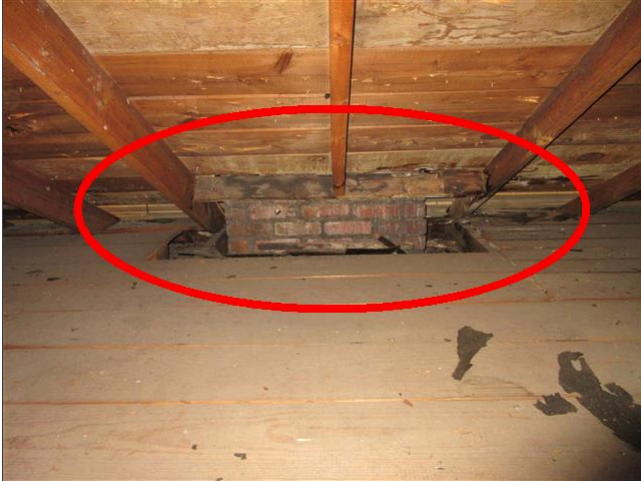
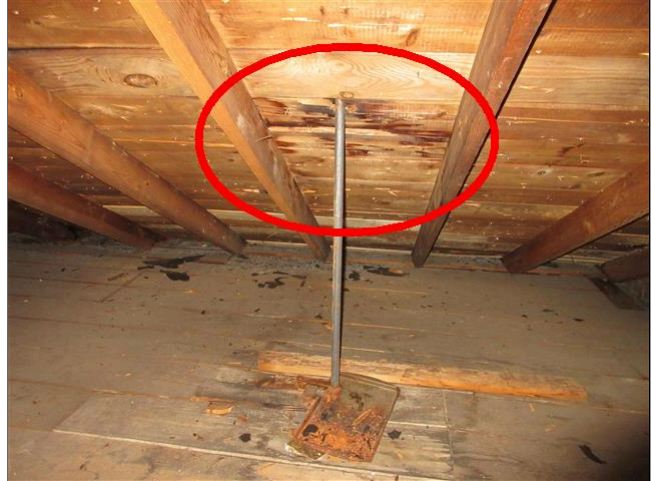
(2) Staining was observed in multiple areas of the roofing materials. This may have been prior to the existing roof and flashing elements as no elevated levels of moisture was measured at the time of the inspection. Identified for reference.

1.7 Item 2(Picture) Staining and Recent Repairs (Around Right Chimney)

1.7 Item 3(Picture) Staining (Around Vent Pipes)

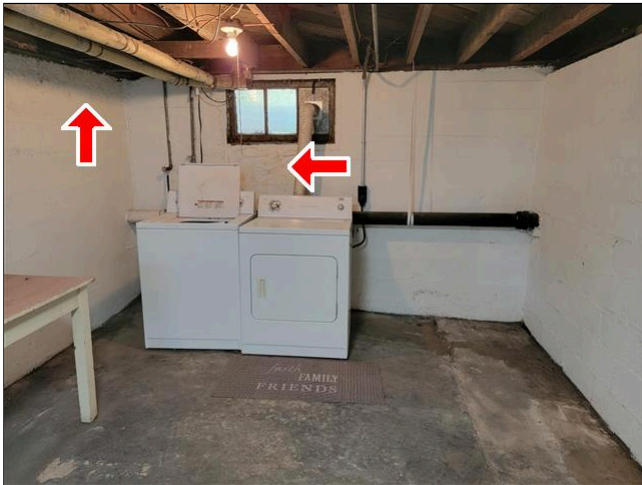
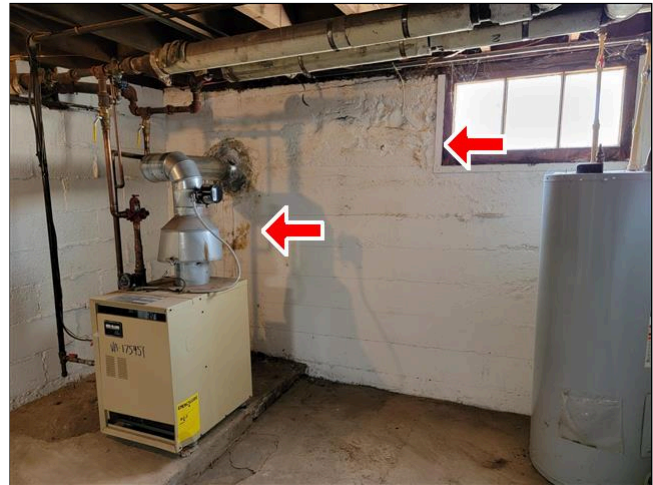
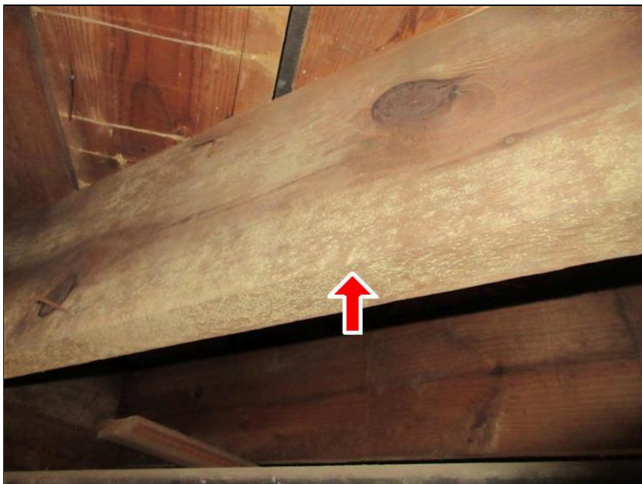
(1) Although no active water was observed in the basement at the time of inspection, historical indications of water intrusion were noted (staining, elevated moisture levels, and organic surface growth). It is not uncommon for older basement foundations to leak under certain rain event conditions. If this occurs, improper exterior grading against the home and clogged or improperly discharging gutters are almost always the cause. Poor exterior siding conditions (openings) can also allow water intrusion at above grade locations. Signs of organic surface growth was also observed on multiple floor joists and may be related to the past water intrusion events. No sampling was performed. Organic growths are also common when the home has been vacant for a period of time as a result of reduced air circulation, poor climate control, and moisture. Suggest spraying and wiping surfaces that have growths with an approved disinfectant. Restoring home use and the introduction of a dehumidifier will significantly reduce surface contamination. Suggest directing attention to the gutter and openings on the exterior plus monitoring during a moderate rain event as leaking may occur. Recommend having a qualified contractor further evaluate and advise corrective actions as needed.

1.9 Item 1(Picture) Staining and Elevated Levels of Moisture

1.9 Item 2(Picture) Staining and Elevated Moisture

1.9 Item 3(Picture) Organic Growth (Multiple Floor Joists)

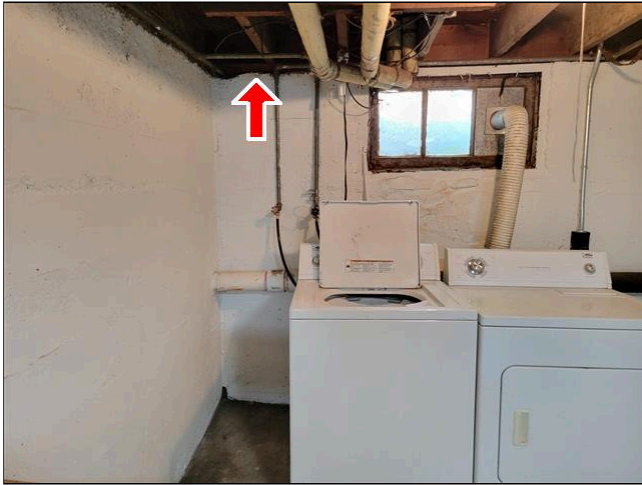
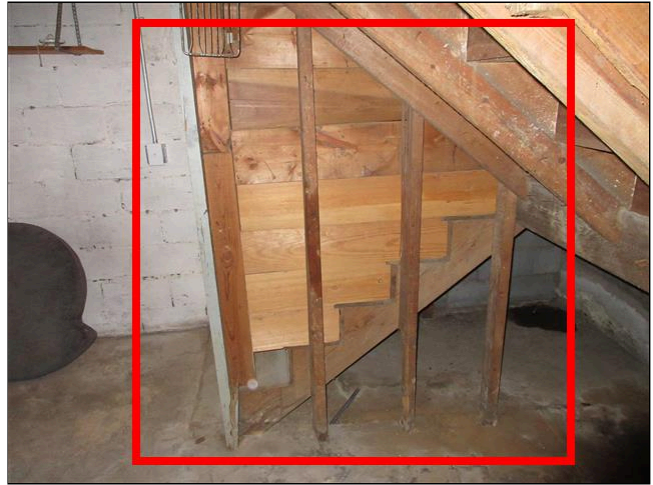
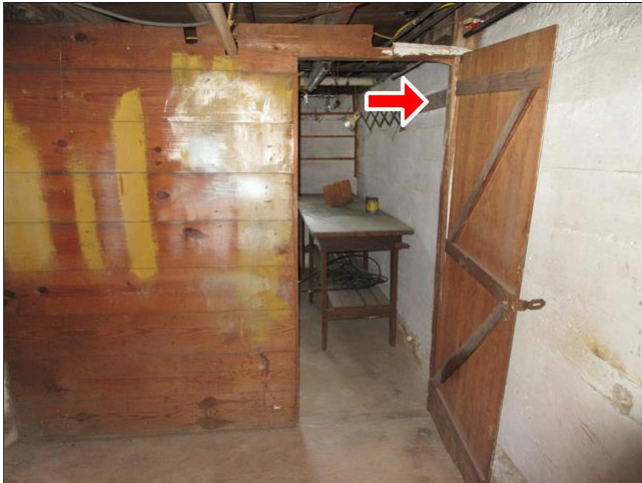
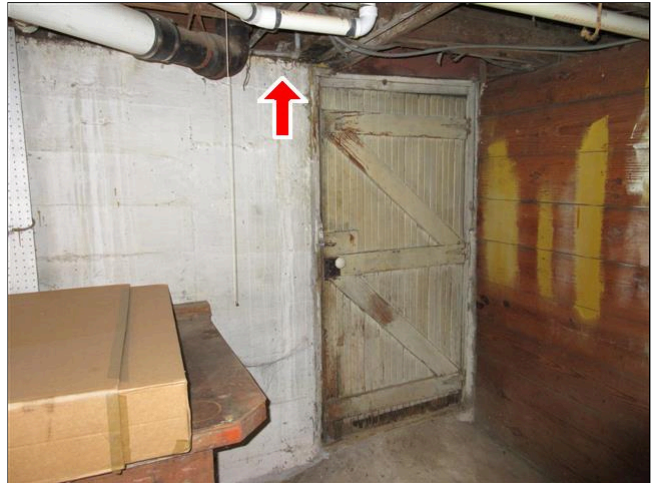
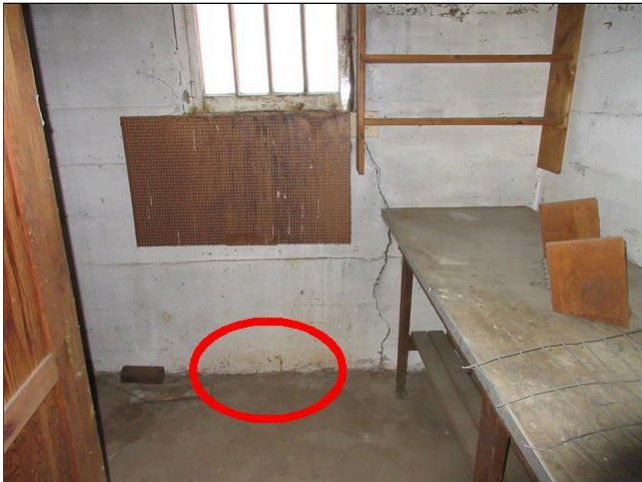
🔍 (2) What appeared to be insect shelter tubes and damage were observed in multiple locations of the basement. No active insects were observed at the time of the inspection. Suggest having a qualified contractor inspect and advise if any insect treatment is necessary. Recommend having a qualified contractor further inspect the framing and repair any damaged areas as needed.

1.9 Item 4(Picture) Insect Damage

1.9 Item 5(Picture) Insect Damage (Under Steps - Multiple Locations)

1.9 Item 6(Picture) Insect Damage

1.9 Item 7(Picture) Insect Damage

1.9 Item 8(Picture) Shelter Tubes

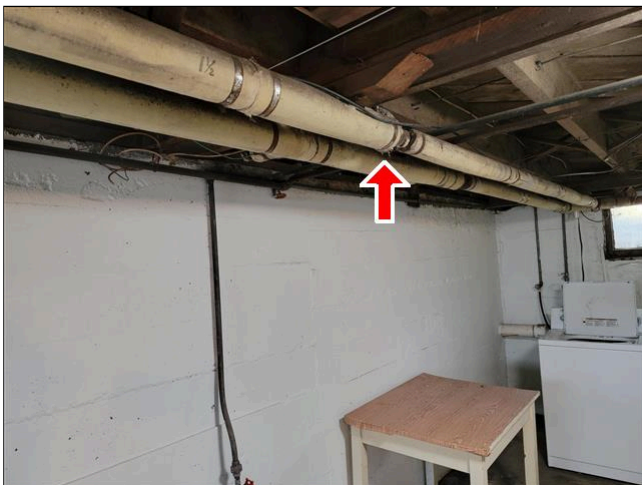
- 🔍 Multiple sections of white "K&M Air Cell" type pipe insulation were observed on the boiler supply pipes. This insulation is consistent with era insulation that may contain asbestos fibers. The insulation was observed in good condition. If left alone, it does not pose a concern. The insulation should not be removed by any means other than trained contractors.

2.2 Item 1(Picture) Potential Asbestos Pipe Insulation

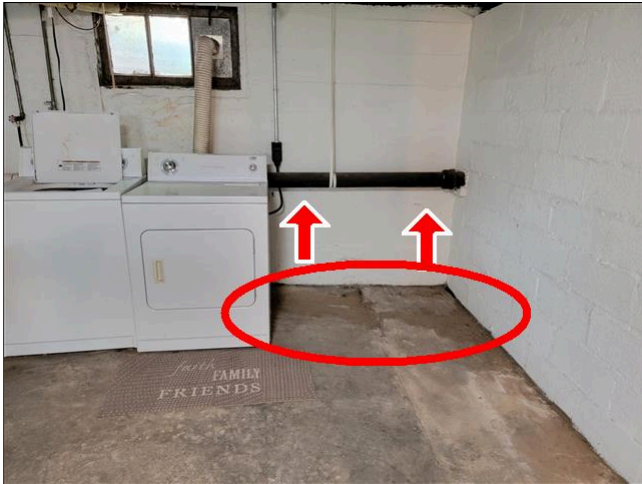
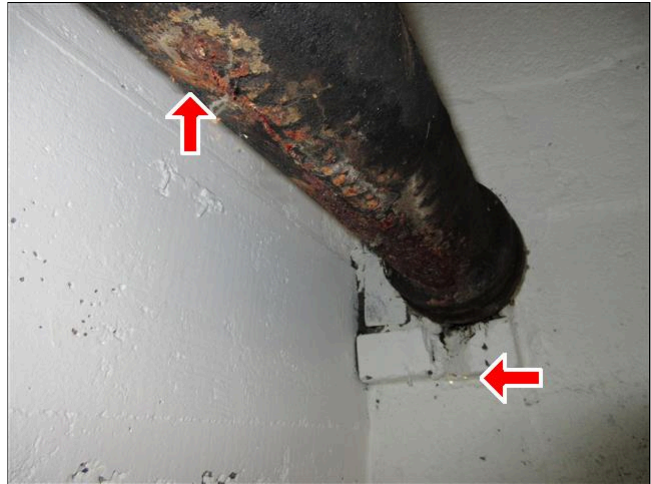
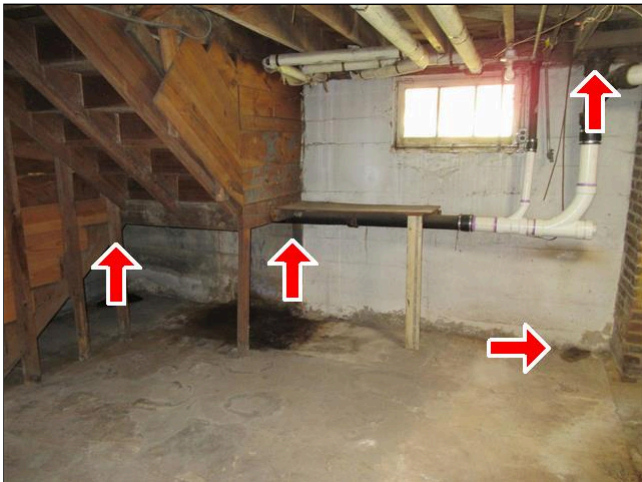
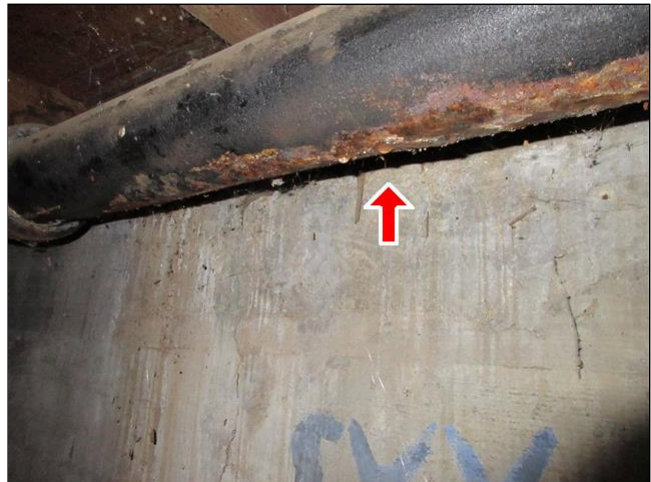
Multiple sections of the cast iron waste line are cracked/deteriorated and leaking waste water into the basement. Additionally, a support strap was not connected causing the weight of the cast iron to make the waste line sag at the end. Suggest replacing damaged cast iron pipe with modern materials, and having the lines properly supported. Recommend having a qualified contractor further evaluate these observations and repair as necessary.

3.0 Item 1(Picture) Cracked and Leaking

3.0 Item 3(Picture) Cracked and Leaking

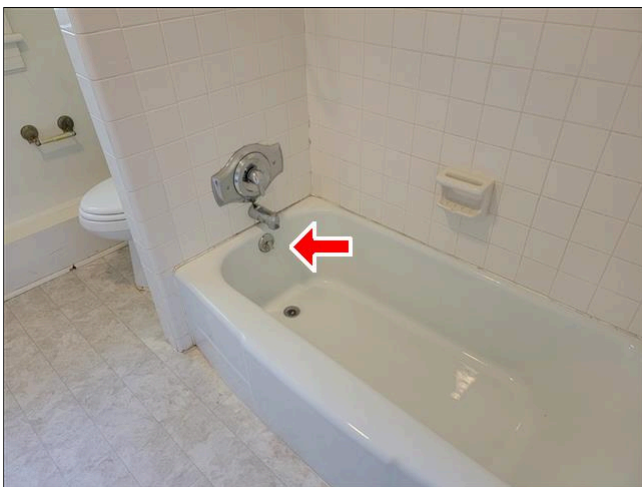
🔍 The upstairs bathroom tub drain stopper did not function properly. Suggest repair or adjustment of stopper linkage to restore function.

3.2 Item 1(Picture) Not Sealing (Upstairs Bathroom)

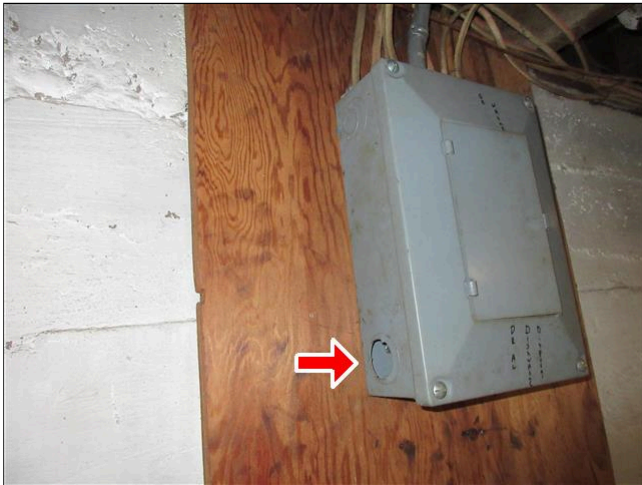
- 🔍 An open slot was observed on the left side of the electrical sub panel. This permits direct access to active electrical components. Suggest installation of a knockout cover(s) to reduce the accidental shock hazard.

4.2 Item 1(Picture) Open Slot (Sub Panel)

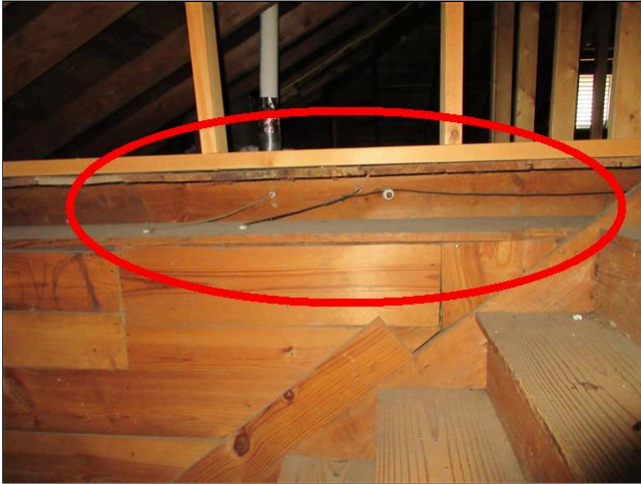
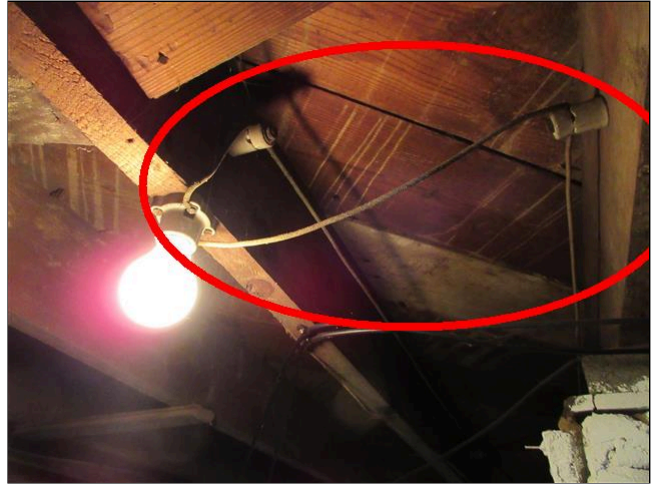
🔍 Active knob and tube wiring was observed in the home (attic and basement). Although not inherently unsafe, exposed and aged conductor sheathing can become brittle. Replacement of exposed conductors with modern wiring will improve electrical function and increase electrical longevity. Although areas have been upgraded to modern wiring methods, recommend having a qualified contractor further evaluate the knob and tube wiring and advise on upgrade and improvement options.

4.3 Item 1(Picture) Active Knob and Tube Wiring (Attic View)

4.3 Item 2(Picture) Active Knob and Tube (Basement)

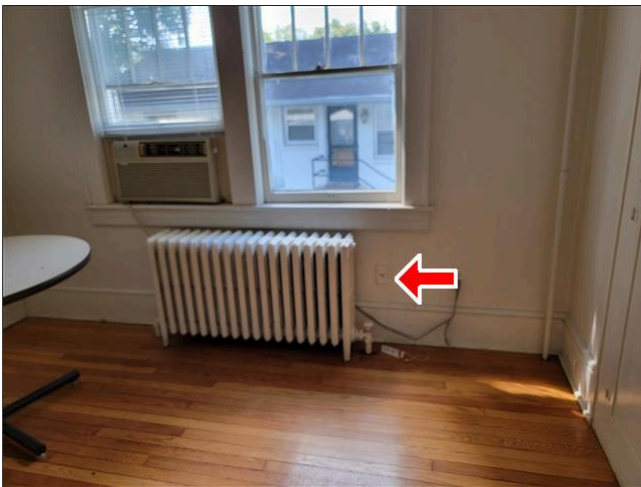
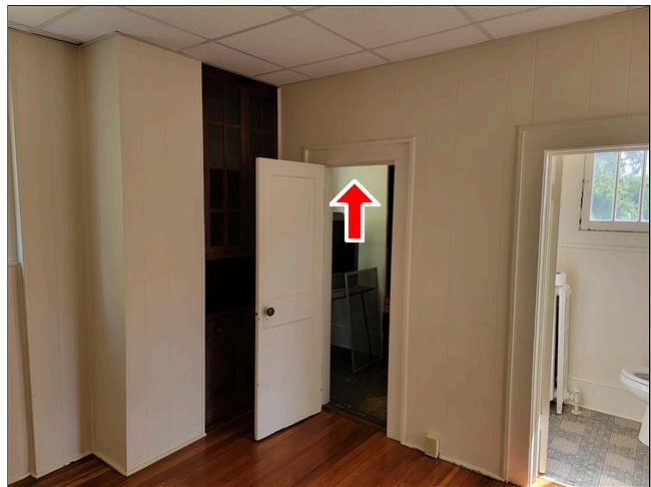
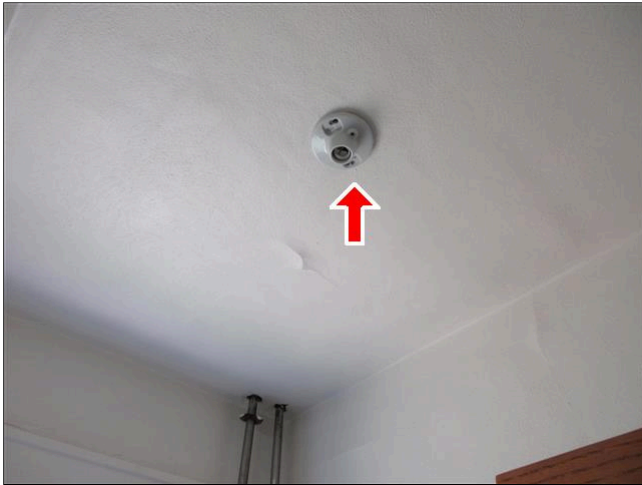
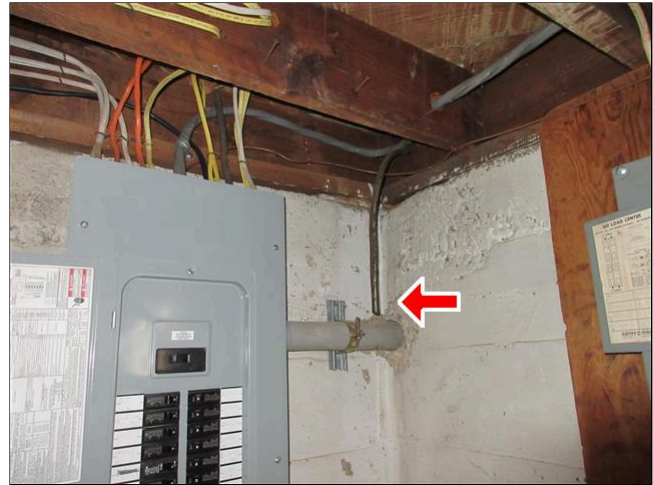
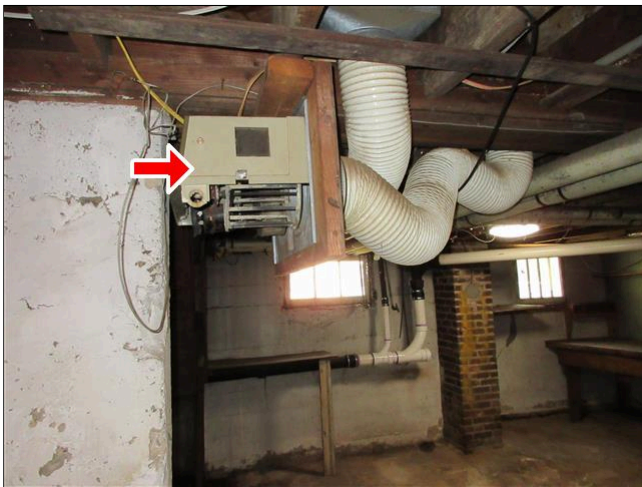
🔍 (1) An inactive 220 outlet was located in the dining room, the pull chain was missing for the rear den closet light fixture, an inactive and abandoned circuit was observed near the electrical panel in the basement, and the basement has a ventilation fan that was active but did not function. Suggest replacing the closet light fixture to restore normal use and removing the inactive circuit plus the ventilation fan. The old inactive 220 outlet was identified for reference.

4.4 Item 1(Picture) Inactive 220 Outlet (Dining Room)

4.4 Item 2(Picture) Missing Pull Chain (Den Closet Light Fixture)

4.4 Item 4(Picture) Inactive and Abandoned Circuit (Basement)

4.4 Item 5(Picture) Active but Non-Functional Ventilation Fan (Basement)

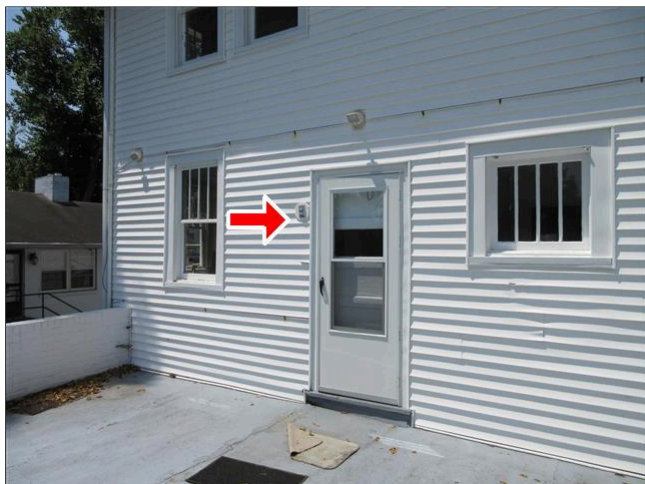
4.5 Item 1(Picture) Rear Exterior

- 🔍 (1) The noted wet location outlet was observed ungrounded. Ungrounded outlets near water sources pose an increased shock concern. GFCI devices provide additional electrical safety in these locations. Recommend upgrading noted outlets/circuits to improve electrical safety.

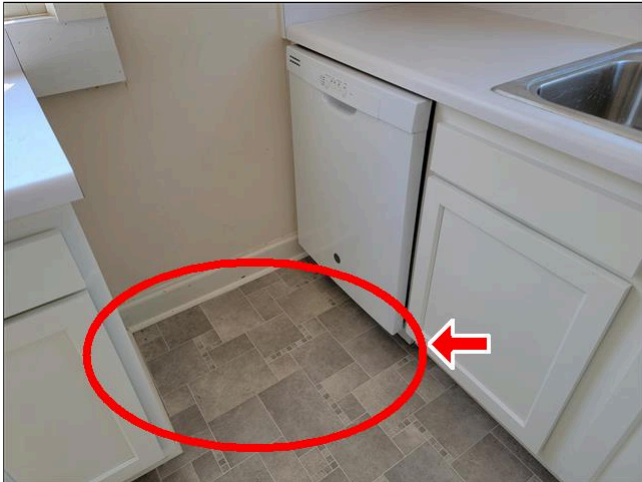
Although the dishwasher appeared to be newer and functional, a leak was observed around the right side of the unit. The exact location of the leak was not located during the inspection. Recommend repair to eliminate the leak.

5.0 Item 1(Picture) Leak/Water

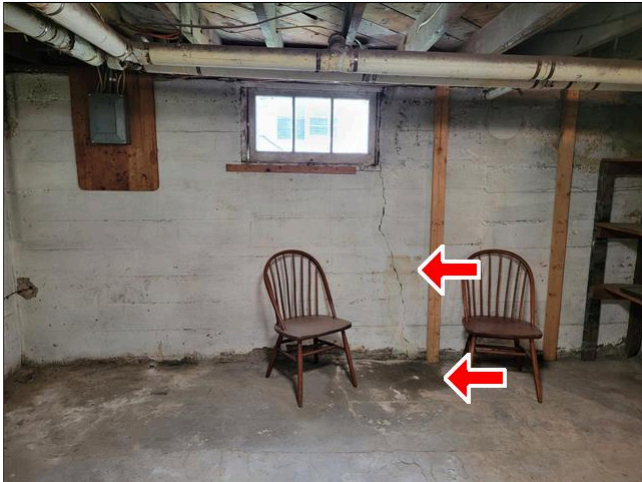
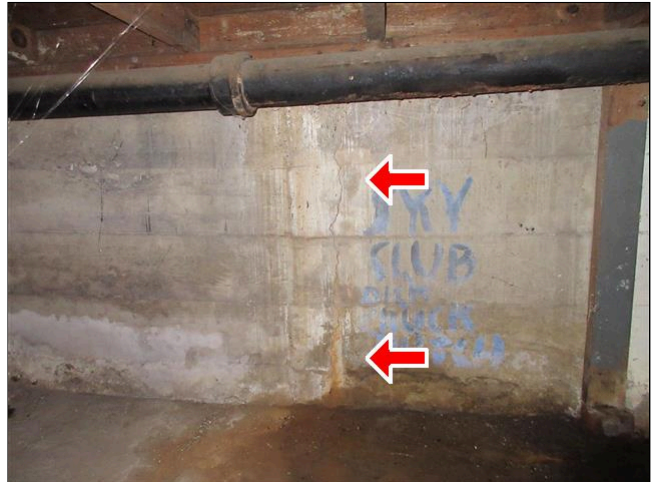
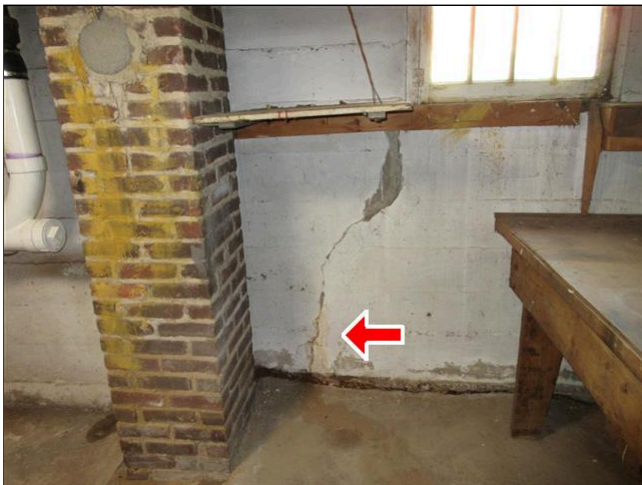
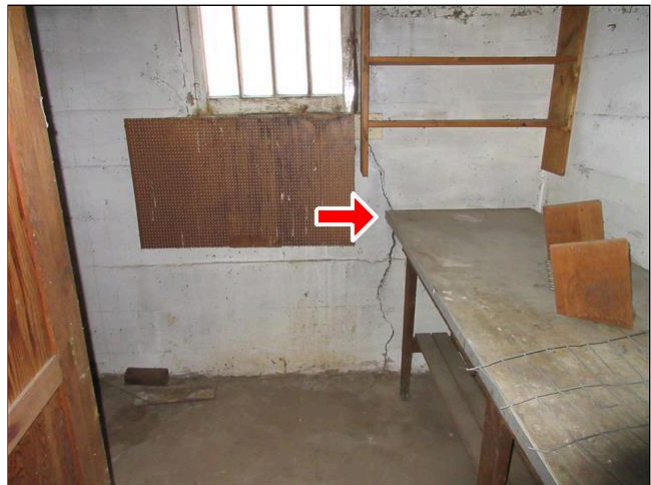
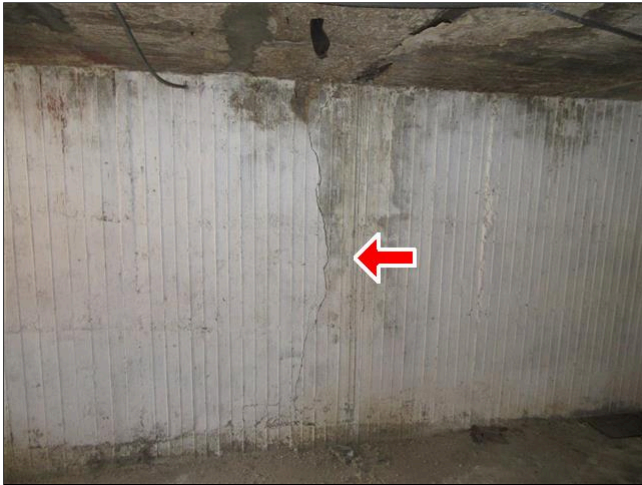
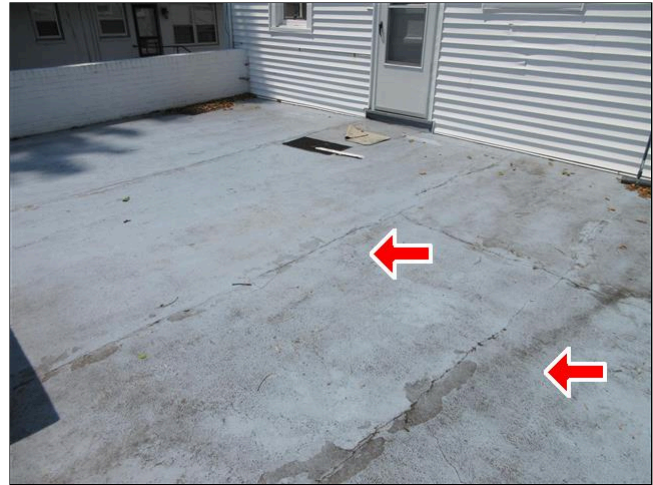
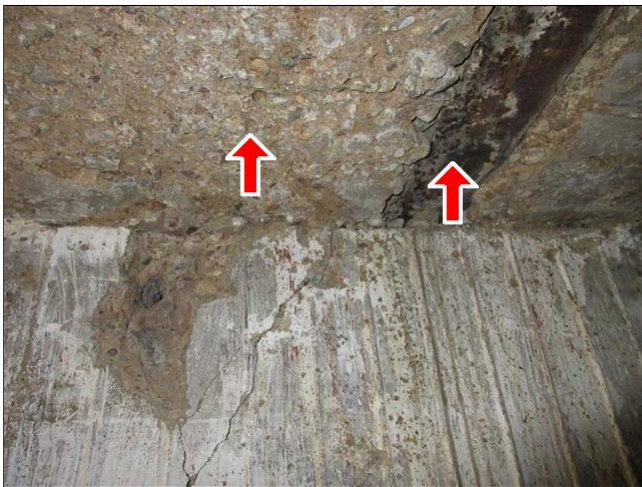
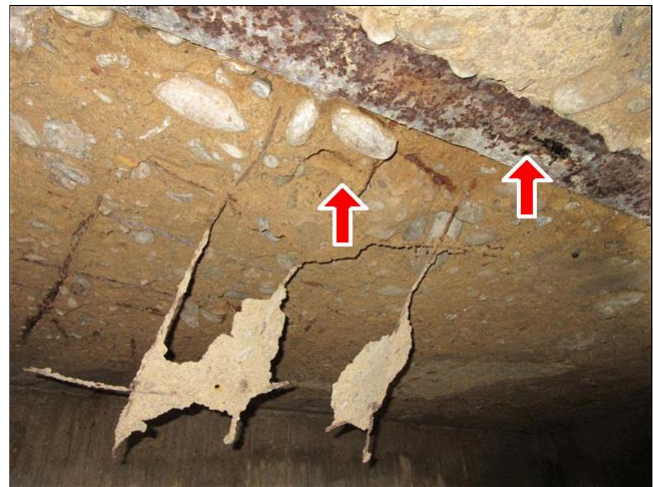
Vertical foundation cracking at/over 1/8" with staining and displacement was observed in multiple locations. Additionally, the concrete ceiling materials for the rear storage rooms was failing. This is most likely due to moisture in the cracks above causing the metal to rust and expand. Multiple sections of the metal was exposed and corroded. Suggest sealing any open joints along the foundation as needed with an approved foundation epoxy/concrete sealer and monitoring. Due to the cracks and the ceiling materials for the rear storage rooms, recommend having a qualified contractor further evaluate and advise corrective actions as necessary.

6.0 Item 1(Picture) Crack and Staining (Right Wall)

6.0 Item 2(Picture) Crack and Staining (Left Wall)

6.0 Item 3(Picture) Crack and Staining (Left Wall)

6.0 Item 4(Picture) Crack and Displacement (Right Wall)

6.0 Item 5(Picture) Crack (Rear Storage Room)

6.0 Item 6(Picture) Cracking Patio Slab (Multiple Locations)

6.0 Item 8(Picture) Deterioration and Exposed Metal (Multiple Locations)

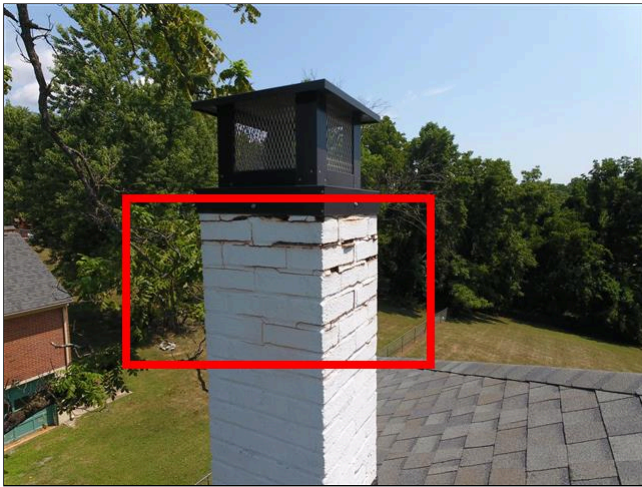
Mortar deterioration was observed around the brick of the left side chimney. This is common when the chimney is no longer used or has been abandoned. Suggest repair of damaged brick and re-pointing of mortar joints to eliminate the potential of future deterioration, then capping since this is an abandoned

6.6 Item 1(Picture) Mortar Joint Deterioration (Left Chimney)

chimney. Recommend having a qualified contractor further evaluate and repair as necessary.

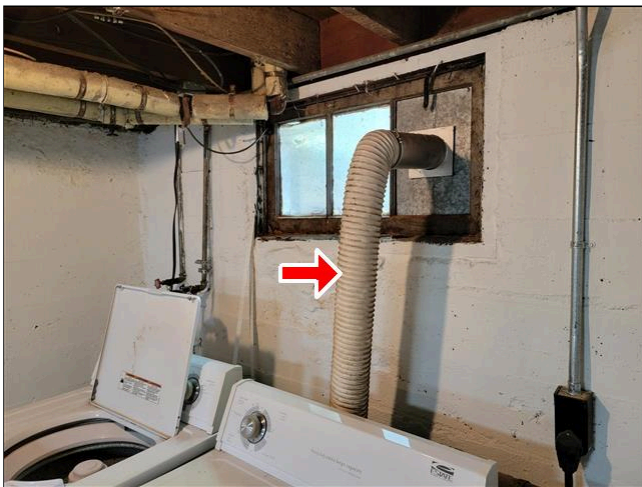
The dryer vent ducting was observed to be flexible vinyl and is no longer considered an acceptable material for venting dryers as this material is an increased fire safety concern. Suggest replacing with 4" flexible or rigid metal ducting.

7.3 Item 1(Picture) Vinyl Ducting

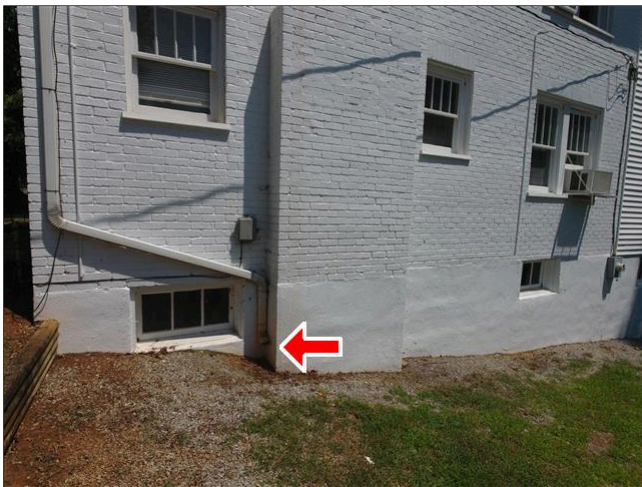
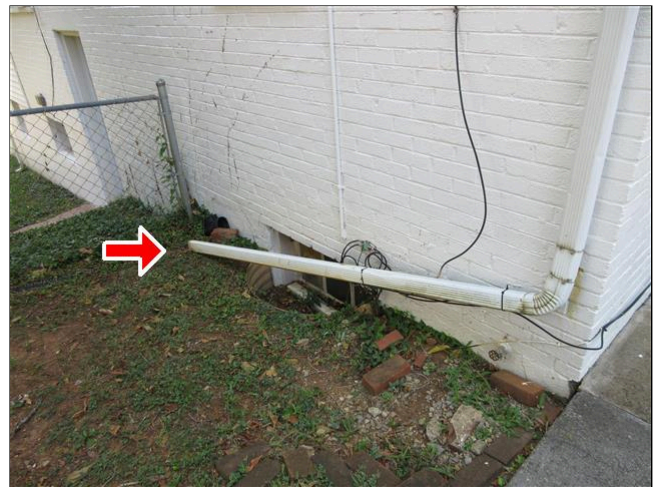
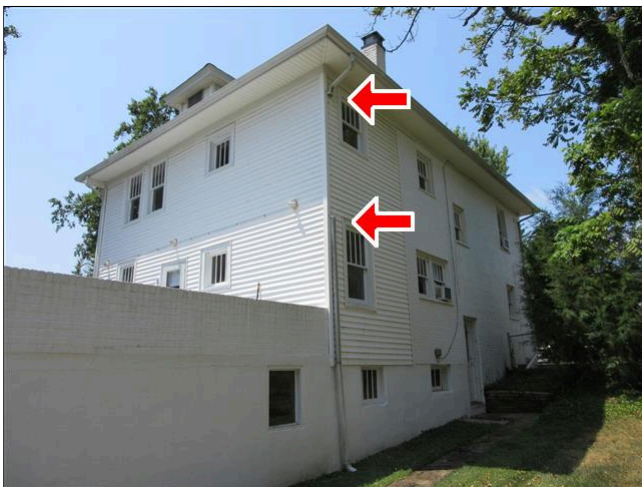
Although gutters were observed around the home, they were observed discharging at the foundation, and a section was missing a downspout. Downspouts should discharge water 4'-6' away from the foundation. Due to the lack of rain during the inspection, gutter functionality was not determined. Suggest installation of downspout leaders, installing the missing downspout and monitoring gutter function during a moderate rain event to identify if any sections need slope adjustments.

8.3 Item 1(Picture) Discharge (Right Side)

8.3 Item 2(Picture) Discharge (Left Side)

8.3 Item 3(Picture) Missing Downspout (Left Rear)

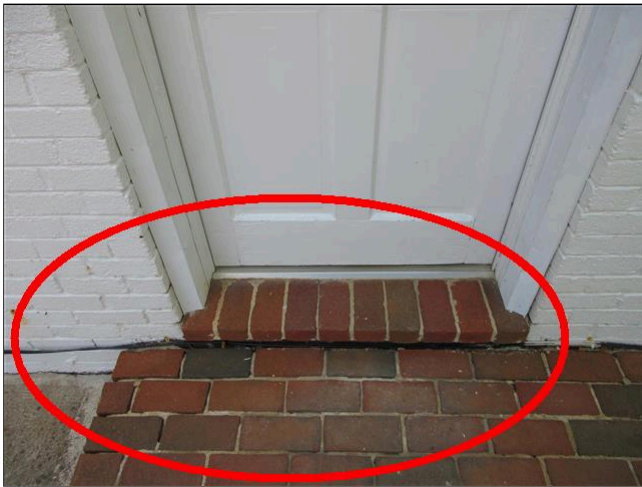
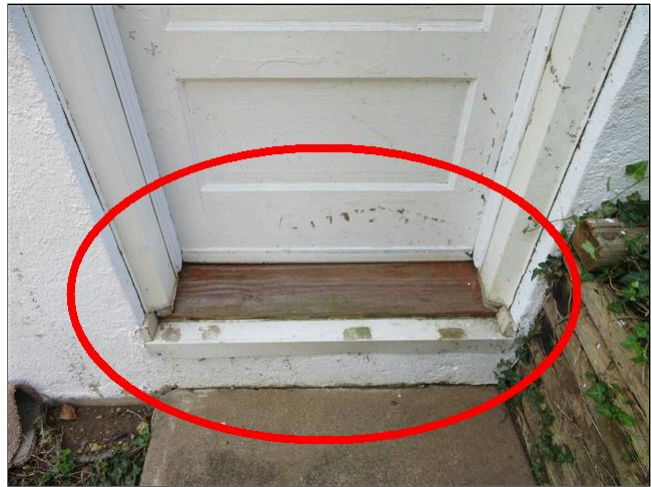
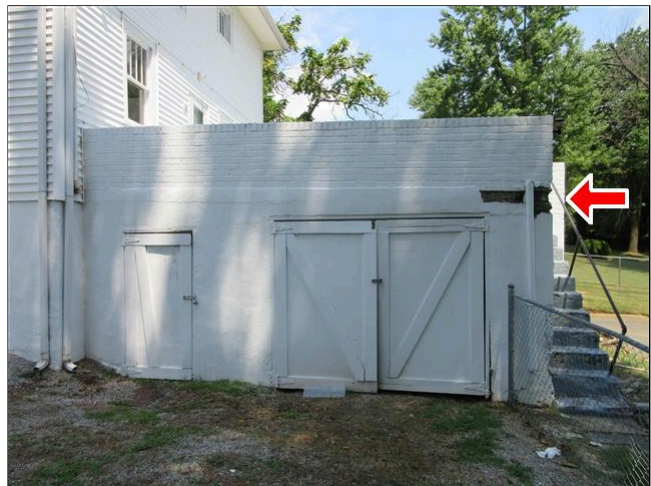
Although typically maintenance related and/or cosmetic issues, open joints, and un-painted or peeling painted surfaces on the exterior of the home can lead to premature decay. Exterior paint is liquid siding that protects the wood from weather. Suggest sealing any open joints (around windows, doors, thresholds, and trim/siding), repairing any damaged areas, and painting any exposed surfaces as needed to reduce the decay potential.

9.0 Item 1(Picture) Open Joints (Around Entrances and Stoop)

9.0 Item 4(Picture) Deterioration From Gutter (Right Rear)

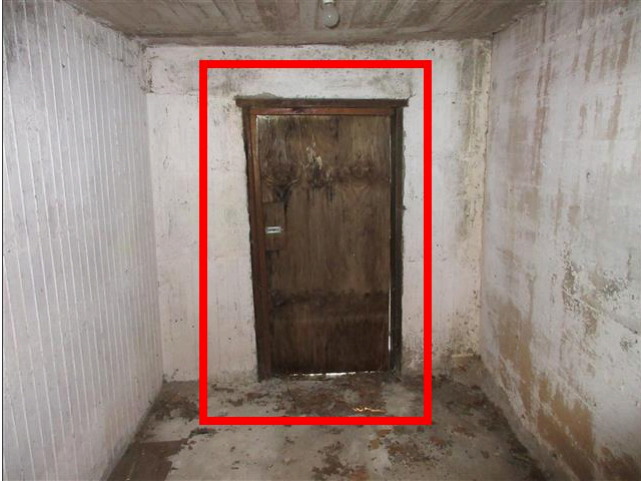
- 🔍 (1) The basement exterior storage room door was observed not adequately sealed resulting in excessive air leakage. This can also allow potential pest and moisture intrusion. Suggest repair to reduce the concerns.

9.1 Item 1(Picture) Gaps and Daylight (Basement)
