# Pre-Listing Inspection Report

**Property Address:**  
502 N Market Street  
Salem VA 24153

**Bateman Home Inspections, LLC**

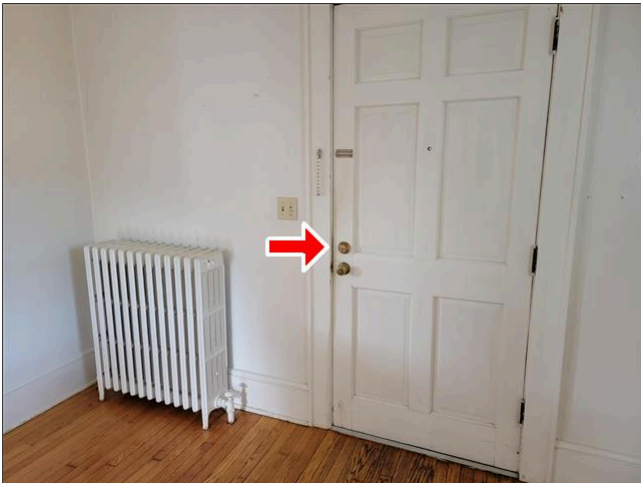
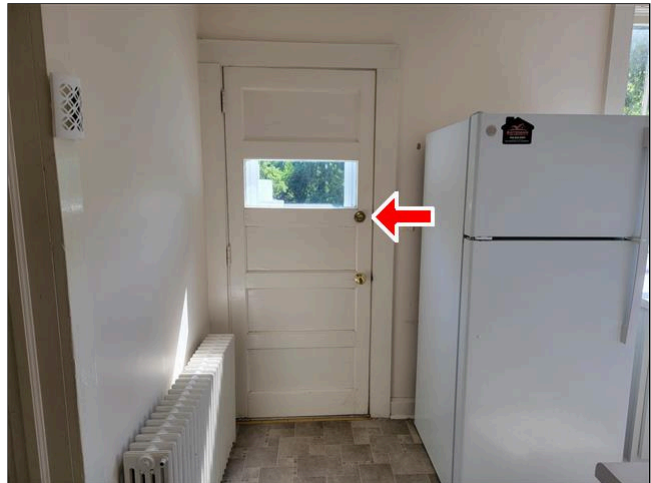
- (2) A double cylinder (keyed both sides) lock was observed on the noted exterior entry door. This is a potential safety concern as it can impede an emergency exit. Although not required, suggest replacing double cylinder locks with single cylinder lock as needed.

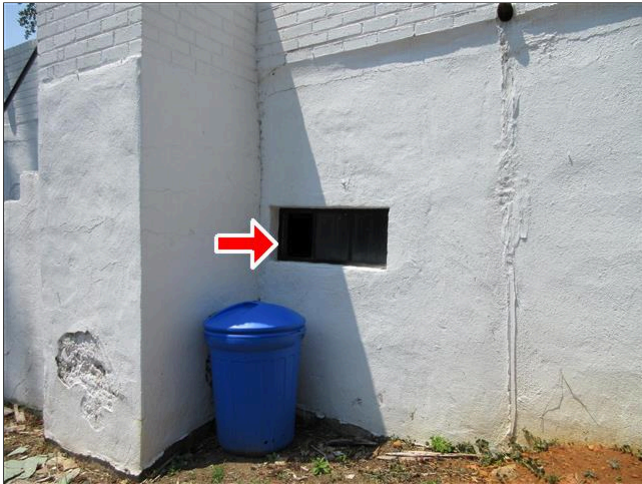
9.2 Item 1(Picture)

- 🔍 Broken glass was observed in the rear storage window. Recommend repair to reduce the safety concern and/or restore sealing capacity.

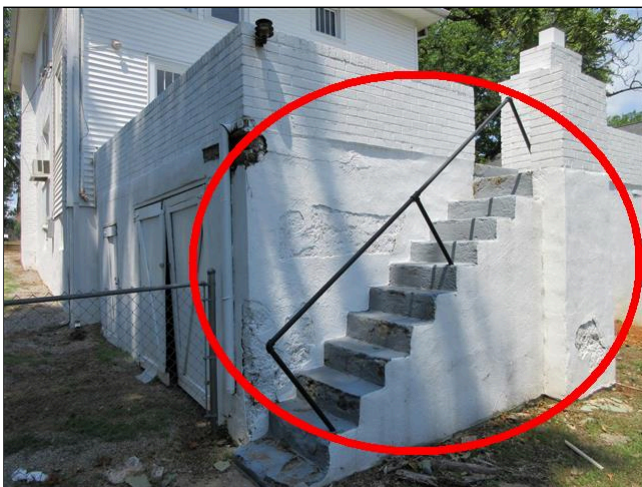
- 🔍 Railing requirements have changed over time. Although not required to, the lack of balusters does not meet current safety specifications. This poses a fall safety concern for toddlers and small children.

9.3 Item 1(Picture) No Balusters (Rear)
