# Pre-Listing Inspection Report

**Property Address:**  
506 N Market Street  
Salem VA 24153

<b>Date:</b> 5/28/2024	<b>Time:</b> 09:00 AM	<b>Report ID:</b> 0524506
<b>Property:</b> 506 N Market Street Salem VA 24153	<b>Customer:</b> Catherine Potter	<b>Real Estate Professional:</b>

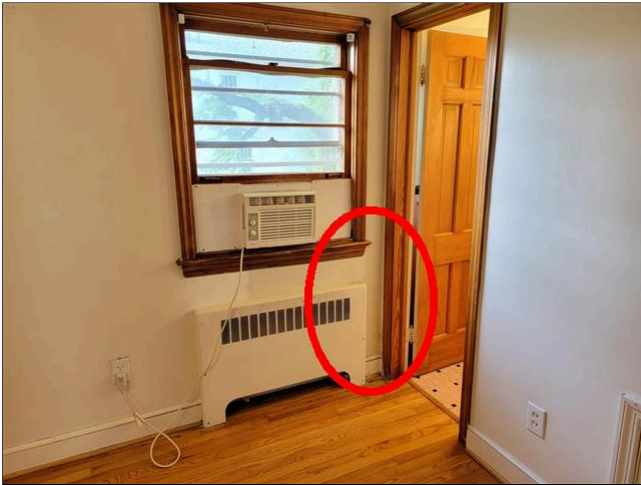
Wall staining was observed in the primary bedroom below the window ac. This may be from past condensation leaks. No elevated levels of moisture was measured and the materials were hard and solid. Suggest ensuring all exterior openings are sealed, and monitoring for condensate leaks once normal use has been restored.

1.1 Item 1(Picture) Staining (Primary Bedroom)

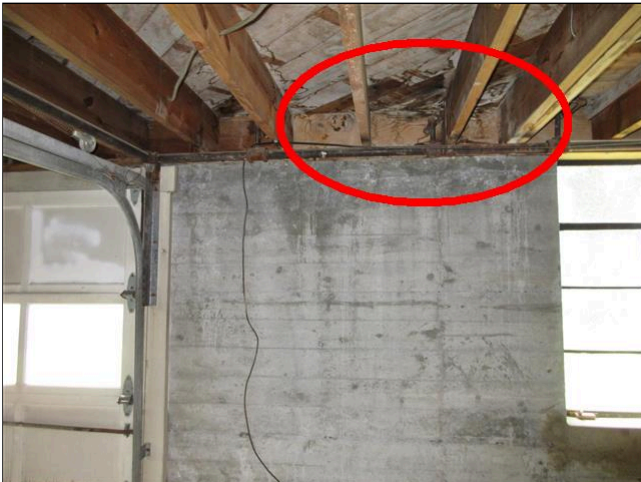
Floor staining was observed under the primary bedroom near the heater lines. No elevated levels of moisture was measured and the materials were hard and solid. As the home has been vacant, recommend monitoring as leaking may occur once normal use of the home is restored.

1.2 Item 1(Picture) Staining

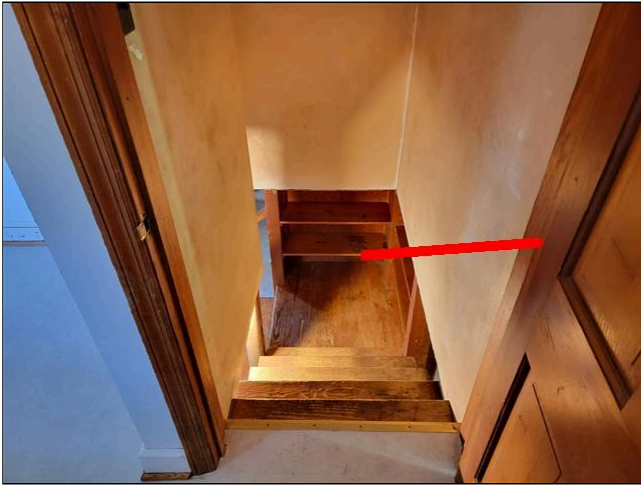
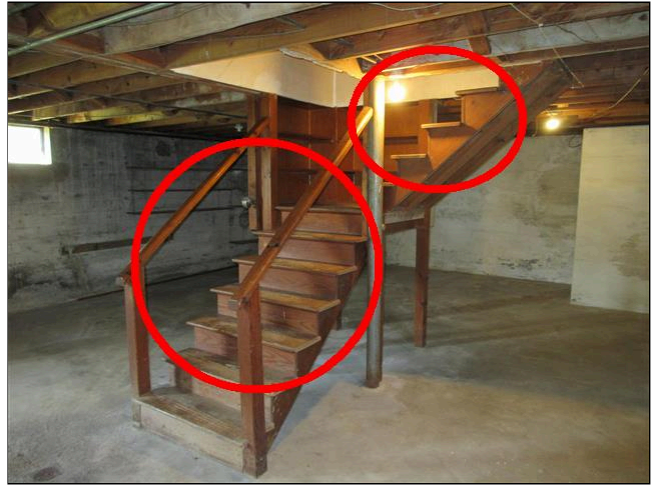
🔍 Railing requirements have changed over time. Although not required to, the lack of a graspable handrail, and the lack of balusters does not meet current safety specifications. Typically stairs over three risers tall have a hand rail for safety. These items create a fall safety concern especially for toddlers and small children.

1.3 Item 1(Picture) No Handrail (Basement Stairwell)

1.3 Item 2(Picture) No Balusters (Basement Stairwell)

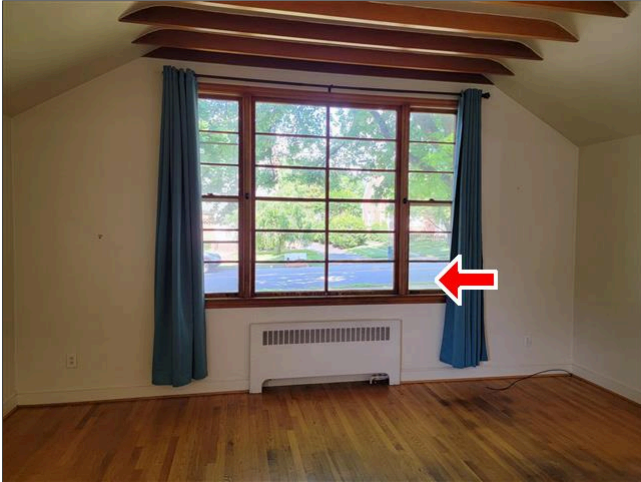
- (1) Broken/cracked glass was observed at the noted living room storm window. Recommend repair to reduce the safety concern and/or restore sealing capacity.

1.6 Item 1(Picture) Cracked Storm Window (Living Room)

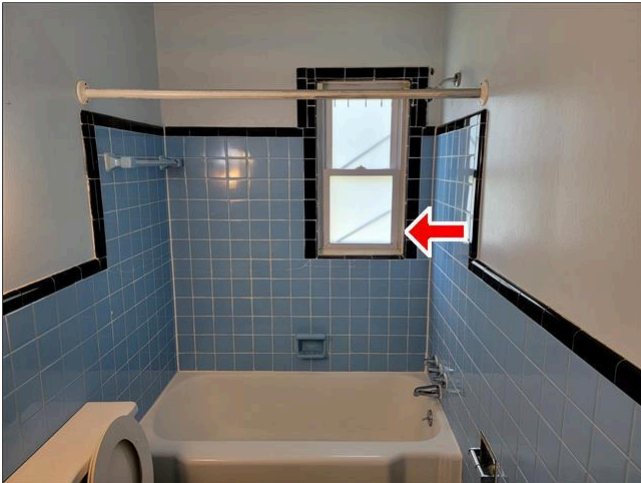
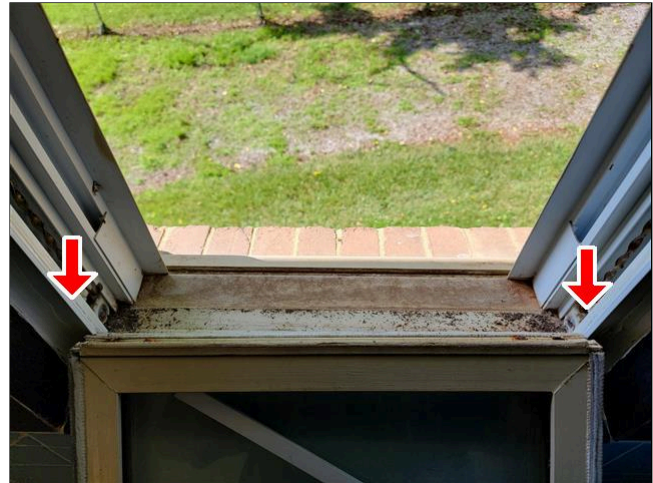
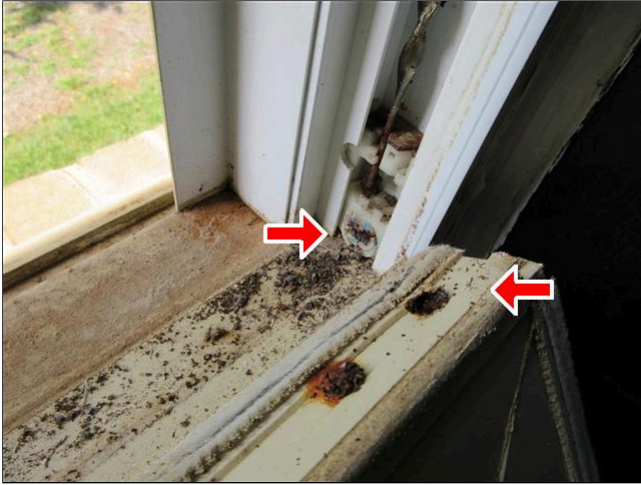
- (2) The main bathroom lower window sash was observed broken pivot shoe arms. The pivot arms connects to the balance. The sash balances are the devices that assists in lifting the weight of the sash and holds the sash in the up position. Window sashes are equipped with one on each side. This may have occurred from long term water contact from the shower head while in use. Additionally, safety glass was not observed in the windows. Although replacement windows are not required to meet current safety specifications, the lack of safety glass poses a safety concern if fallen into. Recommend repair to reduce the concerns.

1.6 Item 2(Picture) No Safety Glass and Broken Pivot Shoe Arms (Main Bathroom)

1.6 Item 3(Picture) Broken Pivot Shoe Arms (Main Bathroom)

1.6 Item 4(Picture) Broken Pivot Shoe and Balance (Both Sides)

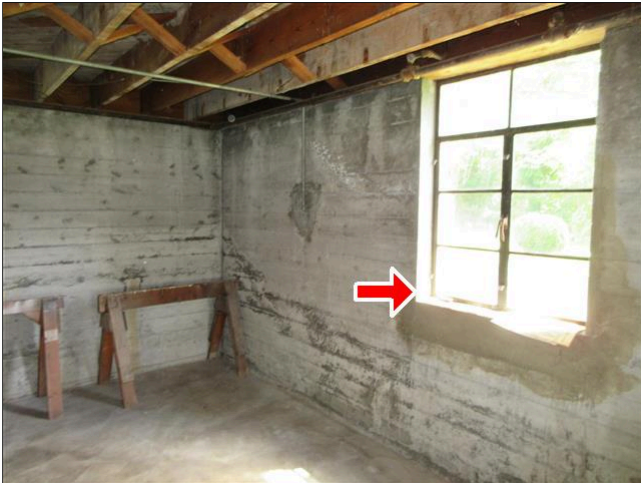
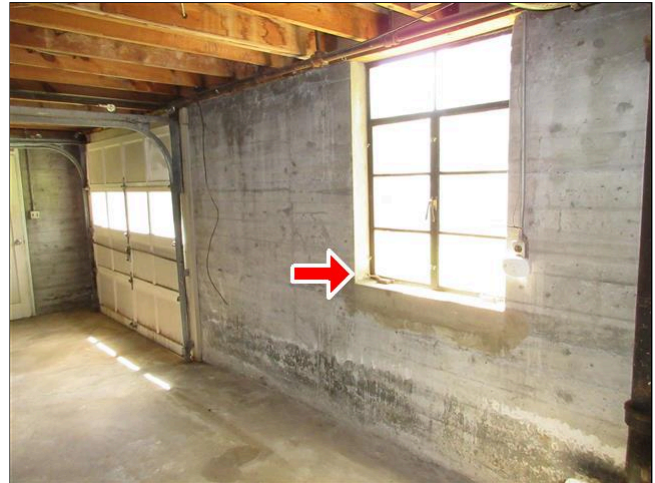
🔍 (3) The noted basement windows were observed stuck shut due to paint and/or lack of use. This creates a safety concern as it can impede an emergency exit. Spraying and greasing the casement gears may correct. Suggest repair to restore normal use.

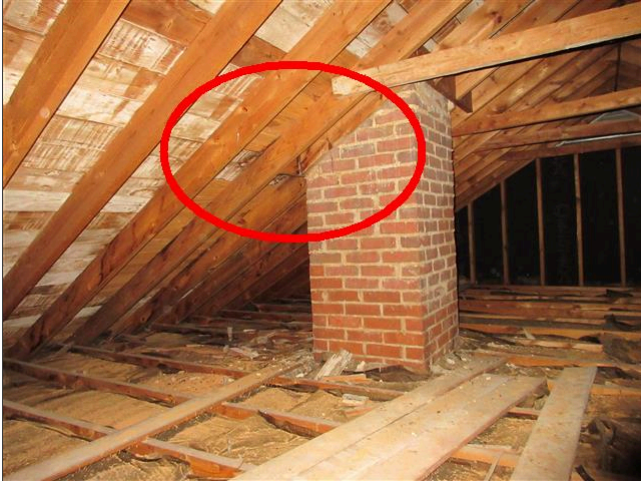
Staining was observed in multiple areas of the roofing materials. This may have been prior to the existing roof and flashing elements as no elevated levels of moisture was measured at the time of the inspection. Identified for reference.

1.7 Item 1(Picture) Staining and Repairs  
(Around Chimney)

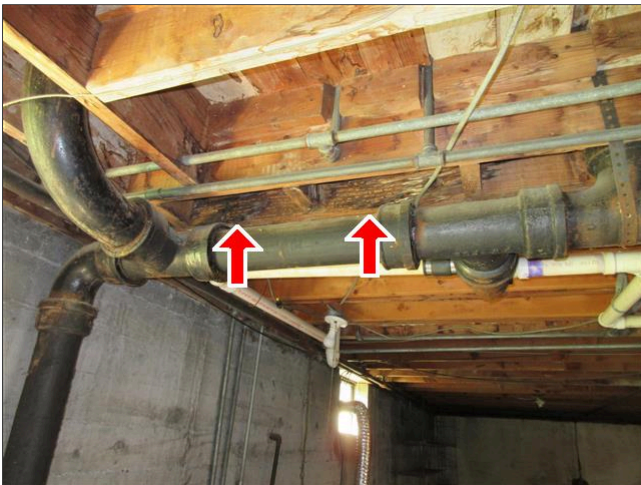
- 🔍 (1) Signs of organic surface growth was observed on several floor joists in the basement. No sampling was performed. This is common when the home has been vacant for a period of time as a result of reduced air circulation, poor climate control, and moisture. This appears to have been from past leaks around the bathroom as repairs were present. Suggest spraying and wiping surfaces with an approved disinfectant. Restoring home use and the introduction of a dehumidifier will significantly reduce surface contamination.

1.9 Item 1(Picture) ORganic Growth (Under  
Bathrooms Only)

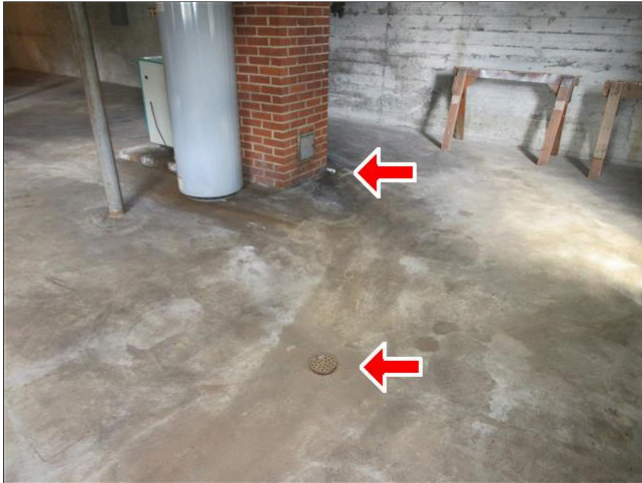
(2) A floor drain was observed in the basement. Its operation was not verified. Additionally, the discharge tube for the boiler was not fully routed to the drain. Suggest having the drain cleaned to ensure proper flow thus reducing the potential of a backup, and extending the drain line to the drain hole.

1.9 Item 2(Picture) Drain and Discharge

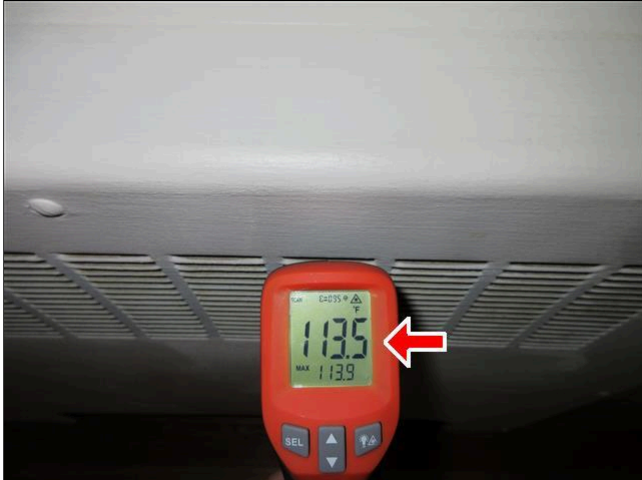
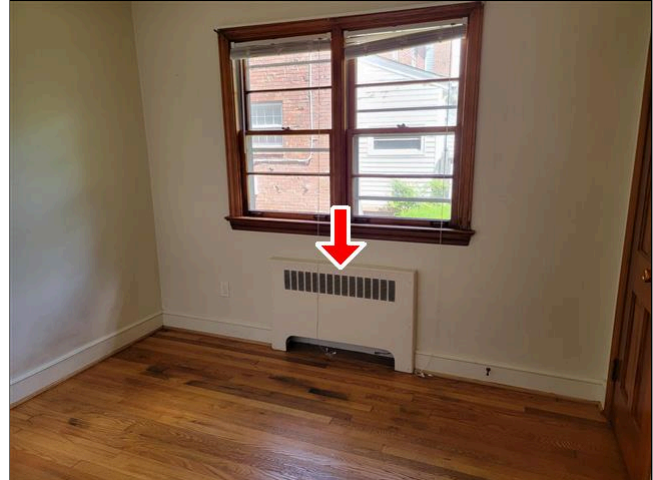
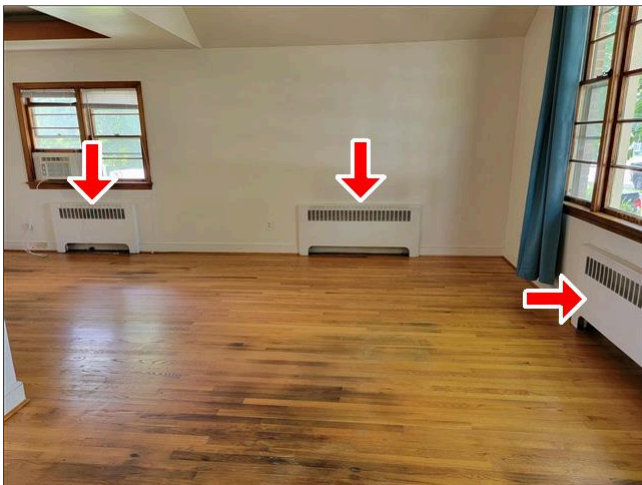
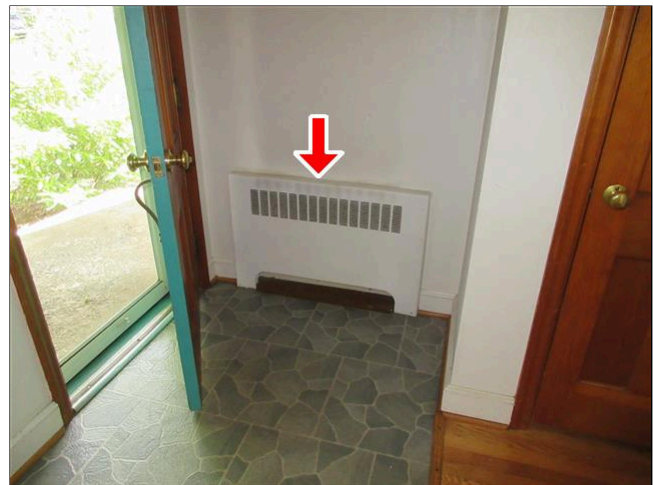
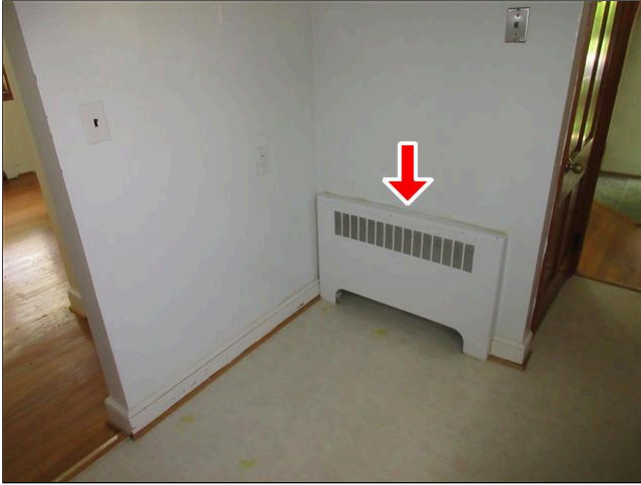
Although the heating system was functional, the noted heaters were not function as no heat was present during the inspection. The system may have air in the lines, or need additional water. Recommend having a qualified contractor further evaluate and repair as necessary to restore normal use.

2.0 Item 2(Picture) Left Bedroom (Not Functional)

2.0 Item 3(Picture) Living Room (Not Functional)

2.0 Item 4(Picture) Front Entrance (Not Functional)

2.0 Item 5(Picture) Kitchen (Not Functional)

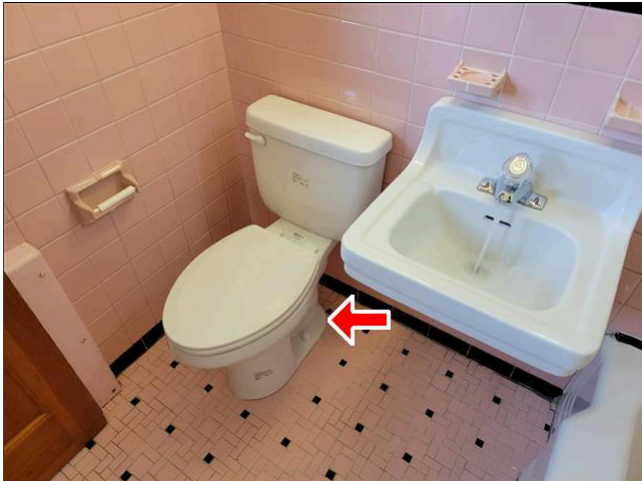
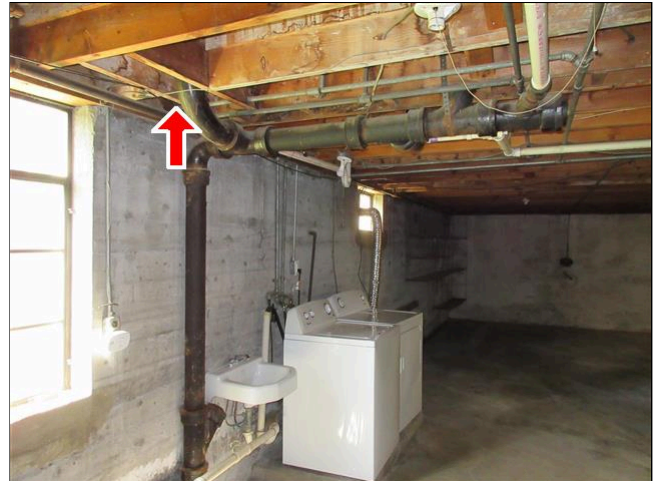
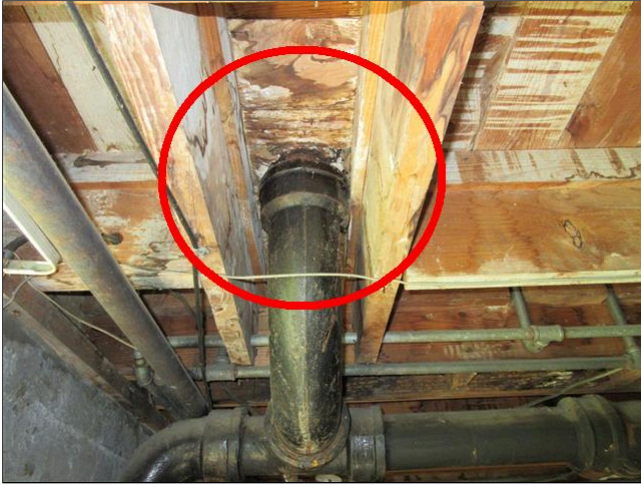
- 🔍 (1) The primary bathroom toilet fixture connection to floor was observed loose. Staining was observed on the floor materials around the toilet in the basement. This is typical of a loose toilet and/or faulty wax seal. As the home has been vacant for a period of time, it is not possible to determine if the stains are active or old. Suggest tightening the toilet bolts and monitoring for leaks once normal use has been restored as additional repairs may require wax ring replacement or a qualified contractor.

3.2 Item 1(Picture) Loose Toilet (Primary Bathroom)

3.2 Item 2(Picture) Staining (Below Toilet)

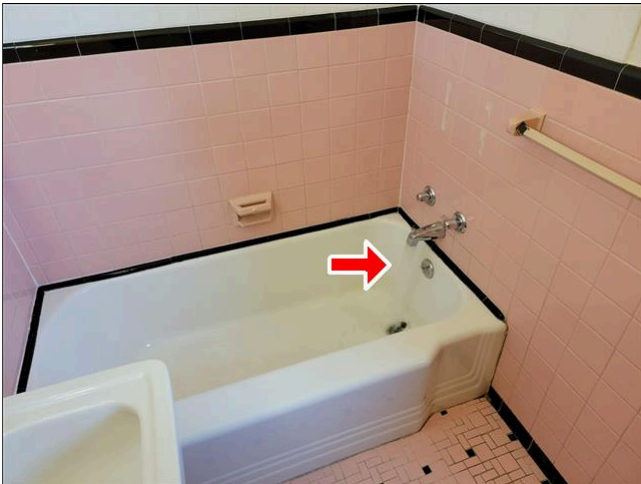
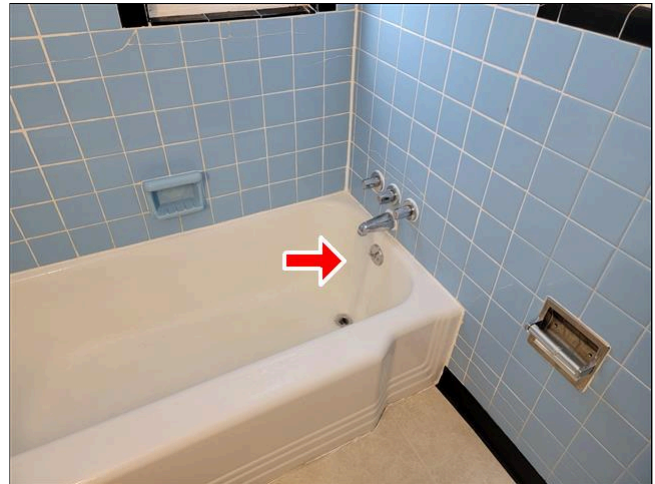
🔍 (2) The tub drain stoppers did not function properly. Suggest repair or adjustment of stopper linkage to restore function.

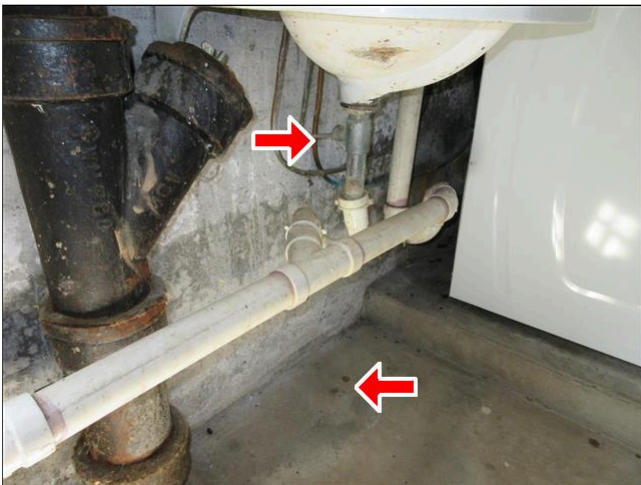
🔍 (3) The basement sink pivot arm connection was dripping. Suggest cleaning the threads and then tightening the connection nut. If this does not correct, suggest replacing with new components.

3.2 Item 6(Picture) Minor Drip (Under Basement Sink)

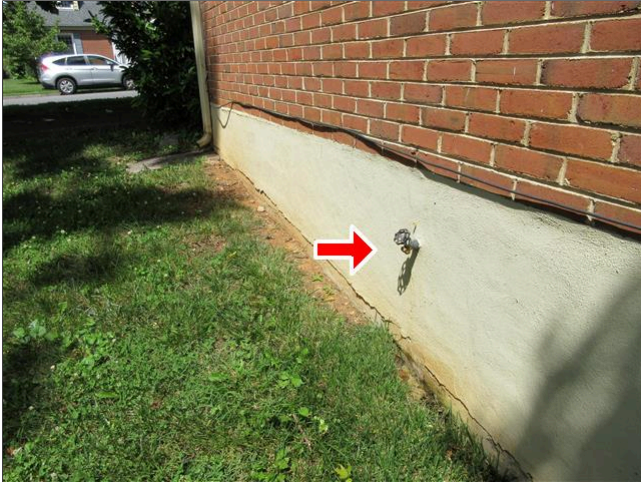
- (4) The right side exterior hose bib was constantly dripping. An attempt was made to tighten the handle. Suggest tightening the packing nut to eliminate the drip.

3.2 Item 7(Picture) Constant Drip (Right Side)

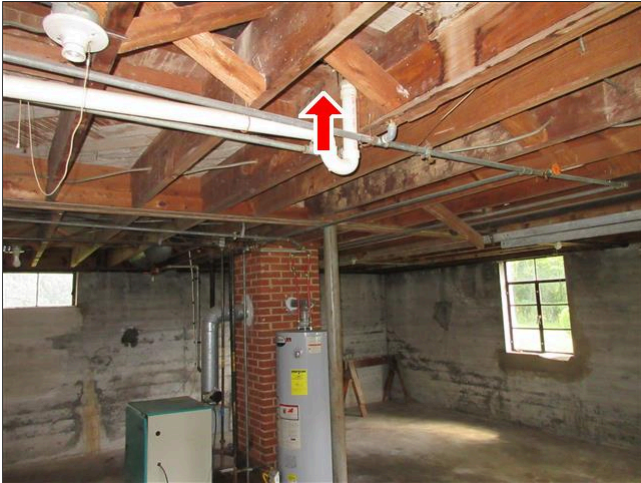
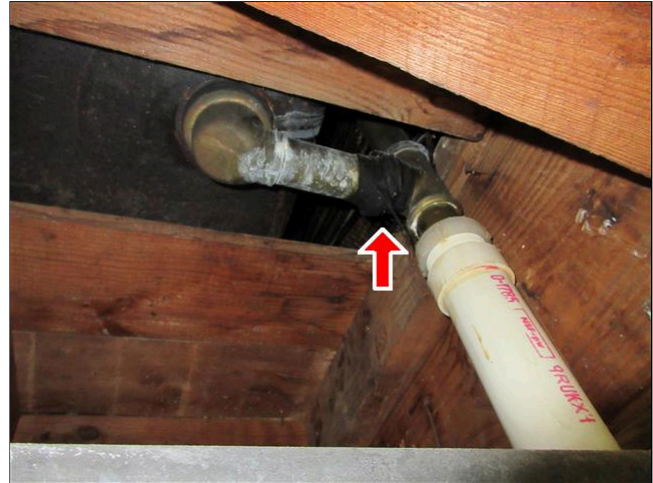
- (5) A section of the water line under the primary bathroom tub was wrapped in tape. Although no leaking was observed at the time of the inspection, this may leak once normal use has been restored. Suggest repair as needed to reduce the concern.

3.2 Item 9(Picture) Wrapped in Tape

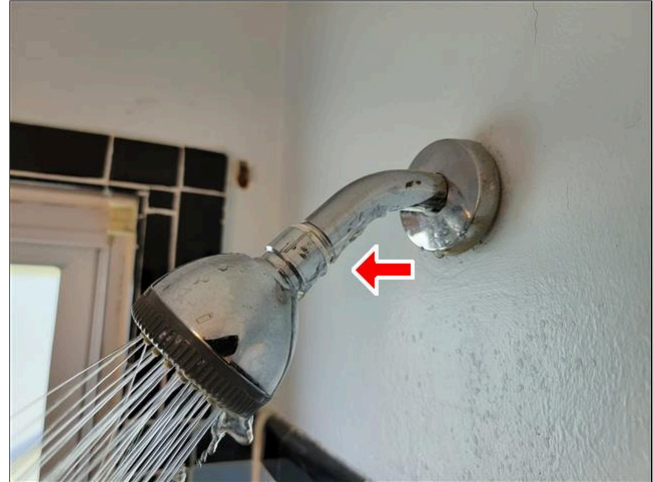
3.2 Item 10(Picture) Dripping Shower Head (Main Bathroom)

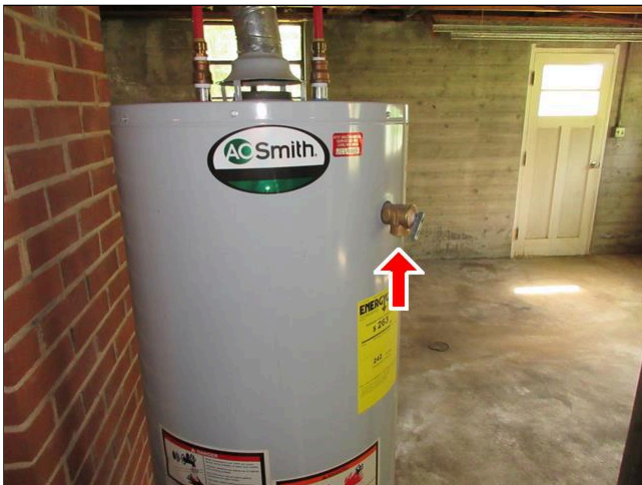
3.3 Item 1(Picture)

- (1) No temperature / pressure (T&P) relief valve discharge pipe was observed attached to the water heater at the time of inspection. The T&P relief valve on the water heater is designed to safely discharge hot water in the event of a water heater failure. A 3/4" discharge pipe is required to safely direct the discharging hot water to within 6" of the floor. Suggest installation of a discharge pipe.

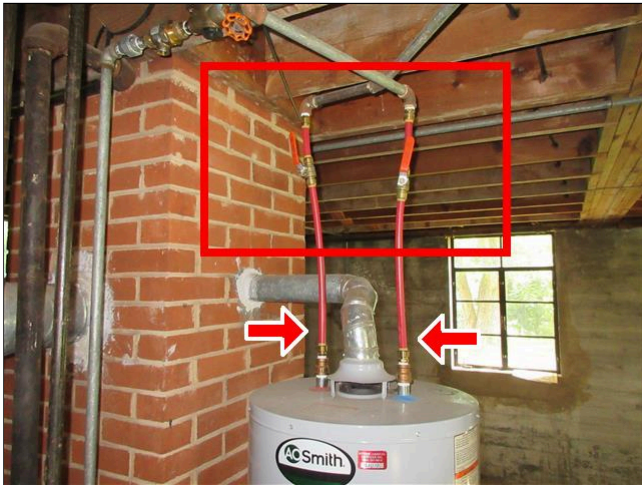
(2) The homes water supply is delivered by a city water main. Typically a back flow preventer will be present at the meter. This provides a hard stop preventing house water from flowing back into the city water main. This feature in combination with the ability of the homes gas water heater to quickly heat water can cause excess pressure to develop in the homes water supply system. Excess pressure will leak out of the water heater temperature and pressure (T&P) relief valve. This valve is designed for release of pressure as an emergency safety feature and not for sporadic operation. To prevent sporadic valve operation, a thermal expansion tank is used to absorb the excess pressure. Although no expansion tank was observed, the valve appeared stable and not leaking. If the valve begins to leak, suggest having a qualified contractor evaluate and advise on the installation of an expansion tank. Additionally, plastic piping was observed connected to the gas water heater. Metal piping is typically required in the first 18" of this application as radiant heat from the flue can damage the plastic pipe material over time. Suggest monitoring the plastic lines and repair as needed.

3.3 Item 2(Picture) Typical Expansion Tank Location and Plastic Piping

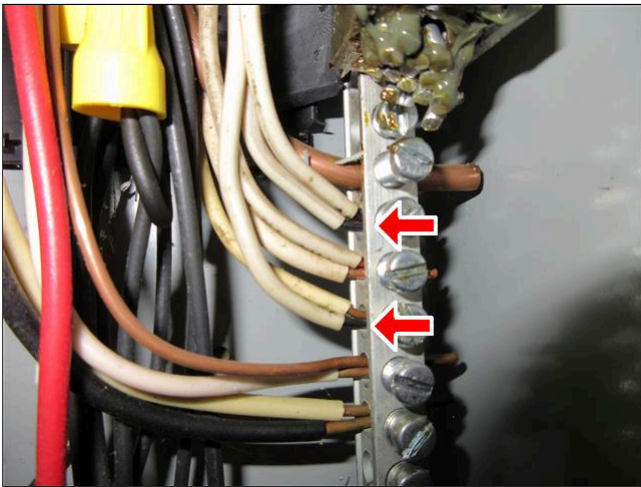
- Although no substantial concerns were observed, the panel manufacturer "Challenger" was installed in the home. This panel was installed in thousands of homes between the 1980s and 1990s but brought potential safety hazards and was recalled. Several neutral wires on the right side bus bar appear to be overheated and have turned black. The sheathing was not blistered. Due to the black neutral wires, suggest having a qualified contractor further evaluate and advise if any corrective actions are necessary.

4.2 Item 1(Picture) Black Neutral Wires

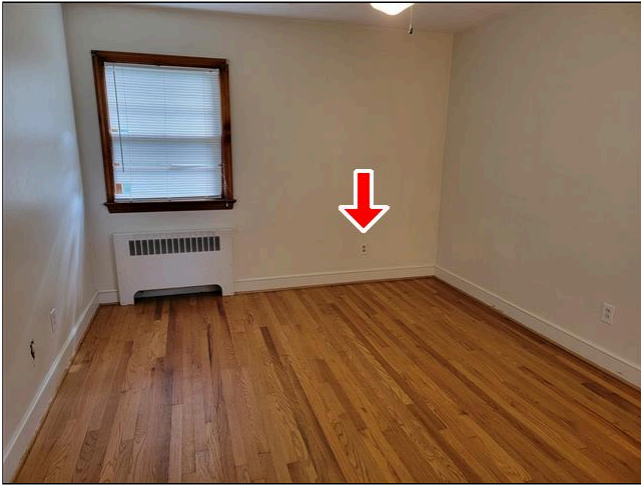
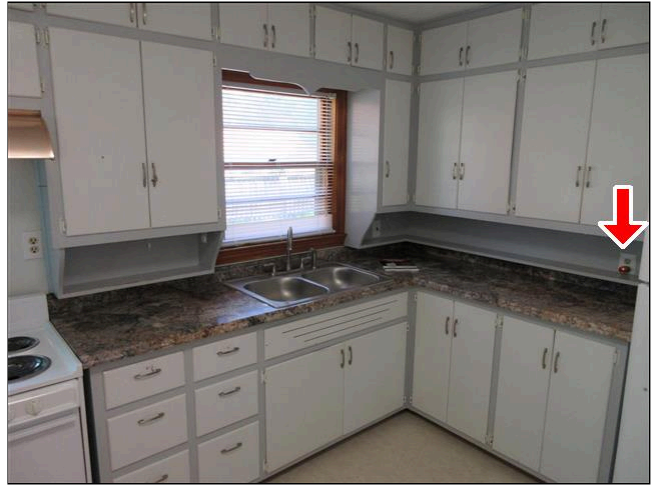
🔍 (1) Although 3-prong outlets were observed throughout the home, the noted 3-prong outlets are not grounded. Suggest labeling any ungrounded 3-prong outlets as non-grounded or replacing with 2-prong outlets to represent the correct ground configuration. The kitchen one needs to be upgraded to a GFCI outlet.

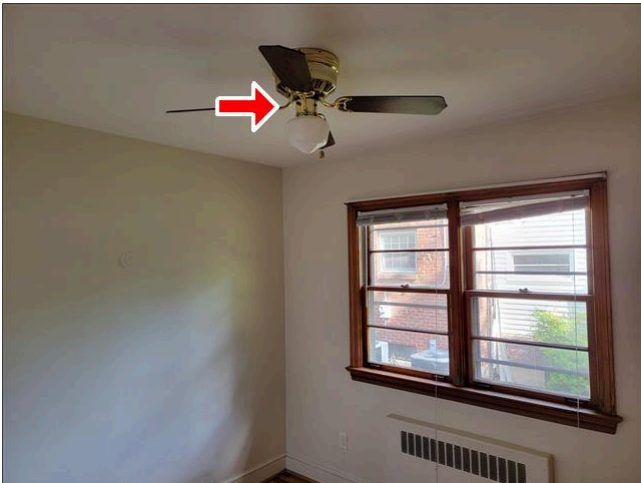
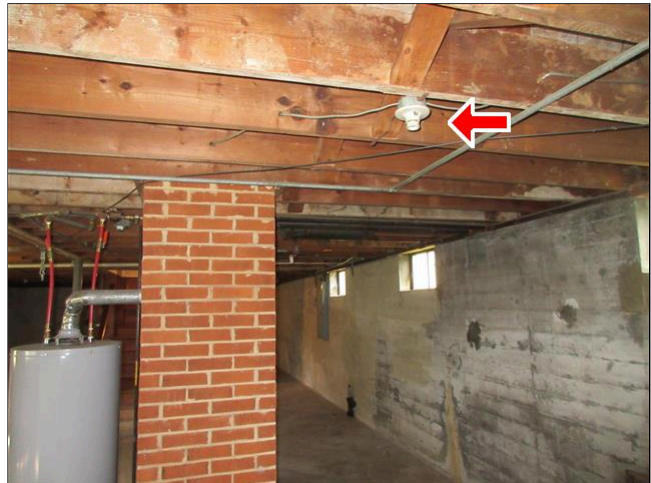
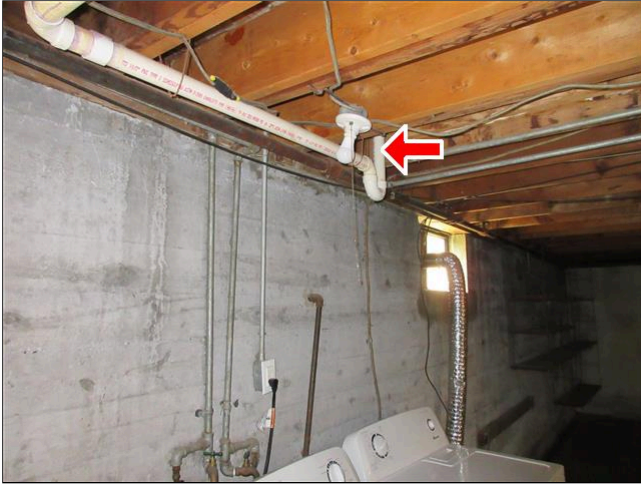
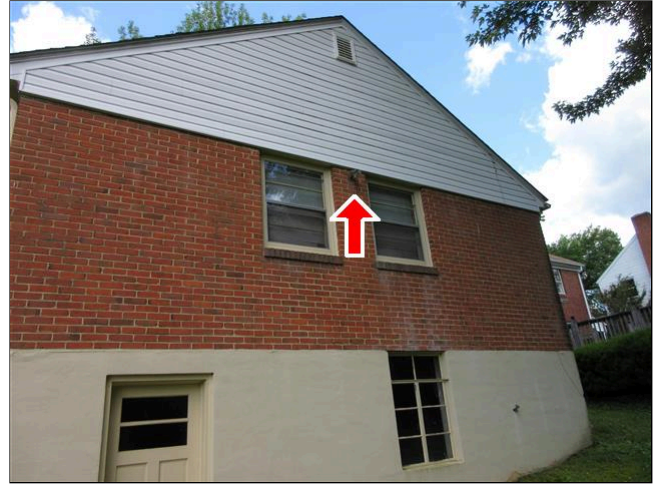
🔍 (2) Although functional, the left side bedroom ceiling fan was missing the pull chain for the lights. Additionally, several light fixtures were missing chains, had seized chains and had potentially faulty bulbs. Suggest repair/replacing faulty fixtures and bad bulbs to restore normal use.

4.4 Item 3(Picture) Missing Light Pull Chain (Left Side Bedroom)

4.4 Item 4(Picture) Missing Pull Chain (Basement Light Fixture)

4.4 Item 5(Picture) Seized Pull Chain (Basement Light Fixture)

4.4 Item 6(Picture) Not Functional/Potential Failed Light Bulbs (Rear)

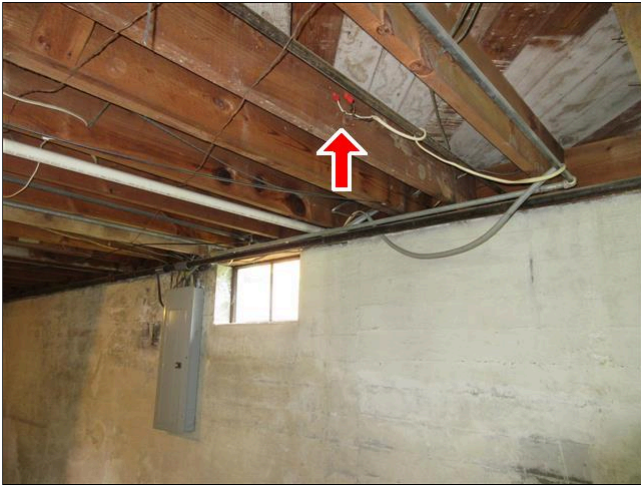
🔍 (3) An exposed and readily accessible electrical connections were observed. Connections should be properly terminated in covered junction boxes or by other approved means.

4.4 Item 7(Picture) No Junction Box (Basement)

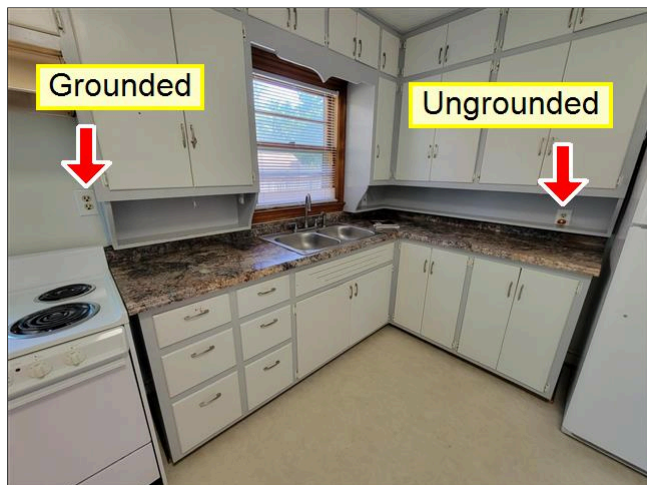
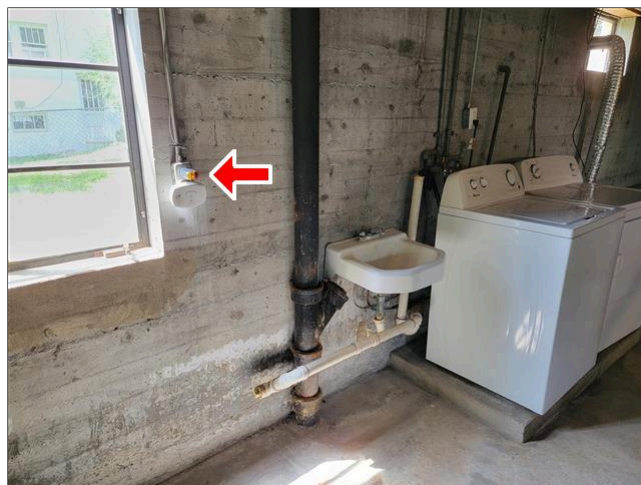
🔍 Outlets near water sources pose an increased shock concern. GFCI devices provide additional electrical safety in these locations. Suggest upgrading noted outlets or circuit to improve electrical safety.

4.5 Item 1(Picture) Kitchen Outlets (Grounded & Ungrounded)

4.5 Item 2(Picture) Basement Sink Outlet (Grounded)

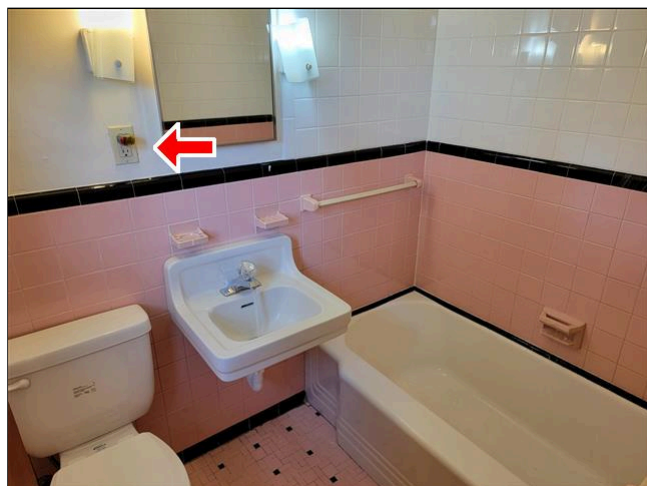
🔍 The primary bathroom GFCI outlet was observed inactive and failed to reset. This is common with age and infrequent testing. Recommend replacing faulty outlet to restore proper safety function.

4.6 Item 1(Picture) Inactive GFCI (Primary Bathroom)

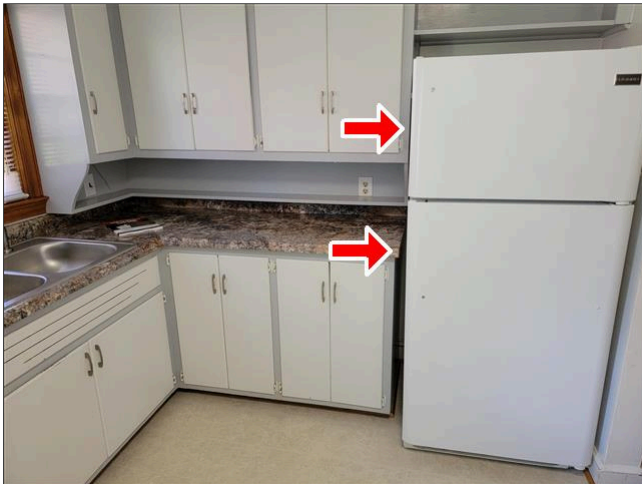
The refrigerator door handles were missing at the time of the inspection, and the refrigerator light bulb needs replacing. Identified for reference.

5.5 Item 1(Picture) No Handles

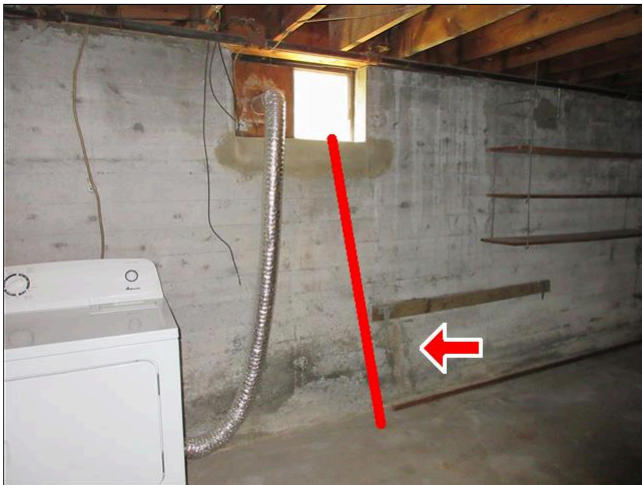
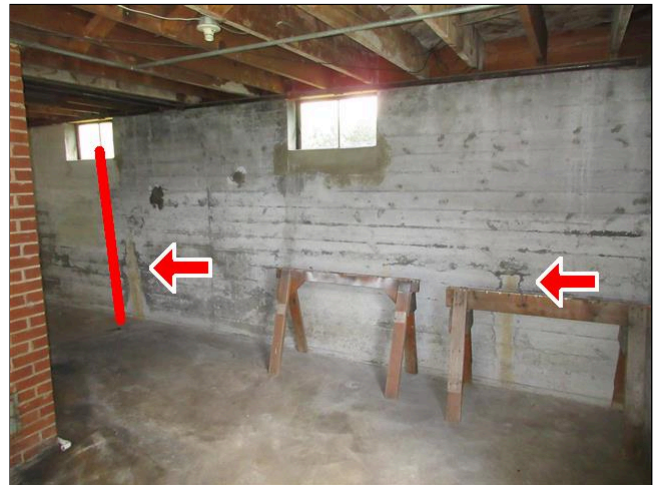
- Vertical foundation cracking and staining was observed in areas of the basement. 1/16" and less cracks are common. No observations indicate any current or on going structural concern. Suggest sealing any open joints as needed with an approved foundation epoxy/sealer and monitoring. If cracking changes in shape or grows to a gap in excess of 3/16", further evaluation is then recommended by a qualified contractor.

6.0 Item 1(Picture) Crack and Staining (Right Wall)

6.0 Item 2(Picture) Crack and Staining (Left Wall)

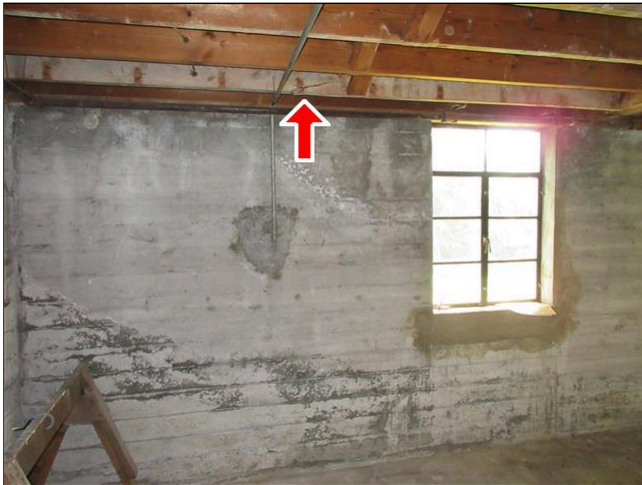
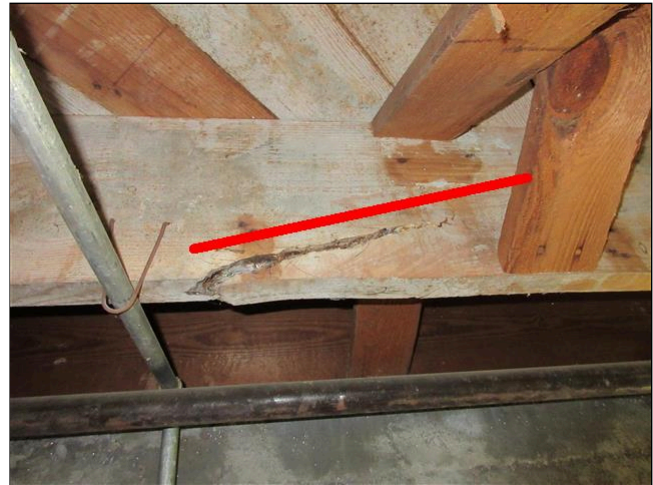
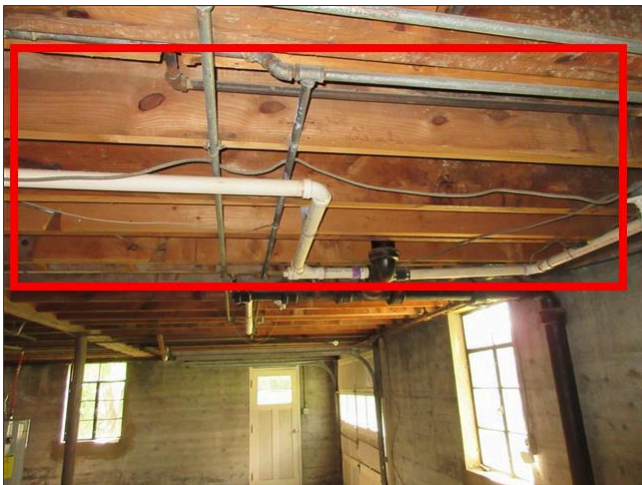
Although the floor appears stable, a cracked floor joist was observed at the rear. Load carrying capacity is reduced due to the reduction in cross sectional area. Additionally, modifications were observed to several joists under the bathrooms. It is outside the scope of the home inspection to determine if the modifications meet any requirements but they were not fully sistered to full length of the original floor joists. Suggest installation of a sister joist (additional joist bolted to the existing joist) to the cracked joist to restore the proper load carrying capacity. Recommend having a qualified contractor further evaluate and repair as needed.

6.2 Item 1(Picture) Cracked Joist (Rear)

6.2 Item 3(Picture) Sistered Floor Joists/ Modifications

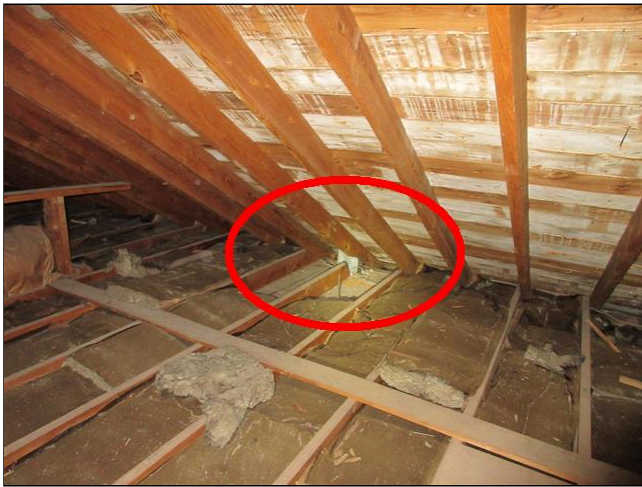
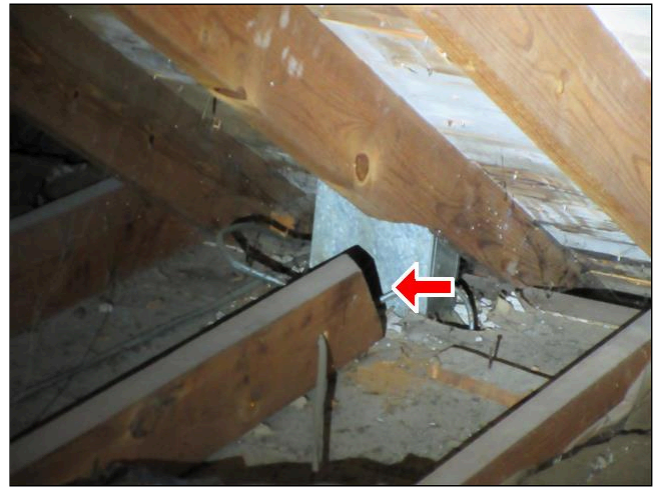
🔍 Limited visibility as ceiling surfaces were finished or covered by insulation. Although the ceiling appears stable, a cut ceiling joist was observed at the range hood exhaust vent and not properly reinforced. Suggest properly heading the joist to reduce the potential of movement. Recommend having a qualified contractor further evaluate and repair as necessary.

6.4 Item 1(Picture) Cut Ceiling Joist

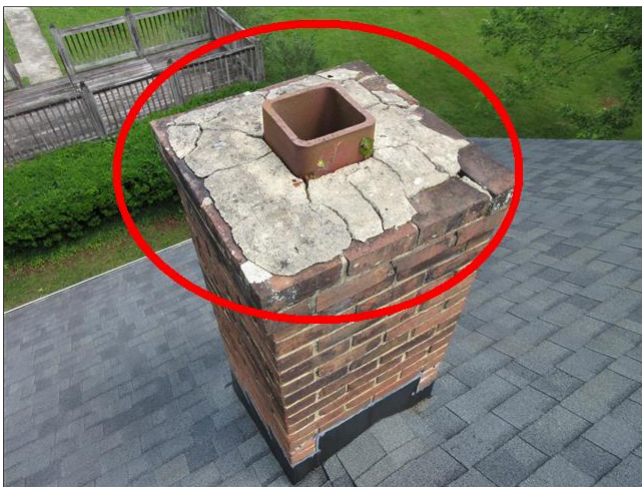
🔍 The crown was observed cracked and worn from age and weather. Cracking can potentially allow water to enter the chimney chase which increases deterioration especially when the chimney is no longer used or abandoned. The installation of a rain cap over the top of the chimney would be an improvement over the current configuration. Recommend having a qualified contractor further evaluate and repair as necessary.

6.6 Item 1(Picture) Cracked/Worn Crown and Openings

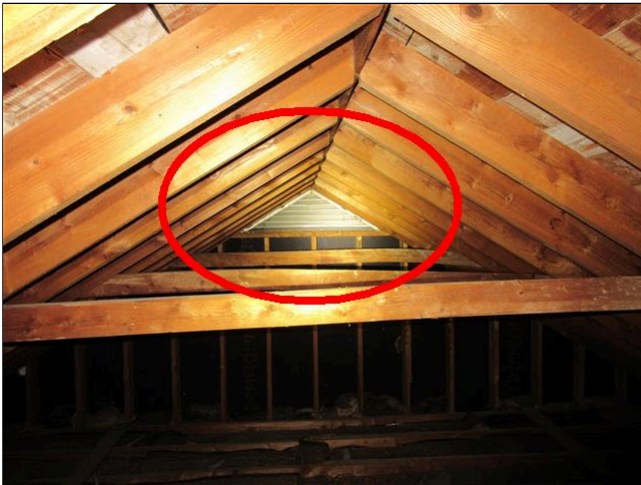
- 🔍 The screen for the front and rear attic gable vents were observed missing leaving an opening in the vent. This can allow pests to enter the attic area. Suggest installation of screen(s) to reduce the concern.

7.2 Item 1(Picture) No Screen (Front and Rear)

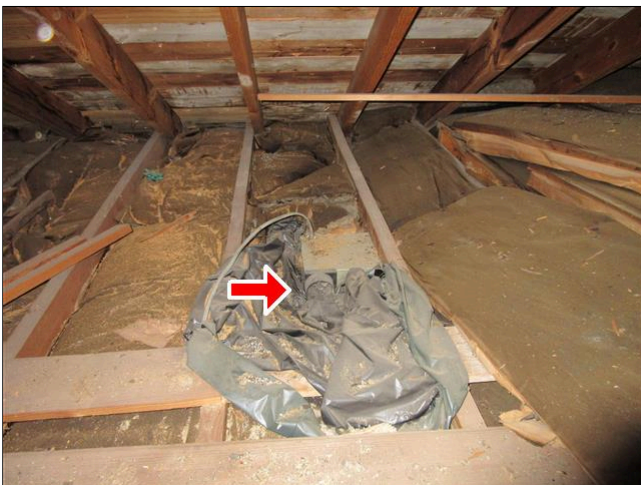
- 🔍 The main exhaust fan/ducting was observed discharging directly into the attic space. Although once a common practice, warm and moist air can damage building materials over time. Suggest venting the exhaust to the exterior, or through the roof.

7.3 Item 1(Picture) Main Bathroom Exhaust Fan Discharge

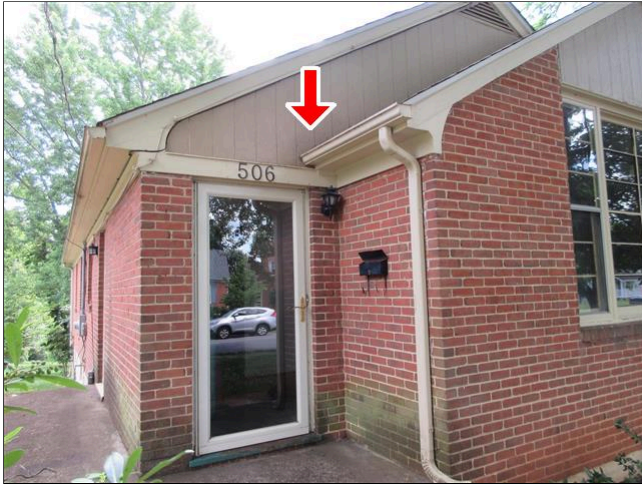
8.1 Item 1(Picture) Front

Although not required, no kick out flashing or diverter was observed at the roof to side wall transition. Kick out flashing diverts roof water into the gutter and prevents large volumes of water from running down the siding. Suggest installation of kick out flashing to improve rain water management and reduce the potential for water intrusion.

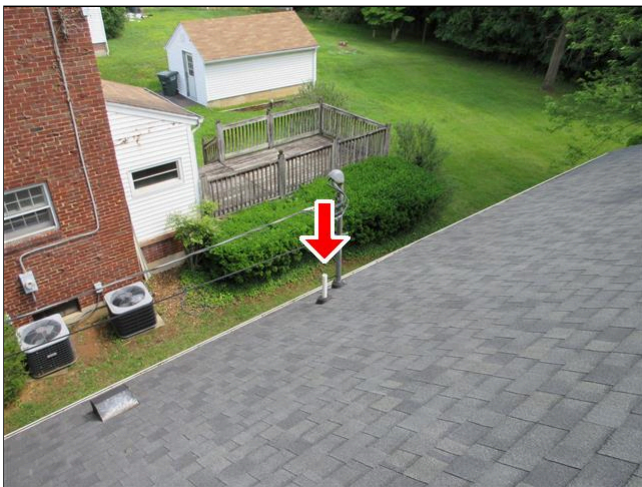
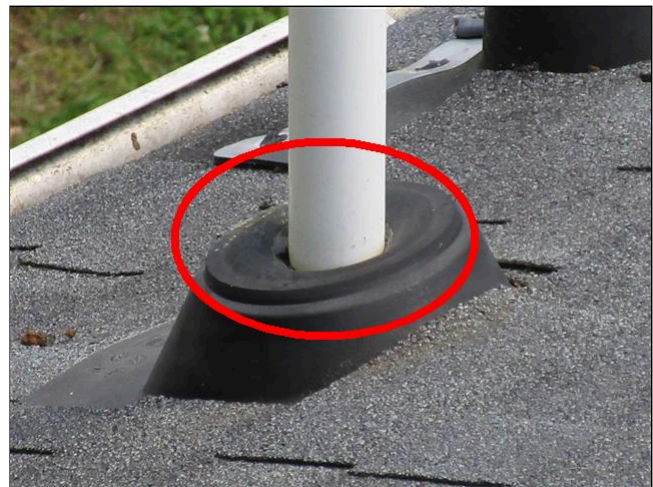
Although no visible active leaking was observed at the time of the inspection, a seal flare was rolled down. Rolled seals may leak during moderate rain events. This is typically a result of a vent pipe that has slipped and pulled the seal inward. Lifting and securing the vent pipe is a common repair action to reset the seal. Suggest repair to reduce the concerns.

8.2 Item 2(Picture) Rolled Seal

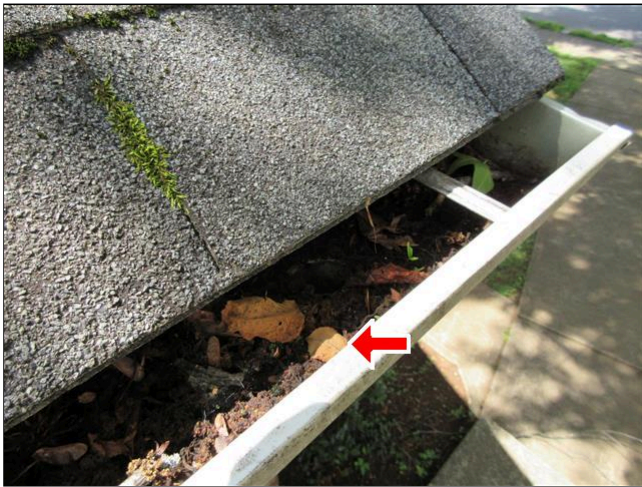
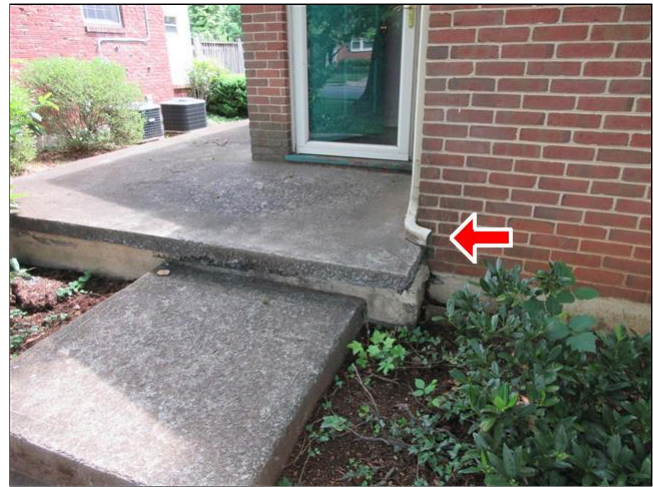
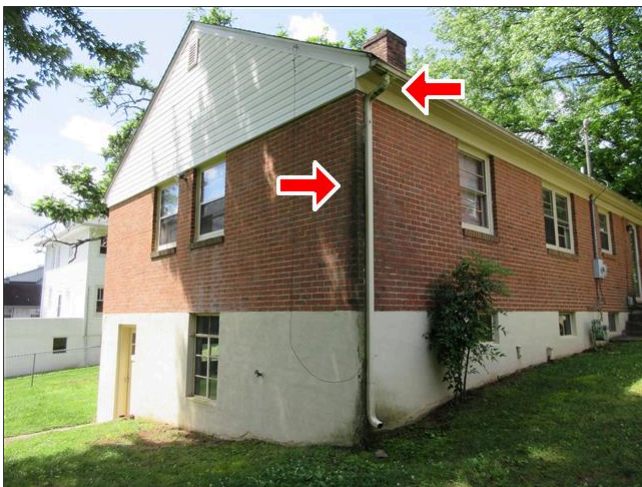
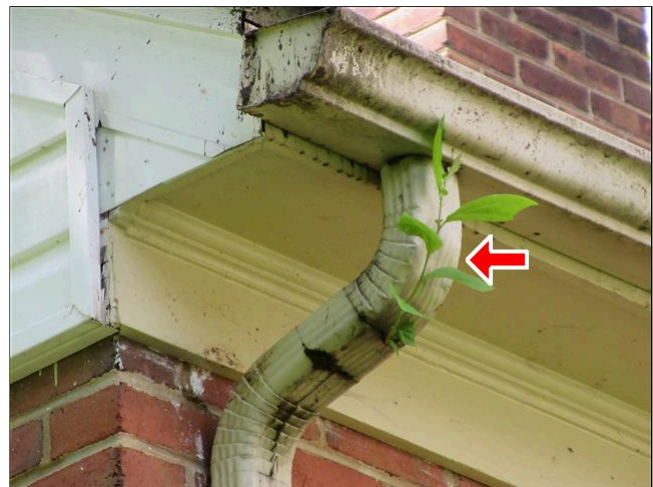
Although the gutters appear intact and complete, they were observed clogged with debris, and

discharging at the foundation. Excessive debris can cause gutters to overflow around the home. Downspouts should discharge water 4'-6' away from the foundation. Due to the lack of rain during the inspection, gutter functionality was not determined. Suggest clearing debris, installation of downspout leaders, and monitoring gutter function during a moderate rain event to identify if any sections need slope adjustments.

8.3 Item 1(Picture) Debris (Multiple Areas)

8.3 Item 2(Picture) Discharge (Multiple Locations)

8.3 Item 3(Picture) Overflow Indications and Overgrowth

8.3 Item 4(Picture) Additional View of Overgrowth
