# Pre-Listing Inspection Report

**Property Address:**  
506 N Market Street  
Salem VA 24153

<b>Date:</b> 5/28/2024	<b>Time:</b> 09:00 AM	<b>Report ID:</b> 0524506
<b>Property:</b> 506 N Market Street Salem VA 24153	<b>Customer:</b> Catherine Potter	<b>Real Estate Professional:</b>

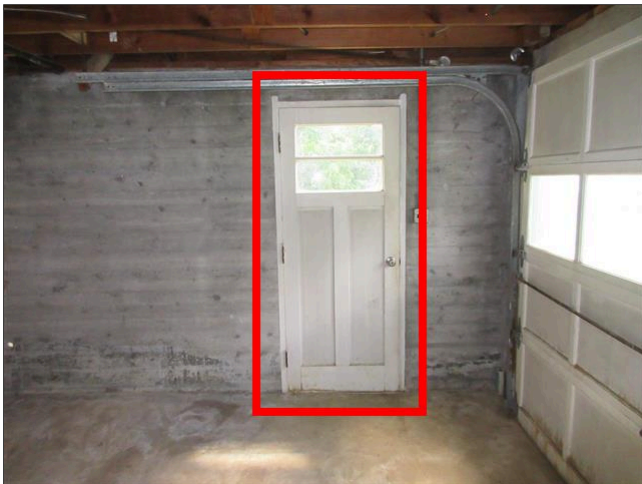
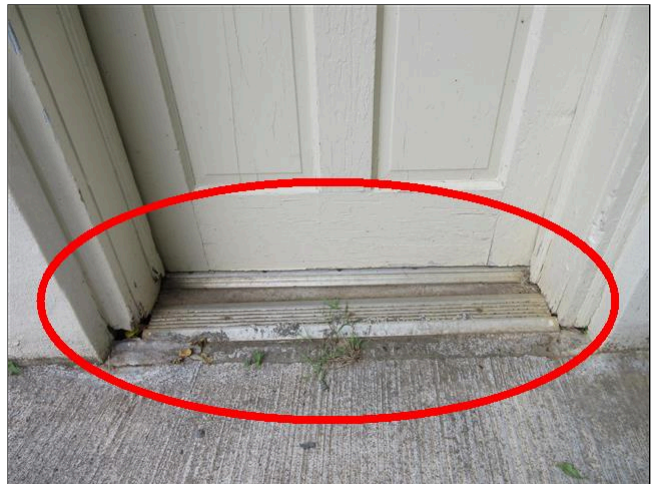
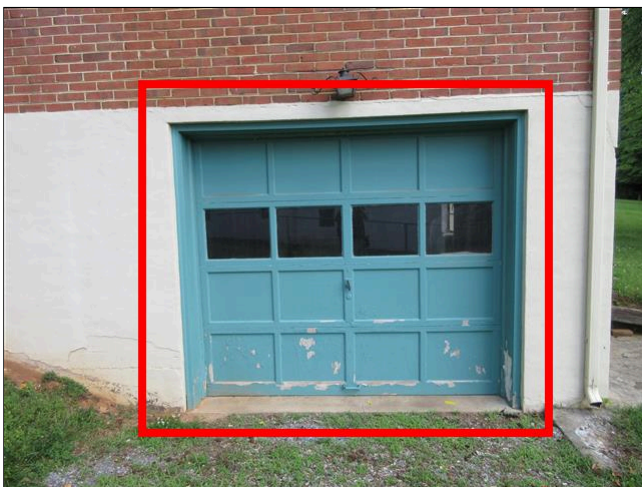
🔍 The basement exterior door, and garage door were observed not adequately sealed resulting in excessive air leakage. This can also allow potential pest and moisture intrusion. Openings and deterioration were observed on the exterior for the basement door. Suggest repair to reduce the concerns.

9.1 Item 1(Picture) No Weather Stripping (Interior View)

9.1 Item 2(Picture) Openings and Deterioration (Exterior View)

9.1 Item 3(Picture) No Weather Stripping
