Pre-Listing Inspection Report

Property Address:
510 N Market Street
Salem VA 24153

Bateman Home Inspections, LLC

Date: 5/2/2024	Time: 09:00 AM	Report ID: 0524510
Property: 510 N Market Street Salem VA 24153	Customer: Catherine Potter	Real Estate Professional:

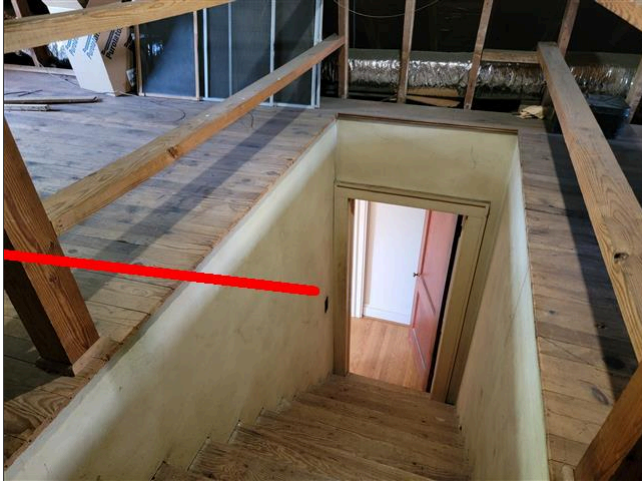
Railing requirements have changed over time. Although not required to, the lack of a graspable handrail and horizontal balusters (interior and exterior) does not meet current safety specifications. Typically stairs over three risers tall have a hand rail for safety and balusters are installed vertically to reduce climbing. This is a fall safety concern especially for toddlers and small children.

1.3 Item 1(Picture) Attic Stairwell (No Handrail and Horizontal Balusters)

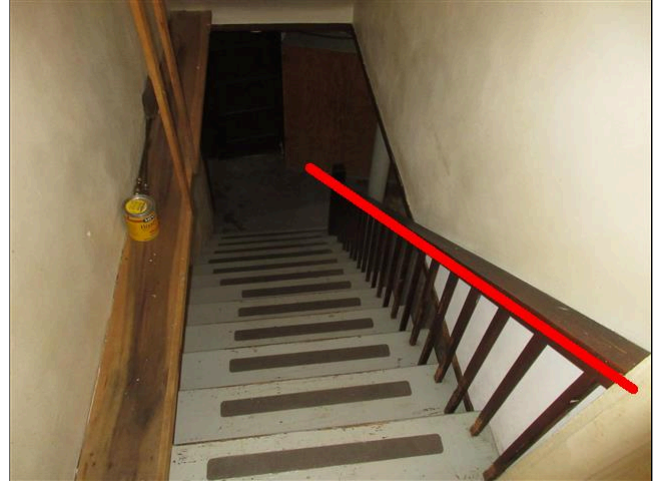
1.3 Item 2(Picture) Basement Stairwell (No Handrail)

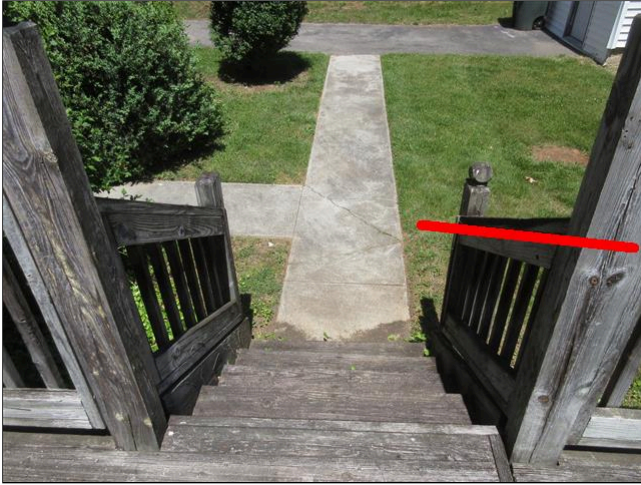
1.3 Item 3(Picture) Exterior Deck (No Handrail)

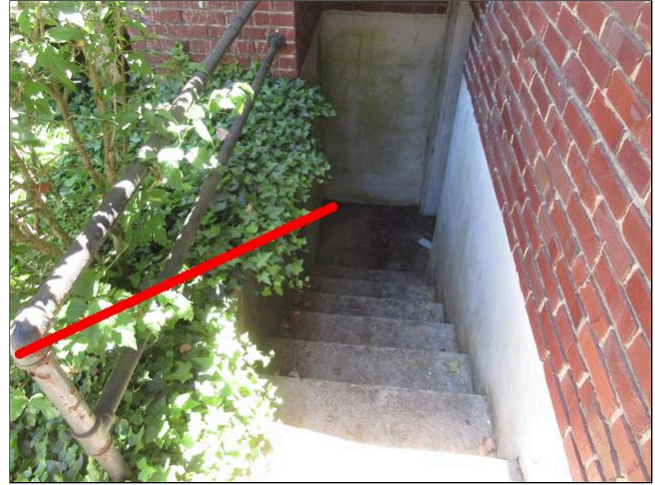
1.3 Item 4(Picture) Exterior Basement Stairwell (No Handrail and Horizontal Balusters)

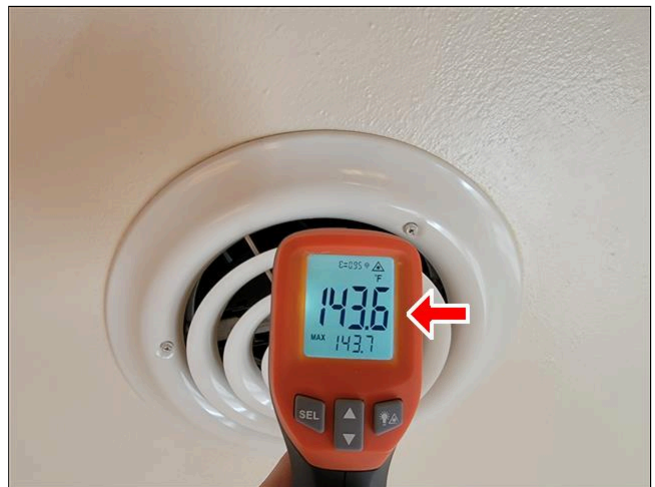
2.1.A Item 2(Picture) 143.6 Degrees (Heat Stage 2 "Aux")

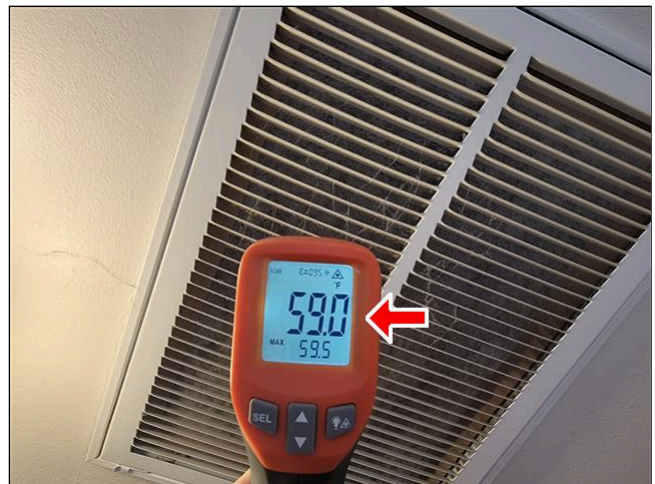
2.10.A Item 2(Picture) 59 Degrees (Return Air)

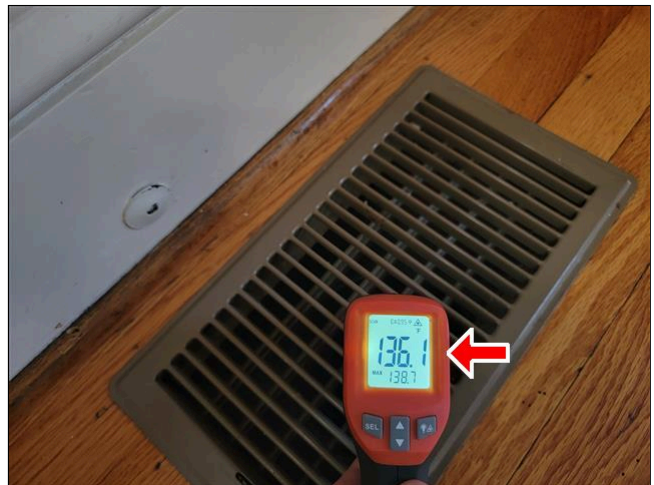
2.1.B Item 2(Picture) 136.1 Degrees (Heat Stage 2 "Aux")

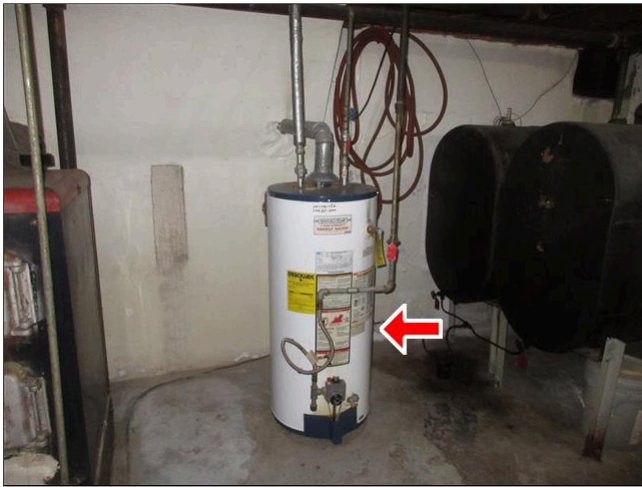
The water heater is located in the basement.

3.5 Item 1(Picture) Water Heater

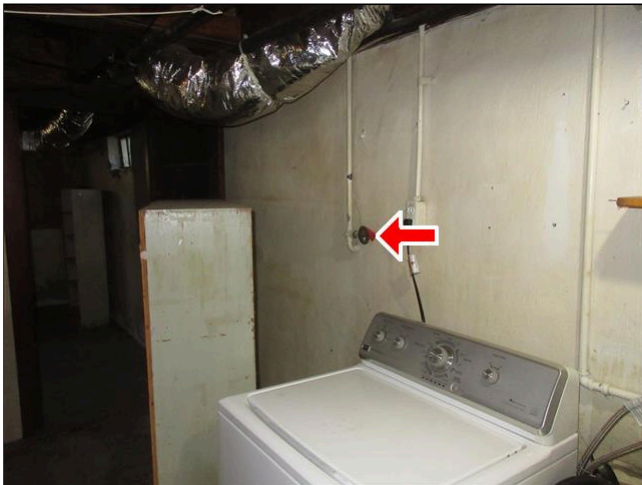
The main water shut-off valve is located in the basement on the front wall.

3.6 Item 1(Picture) Main Valve

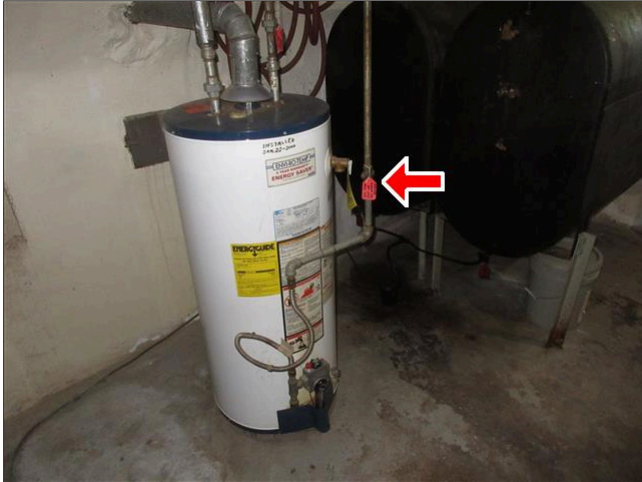
Several appliance fuel shut-off valves were observed around the home. Pictures have been provided for reference.

3.8 Item 1(Picture) Gas Water Heater Valve

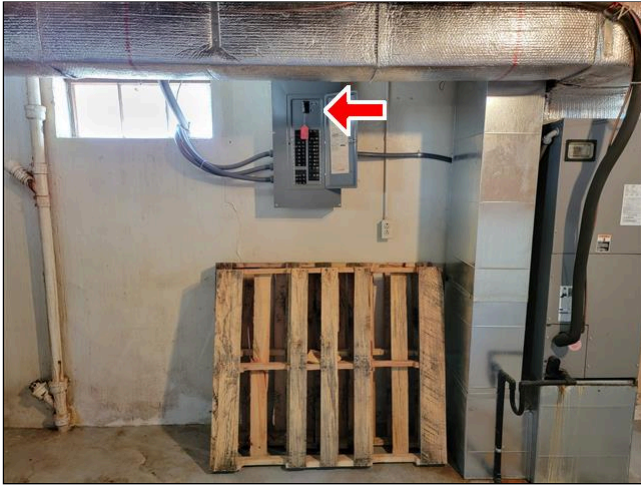
The main electrical disconnect/distribution panel is located in the basement.

4.10 Item 1(Picture) Main Breaker

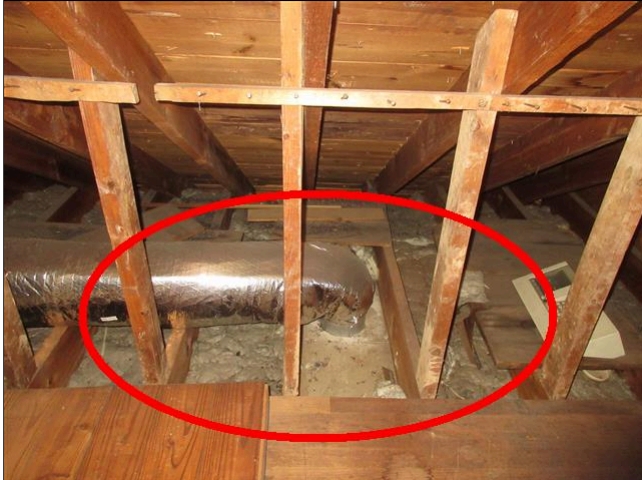
- 🔍 Although acceptable at the time of construction, observed insulation thickness is inadequate by current standards. Installation of an additional 6"-8" of insulation will reduce the thermal transfer between conditioned and unconditioned spaces.

7.0 Item 1(Picture) Little Insulation and Missing Insulation

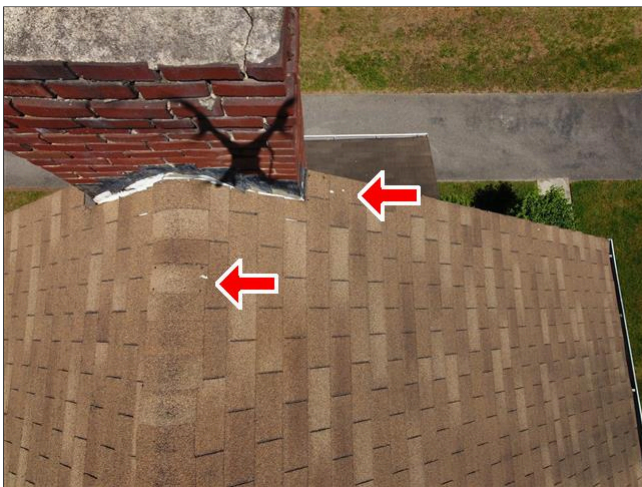
8.0 Item 3(Picture) Exposed Nail Heads (Around Chimney Flashing and Ridge Shingle

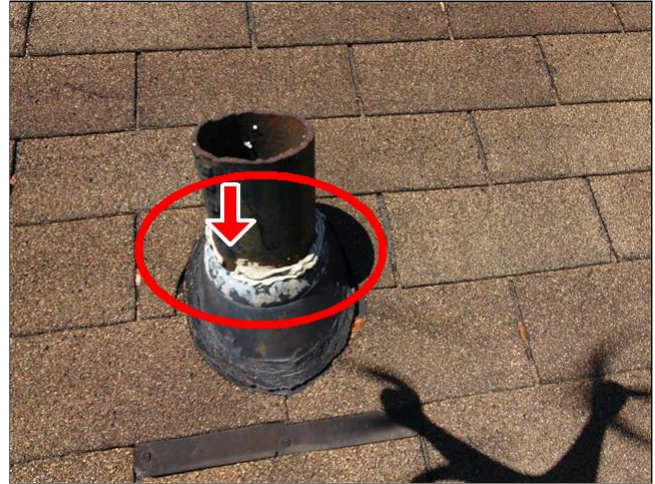
8.2 Item 2(Picture) Temporary Sealant and Openings

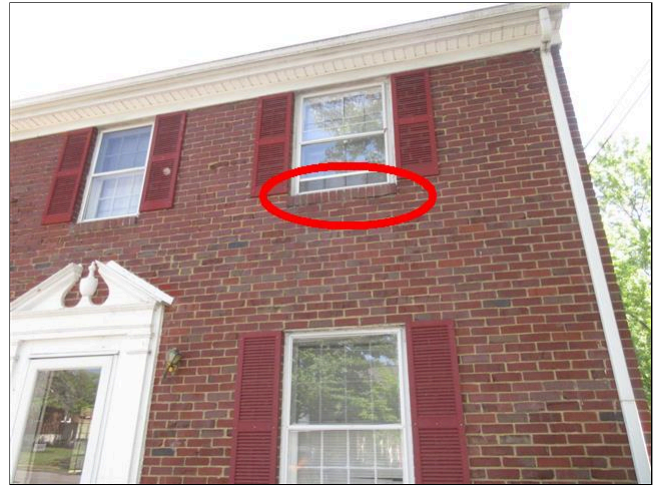
9.0 Item 6(Picture) Open Mortar Joints (Front Right)

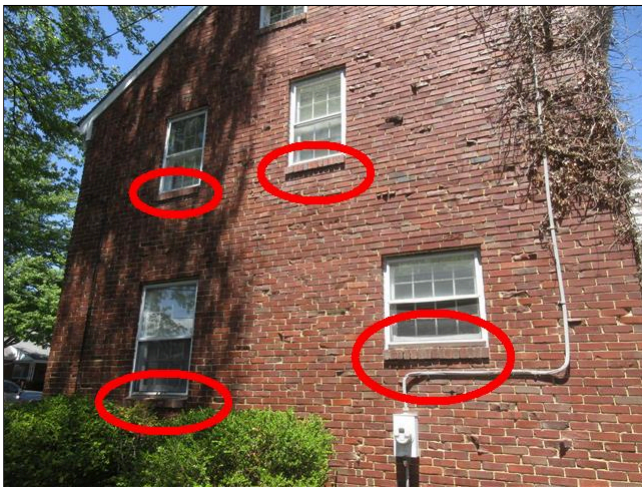
9.0 Item 7(Picture) Open Joints (Right Side)

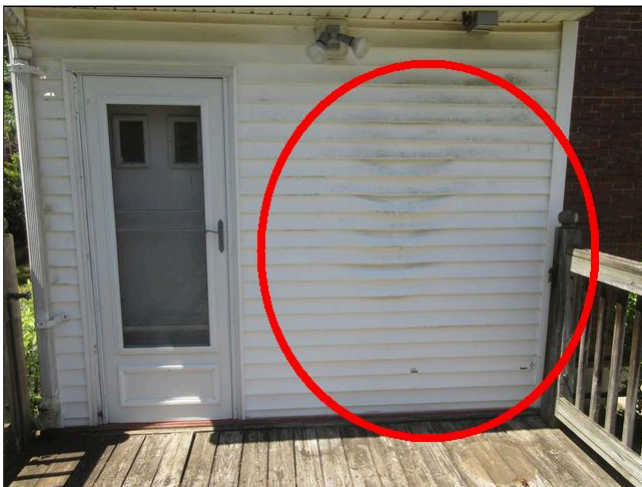
9.0 Item 9(Picture) Siding Disruptions and Holes (Rear)

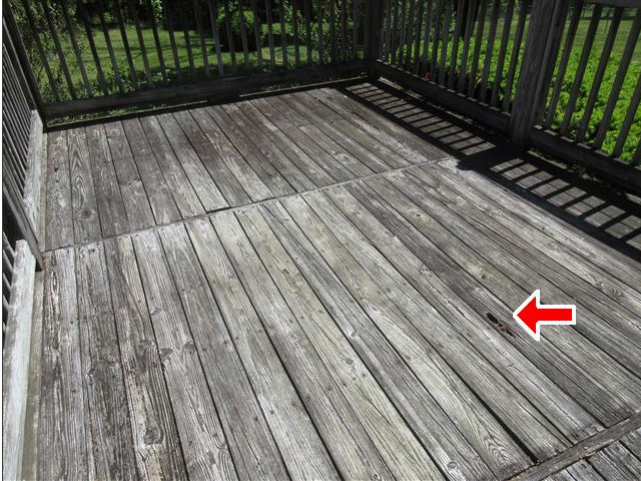
9.3 Item 1(Picture) Deterioration (Decking)

🔍 Although the deck appears to be structurally stable, common exposure related dry rot and deterioration was observed in all of the horizontal deck surfaces (decking, treads and rail top). Suggest replacement of damaged components.
