Home Inspection Report

Property Address:
528 N Market Street
Salem VA 24153

Bateman Home Inspections, LLC

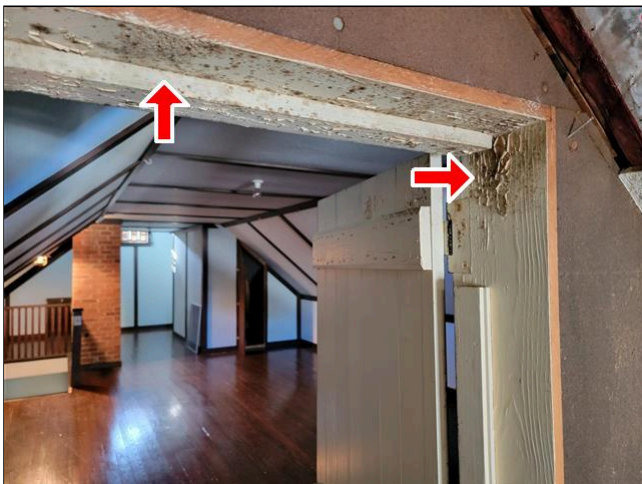
Ceiling staining was observed in multiple locations throughout the home. Moisture was measured in areas and appeared to be an ongoing concern as deterioration is also occurring. Additionally, what appears to be organic growth was also visible in areas and may be from leaks, and poor air circulation. Suggest directing attention to section roofing section 8.0 plus spraying and wiping areas affected with potential organic growth. Recommend having a licensed contractor further evaluate and repair.

1.0 Item 3(Picture) Additional View of Potential Growth and Peeling Paint

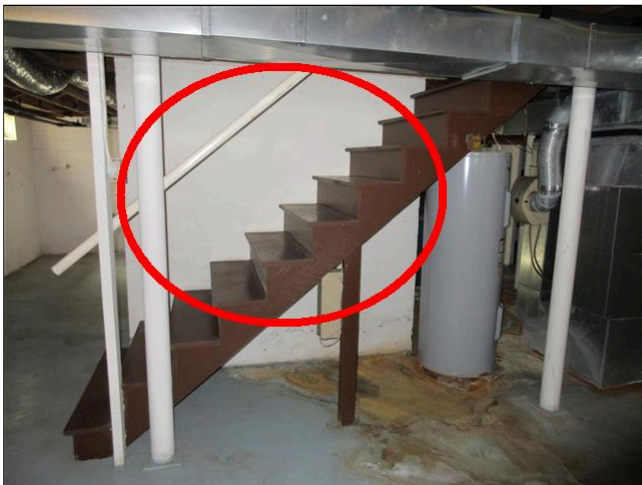
- 🔍 Railing requirements have changed over time. Although not required to, the lack of balusters does not meet current safety specifications. This poses a fall safety concern for toddlers and small children.

1.3 Item 1(Picture) Basement Stairs

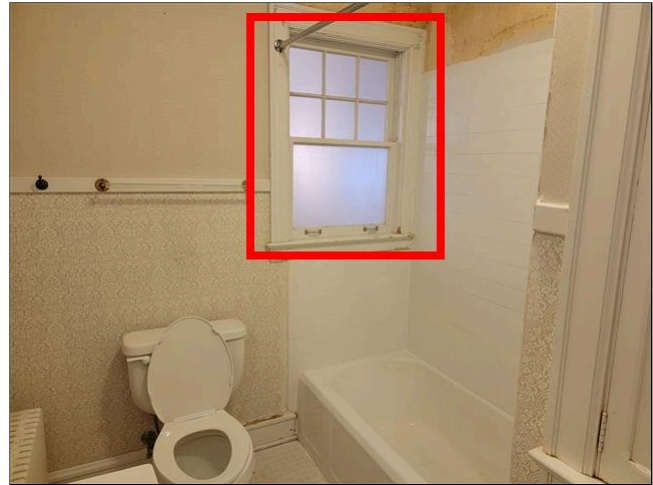
1.6 Item 6(Picture) No Safety Glass (Main Bathroom Shower)

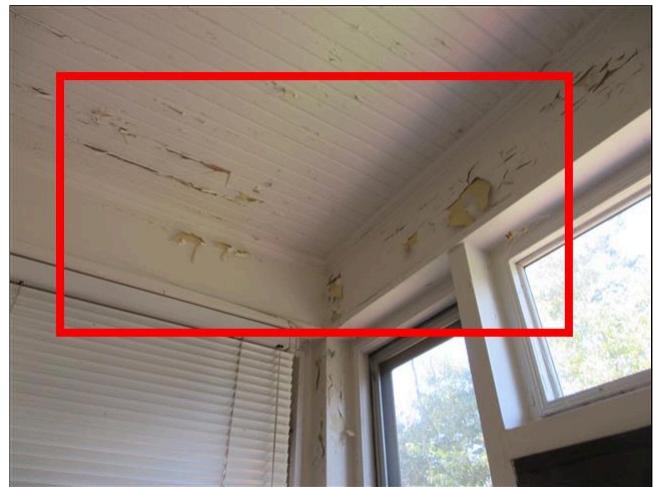
1.8 Item 2(Picture) Paint Chips (Multiple Locations)

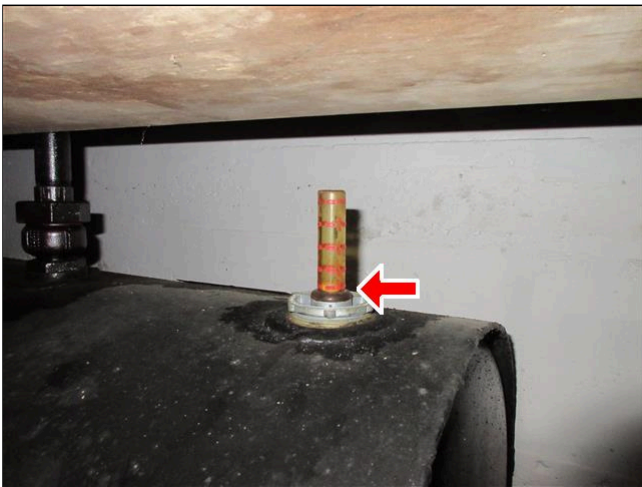
The basement oil tanks were empty at the time of the inspection. Identified for reference.

3.4 Item 1(Picture) Empty Oil Tanks

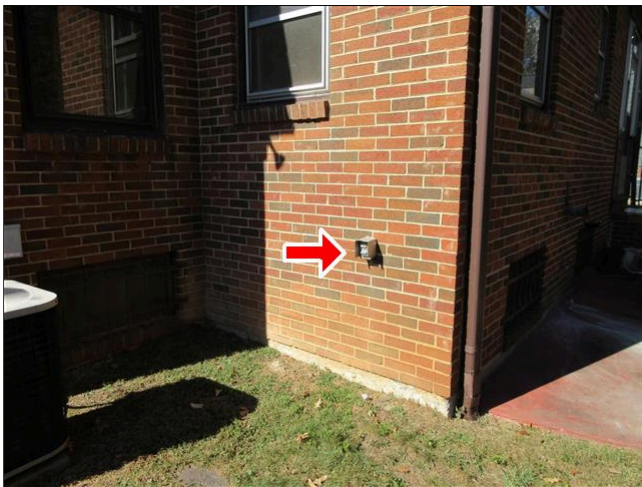
4.5 Item 4(Picture) Grounded (Exterior Outlet)

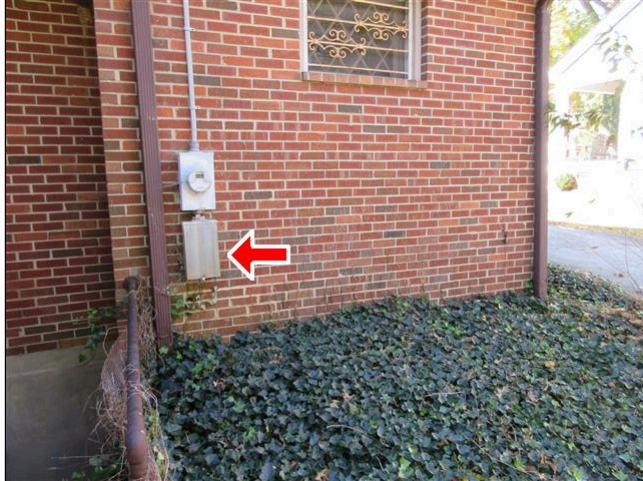
The main electrical service disconnect is located on the rear of the home at the meter base. The main distribution panel is located in the basement. The exterior breaker has to be turned off to remove all power from the house. The exterior panel was locked.

4.10 Item 1(Picture) Exterior Disconnect Panel

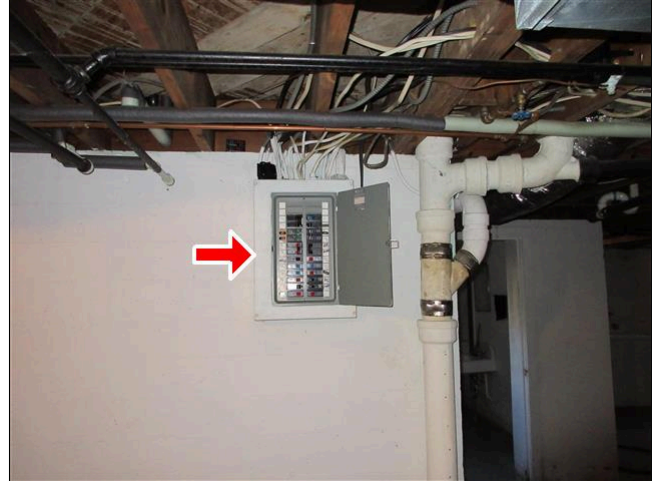
4.10 Item 2(Picture) Main Interior Panel/
Breakers

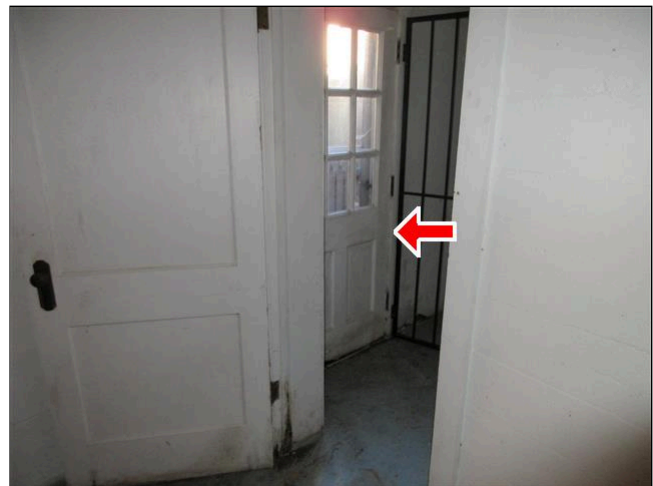
9.1 Item 2(Picture) Not Closing (Basement)

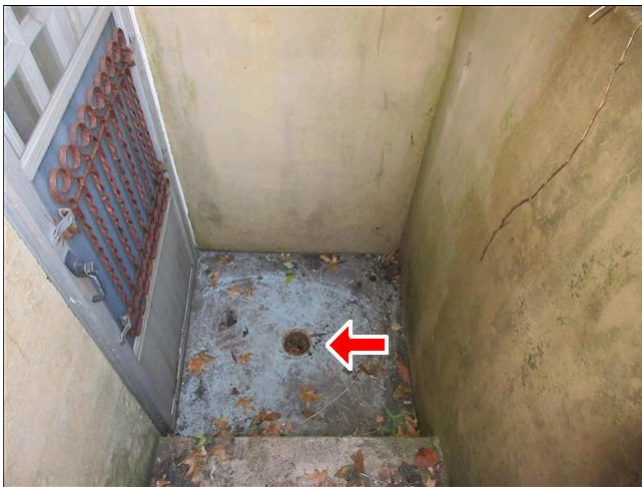
🔍 (1) A floor drain was observed in the basement stairwell, and in the basement floor. The operation of the drains was not verified. Suggest having the drains cleaned to ensure proper flow thus reducing the potential of water intrusion under the basement door, and a backup in the basement as staining was present.

9.4 Item 1(Picture) Stairwell Drain

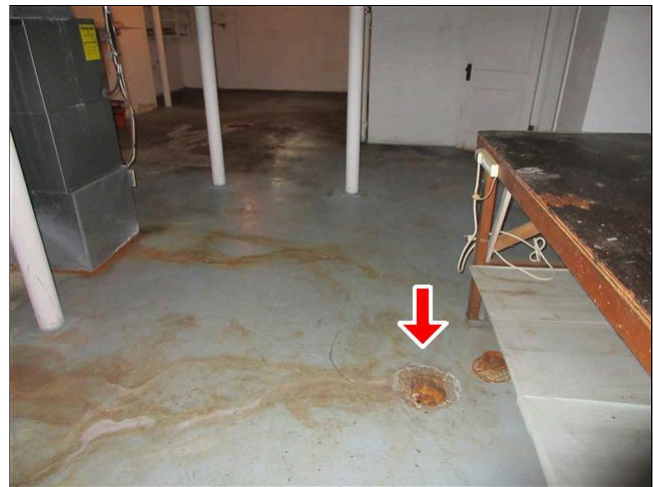
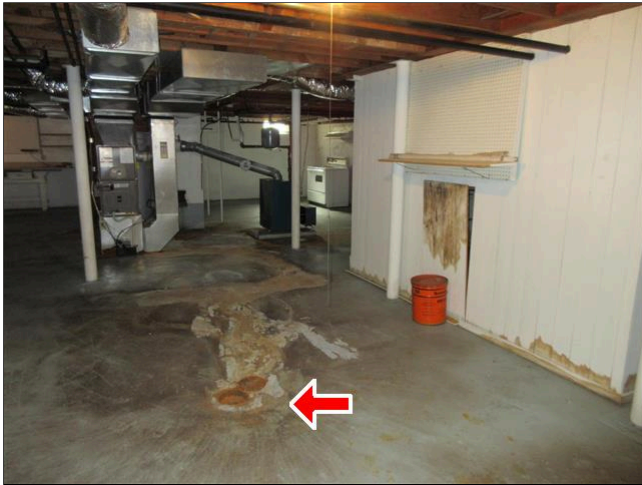
9.4 Item 2(Picture) Basement Floor Drain

9.4 Item 3(Picture) Basement Floor Drain
