# Pre-Listing Inspection Report

**Property Address:**  
516 N Market Street  
Salem VA 24153

<b>Date:</b> 7/9/2024	<b>Time:</b> 09:00 AM	<b>Report ID:</b> 0724516
<b>Property:</b> 516 N Market Street Salem VA 24153	<b>Customer:</b> Catherine Potter	<b>Real Estate Professional:</b>

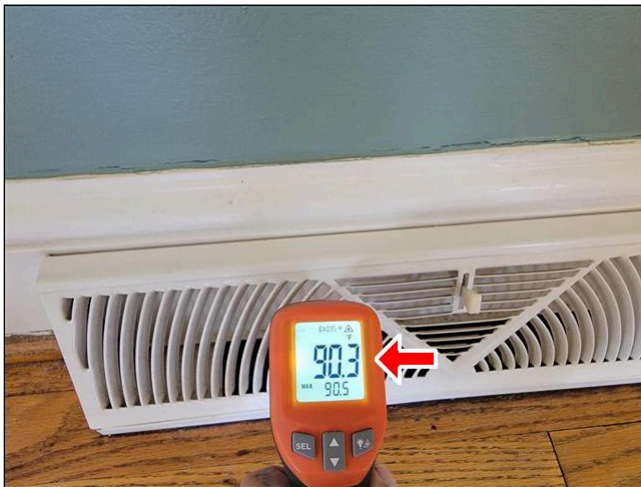
The heating system functioned as intended and produced adequate temperatures. Pictures have been provided for reference.

2.1.B Item 1(Picture) 90.3 Degrees (Heat Stage 1)

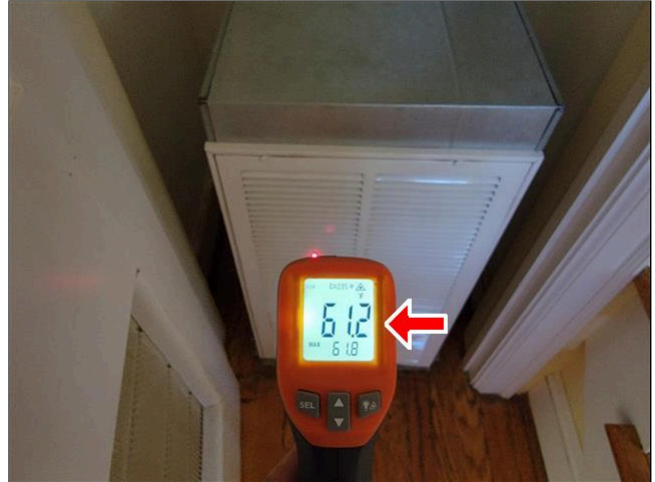
2.10.B Item 2(Picture) 61.3 Degrees (Return Temperature)

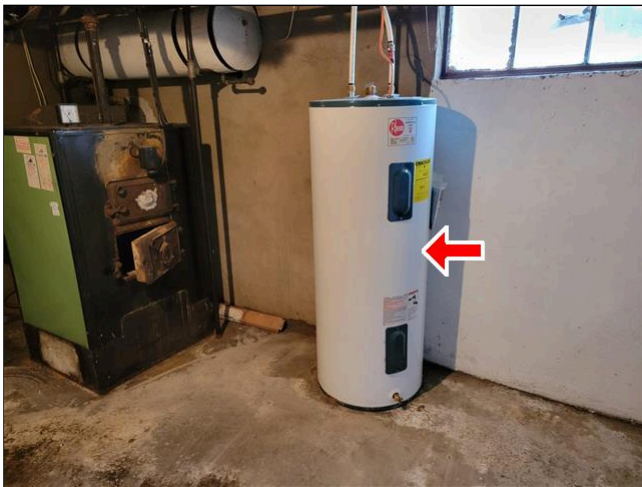
3.5 Item 1(Picture) Water Heater

**Comments:** Inspected  
The water heater is located in the basement.

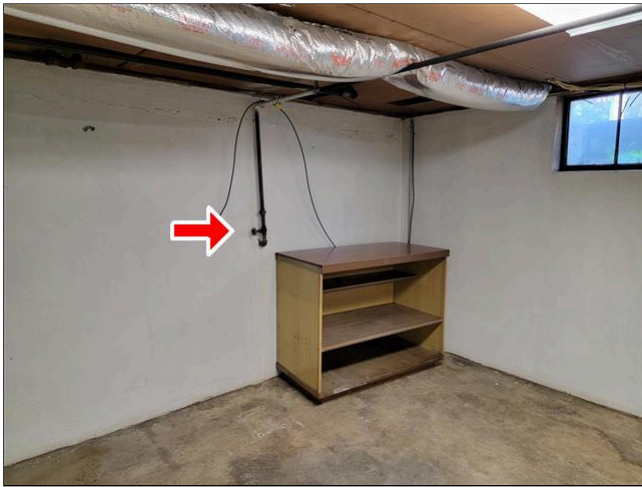
3.6 Item 1(Picture) Main Valve

The main water shut-off valve is located in the basement on the front wall.

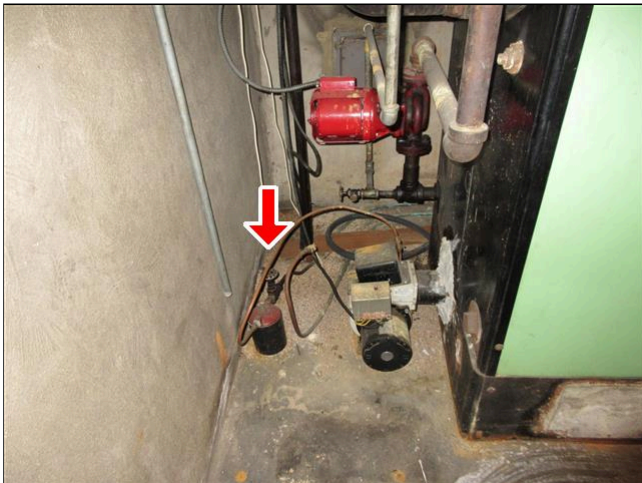
3.7 Item 1(Picture) Main Valve

The main fuel oil shut off is located behind the old boiler in the basement.

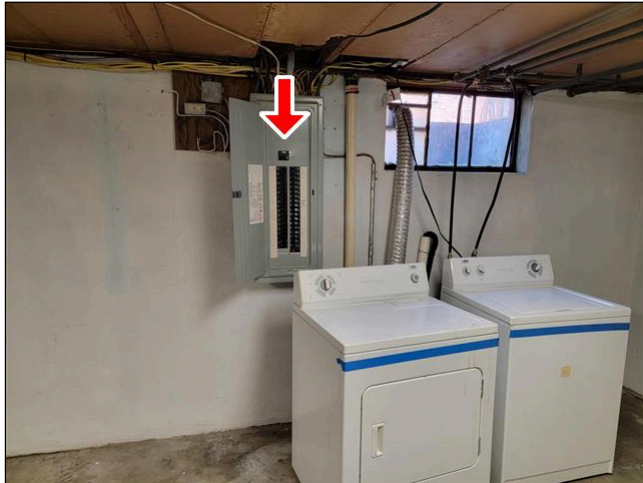
4.10 Item 1(Picture) Main Breaker

The main electrical disconnect/distribution panel is located in the basement.
