Pre-Listing Inspection Report

Property Address:
432 N Market Street
Salem VA 24153

Date: 7/2/2024	Time: 09:00 AM	Report ID: 0724432
Property: 432 N Market Street Salem VA 24153	Customer: Catherine Potter	Real Estate Professional:

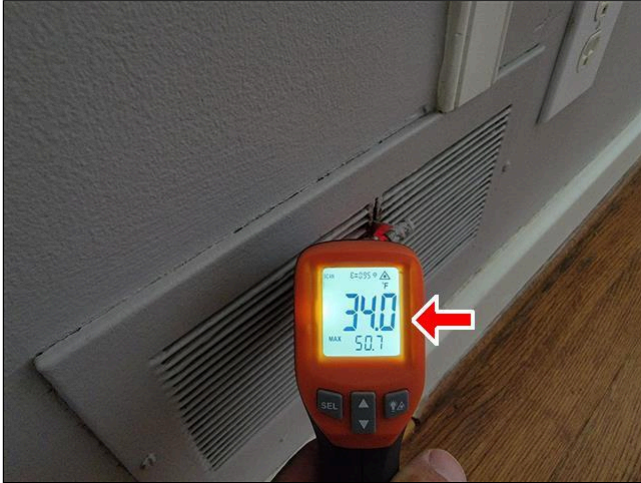
The cooling system functioned as intended and produced adequate temperature differentials. Pictures have been provided for reference.

2.10 Item 1(Picture) 34 Degrees (Supply Temperature)

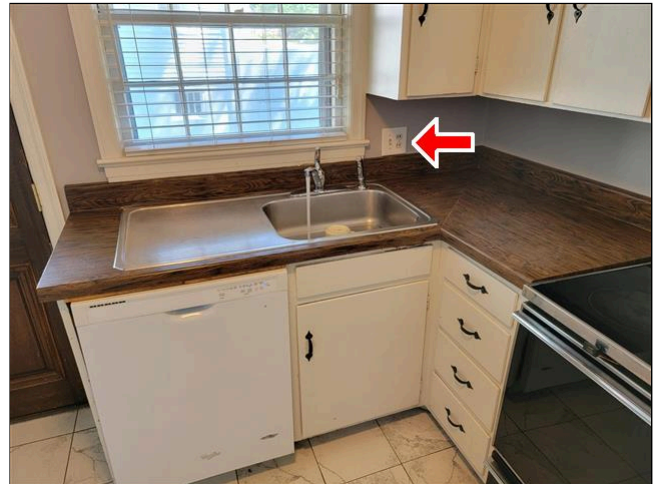
4.5 Item 2(Picture) Ungrounded 2 Prong (Kitchen)

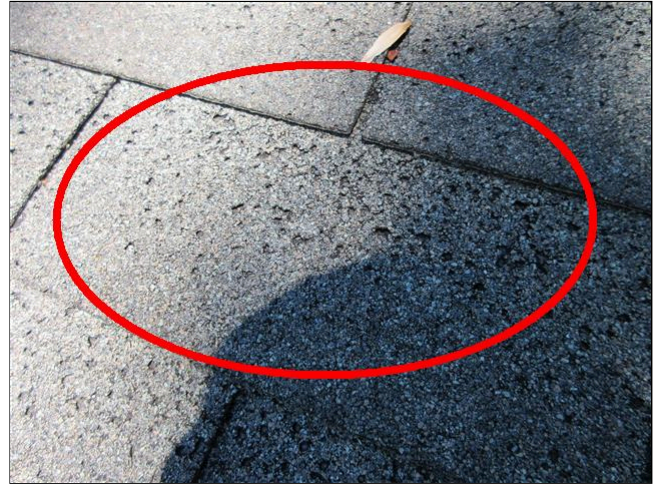
8.0 Item 2(Picture) Shingle Blistering (Multiple Locations)

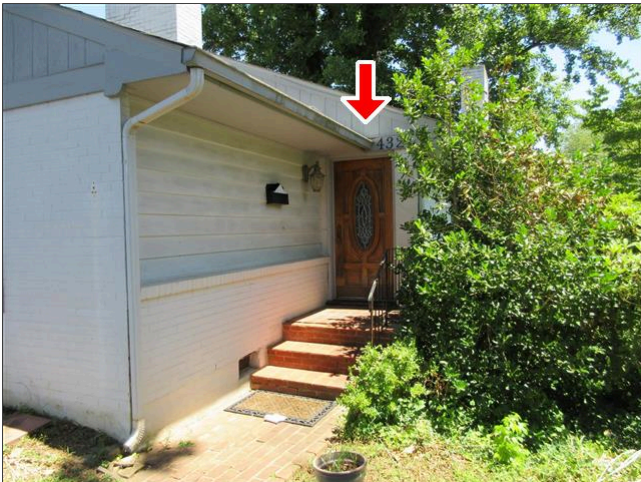
- (2) No kick out flashing or diverter was observed at the roof to side wall transition at the front above the stoop, and at the rear. Kick out flashing diverts roof water into the gutter and prevents large volumes of water from running down the siding. The siding is deteriorated at the front from long term water absorption which can lead to hidden damage. Suggest installation of kick out flashing to improve rain water management and reduce the potential for water intrusion.

8.1 Item 3(Picture) Above Front Entrance

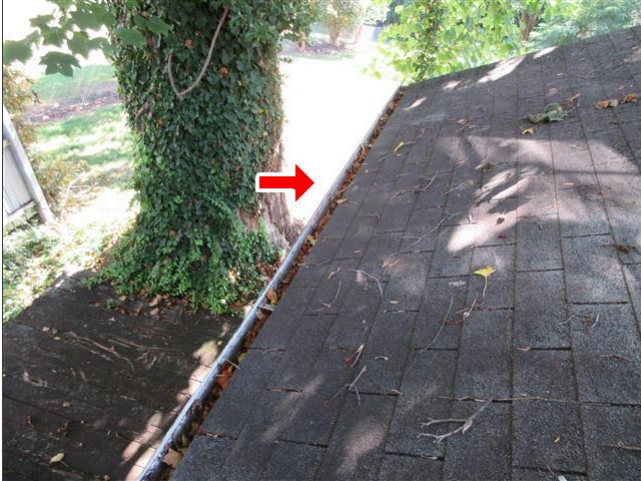
Although the guttering was observed intact and complete, a section appeared to be improperly sloped, areas were clogged with debris, and a downspout was discharging directly at the foundation. Excessive slope and debris will cause water to pile up at the lowest point and overflow. Downspouts should discharge water 4'-6' away from the foundation. Due to the lack of rain during the inspection, gutter functionality was not determined. Suggest adjusting gutters to drain properly, clearing debris, installing downspout leaders, and monitoring gutter function during a moderate rain event to identify if any additional sections need slope adjustments.

8.3 Item 1(Picture) Debris (Rear Patio Roof)

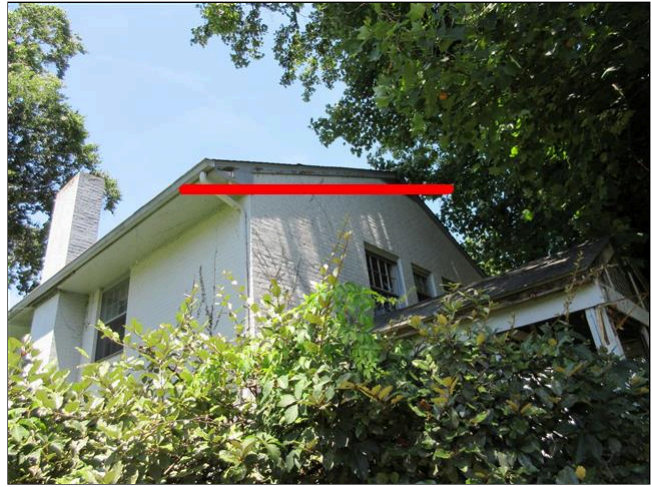
9.0 Item 2(Picture) Bare Wood and Peeling Paint (Rear Rake Board)

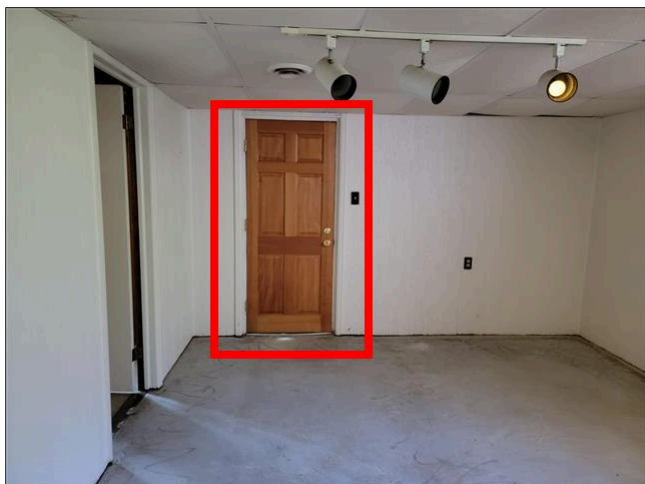
9.1 Item 3(Picture) Openings (Basement Entrance)

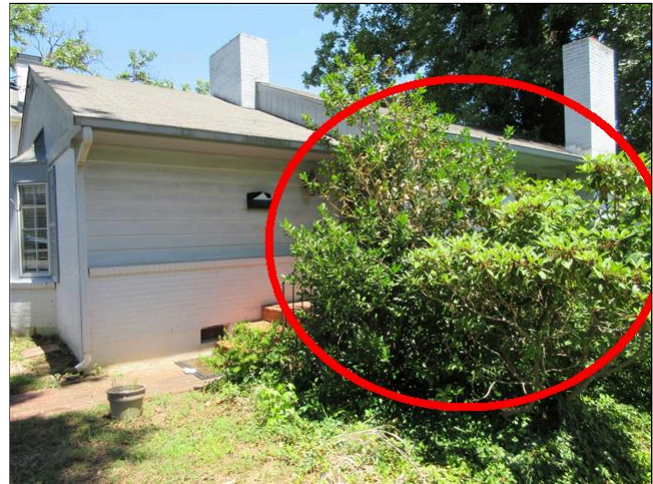
9.4 Item 2(Picture) Overgrowth (Right Side)
