# Pre-Listing Inspection Report

**Property Address:**  
502 N Market Street  
Salem VA 24153

**Bateman Home Inspections, LLC**

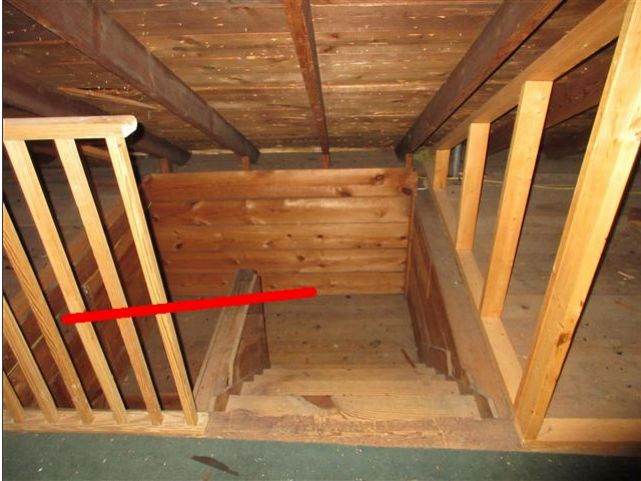
🔍 Railing requirements have changed over time. Although not required to, the lack of a graspable handrail does not meet current safety specifications. Typically stairs over three risers tall have a hand rail for safety. This is a fall safety concern especially for toddlers and small children.

1.3 Item 1(Picture) No Graspable Handrail (Attic Stairwell - Multiple Locations)

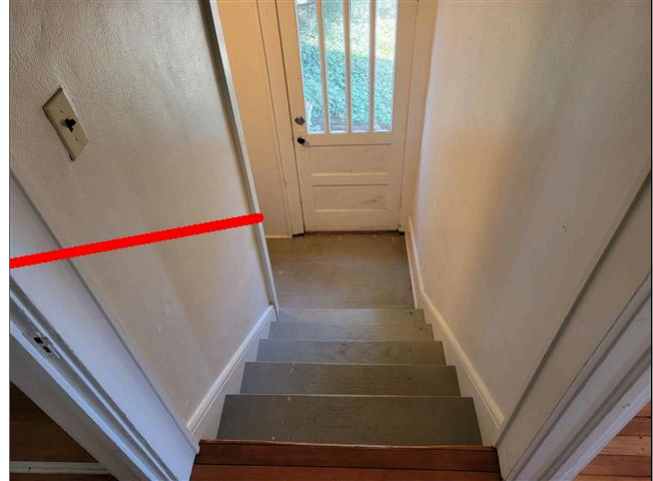
1.3 Item 2(Picture) No Graspable Handrail (Basement Stairwell - Multiple Locations)

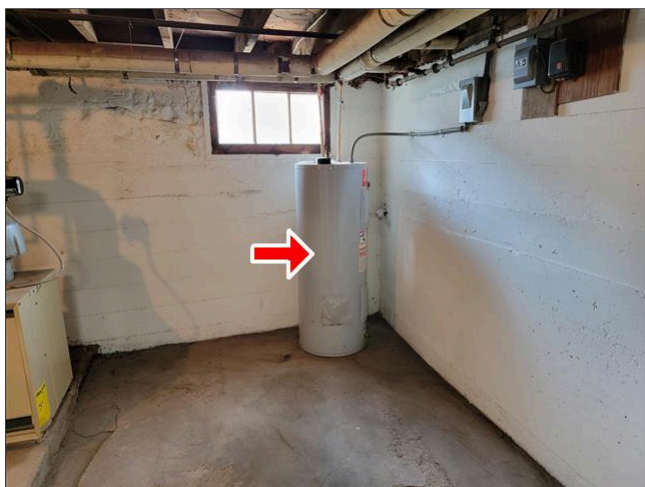
3.5 Item 1(Picture) Water Heater

The water heater is located in the basement.

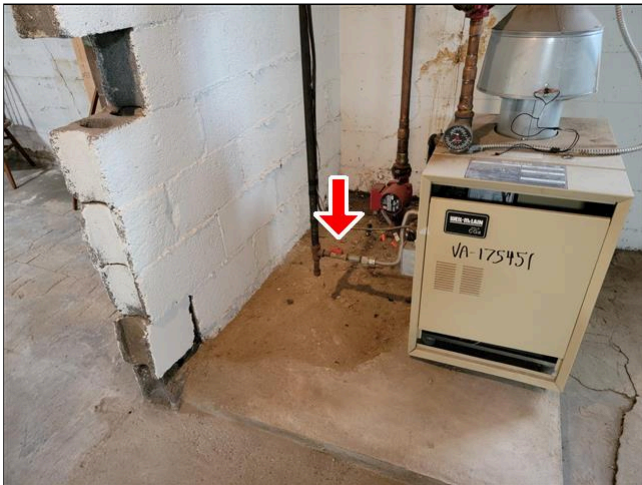
3.8 Item 1(Picture) Gas Boiler Valve

The gas boiler fuel shut-off valve is located next to the unit.

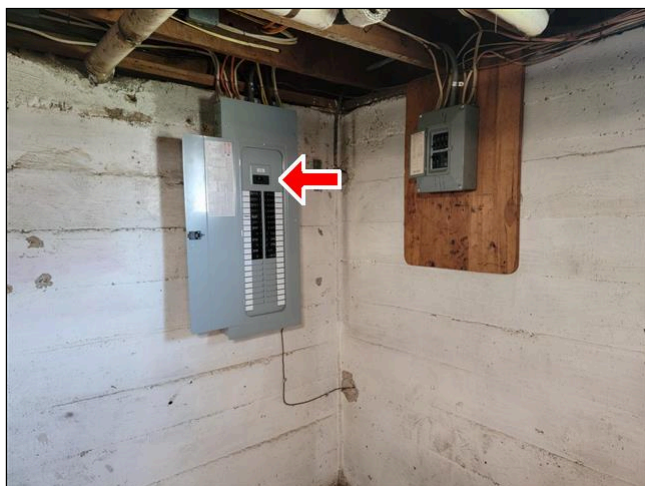
4.10 Item 1(Picture) Main Breaker

The main electrical disconnect/distribution panel is located in the basement. The sub panel is located to the right of the main panel.

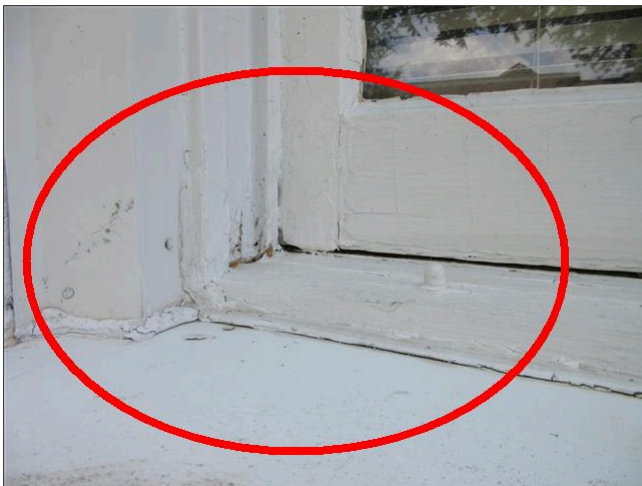
9.0 Item 3(Picture) Open Joints and Gaps (Around Windows)
