# Pre-Listing Inspection Report

**Property Address:**  
506 N Market Street  
Salem VA 24153

<b>Date:</b> 5/28/2024	<b>Time:</b> 09:00 AM	<b>Report ID:</b> 0524506
<b>Property:</b> 506 N Market Street Salem VA 24153	<b>Customer:</b> Catherine Potter	<b>Real Estate Professional:</b>

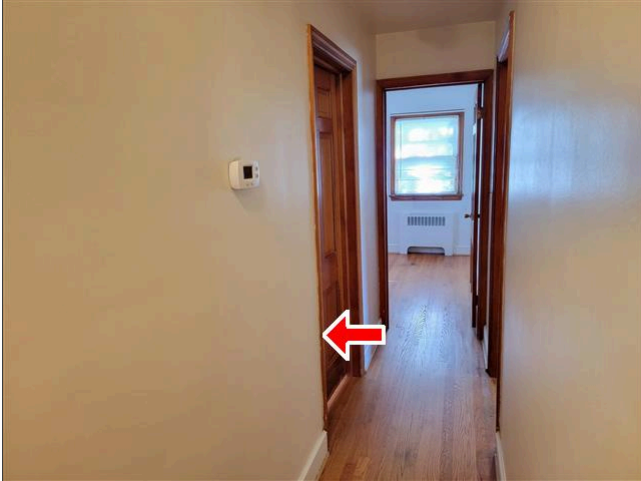
1.5 Item 1(Picture) Left Side Bedroom (Not Closing)

The left side bedroom door would not shut. This is common with age but may require trimming of the door, or hinge adjustment to correct.

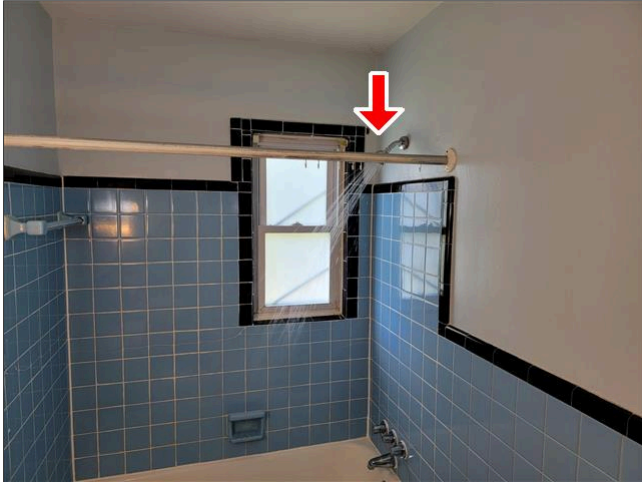
3.2 Item 10(Picture) Dripping Shower Head (Main Bathroom)

(6) The main bathroom shower head connection was dripping while in use. Suggest tightening connection upon moving in. Identified for reference only.

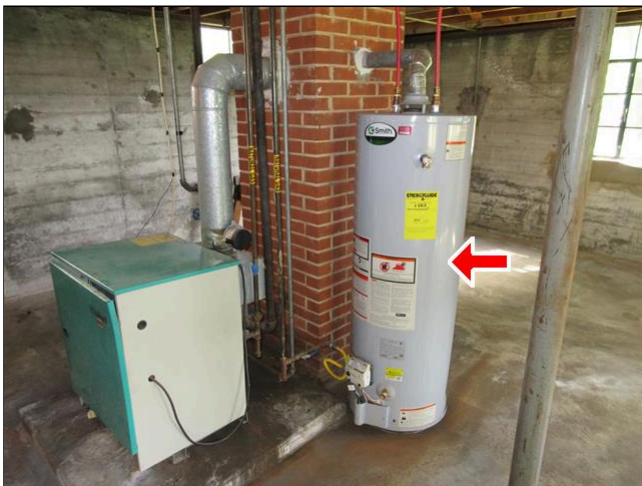
3.5 Item 1(Picture) Water Heater

The water heater is located in the basement.

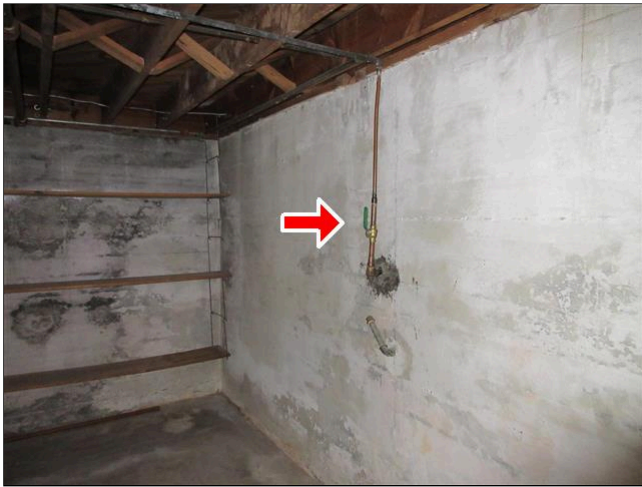
3.6 Item 1(Picture) Main Valve

The main water shut-off valve is located in the basement on the front wall.

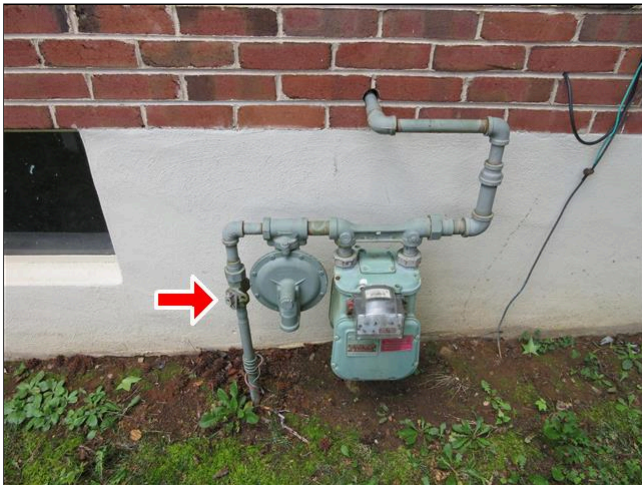
3.7 Item 1(Picture) Main Valve

**Comments:** Inspected  
The main fuel shut off is located on the gas meter outside.

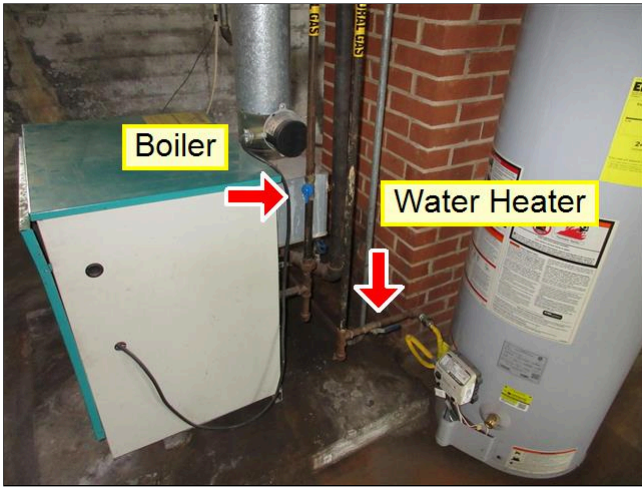
3.8 Item 1(Picture) Valves

Several appliance fuel shut-off valves were observed. A picture has been provided for reference.

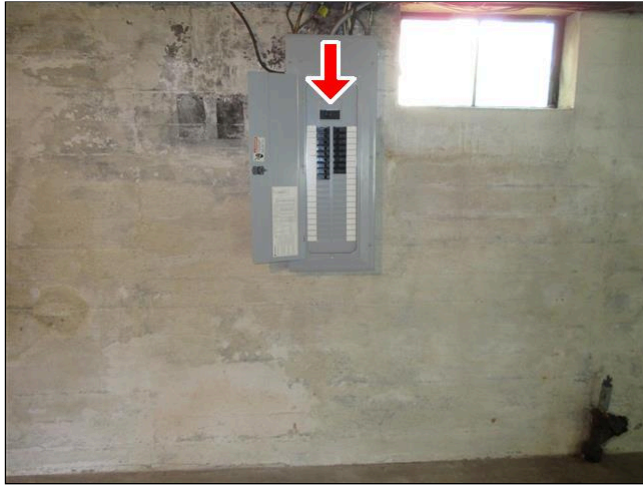
4.10 Item 1(Picture)

The main electrical disconnect/distribution panel is located in the basement.

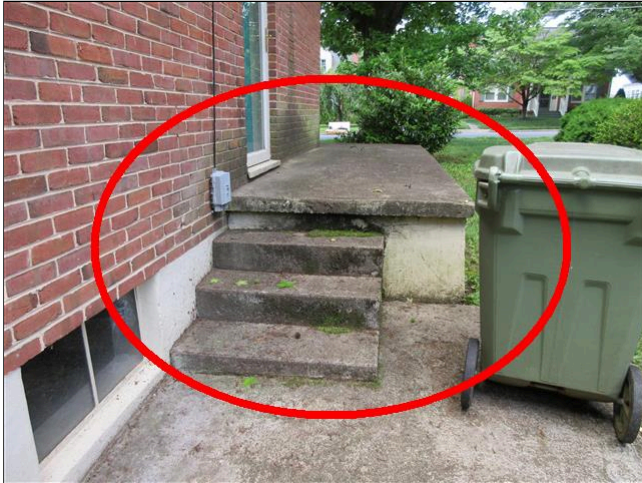
9.3 Item 1(Picture) Left Side

🔍 Railing requirements have changed over time. Although not required to, the lack of a graspable handrail and safety railing does not meet current safety specifications. Typically stairs over three risers tall, and heights over 2.5' have a hand rail or railing for safety. This is a fall safety concern especially for toddlers and small children.

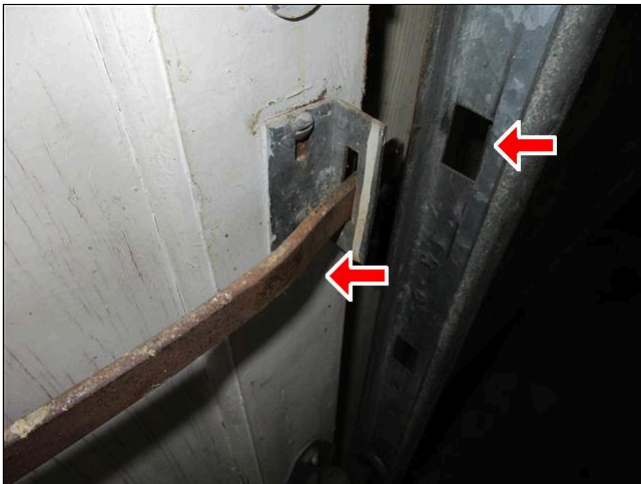
10.2 Item 1(Picture) Bent Lock Guides (Both Sides)

- The garage door would not lock due to bent guides. Suggest straightening out the lock guides to restore proper locking function.
