Pre-Listing Inspection Report

Property Address:
510 N Market Street
Salem VA 24153

Bateman Home Inspections, LLC

Date: 5/2/2024	Time: 09:00 AM	Report ID: 0524510
Property: 510 N Market Street Salem VA 24153	Customer: Catherine Potter	Real Estate Professional:

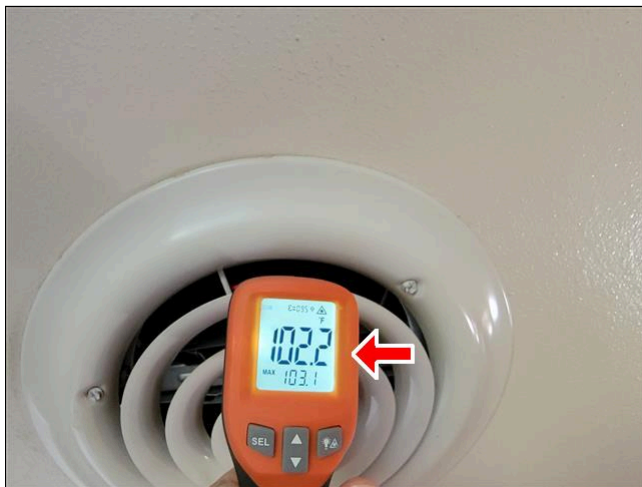
The heating system functioned as intended and produced adequate temperatures. Pictures have been provided for reference.

2.1.A Item 1(Picture) 102.2 Degrees (Heat Stage 1)

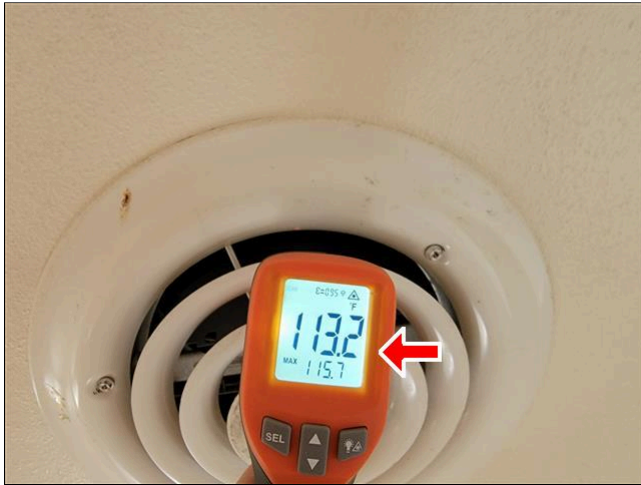
2.1.A Item 3(Picture) 113.2 Degrees (Em.Heat)

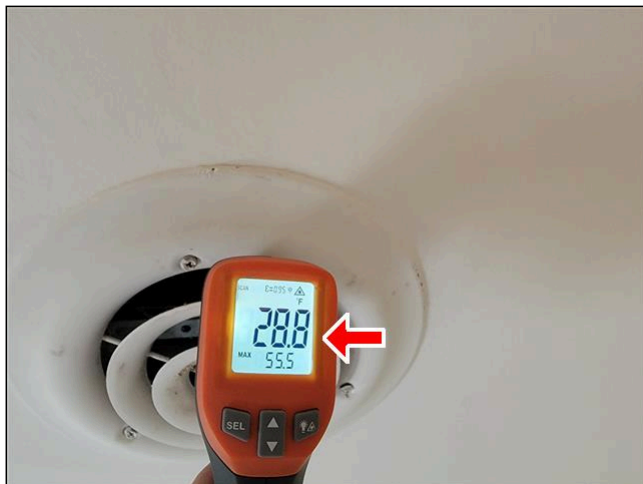
The cooling system functioned as intended and produced adequate temperature differentials. Pictures have been provided for reference.

2.10.A Item 1(Picture) 28.8 Degrees (Supply Air)

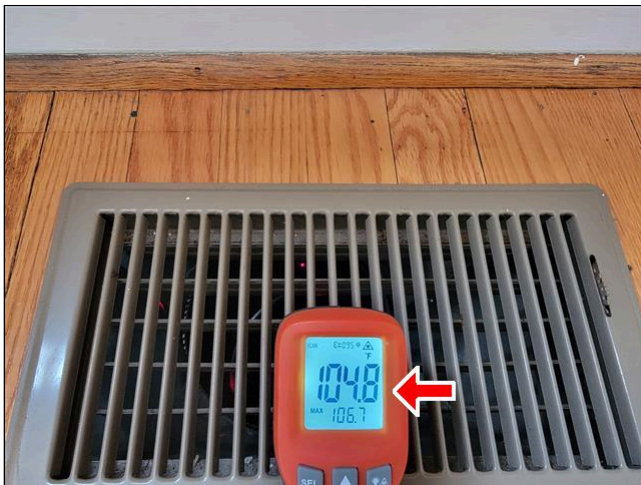
The heating system functioned as intended and produced adequate temperatures. Pictures have been provided for reference.

2.1.B Item 1(Picture) 104.8 Degrees (Heat Stage 1)

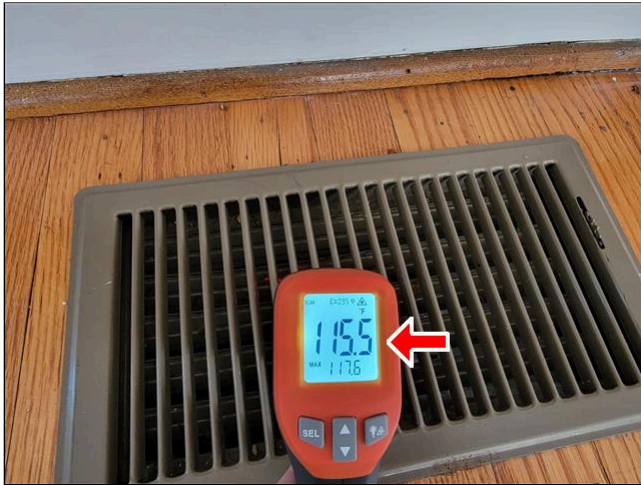
2.1.B Item 3(Picture) 115.5 Degrees (Em.Heat)

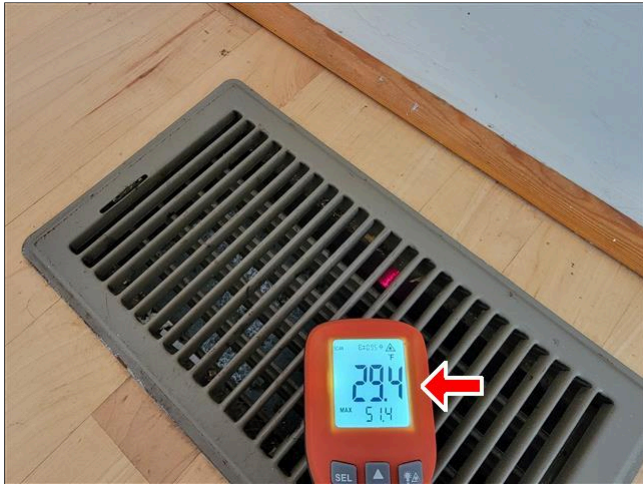
The cooling system functioned as intended and produced adequate temperature differentials. Pictures have been provided for reference.

2.10.B Item 1(Picture) 29.4 Degrees (Supply Air)

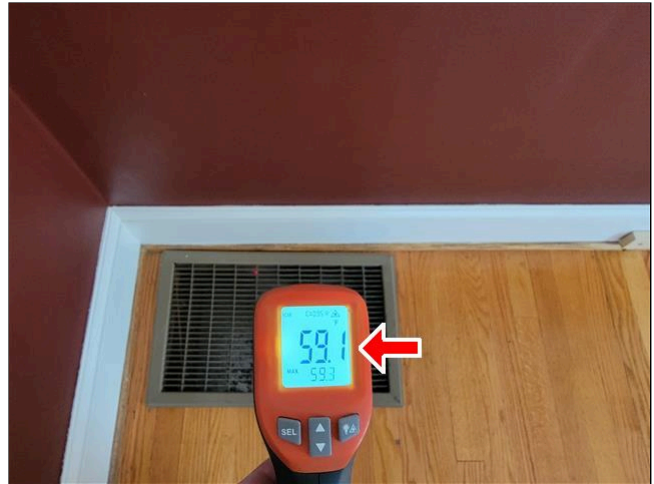
2.10.B Item 2(Picture) 59.1 Degrees (Return Air)

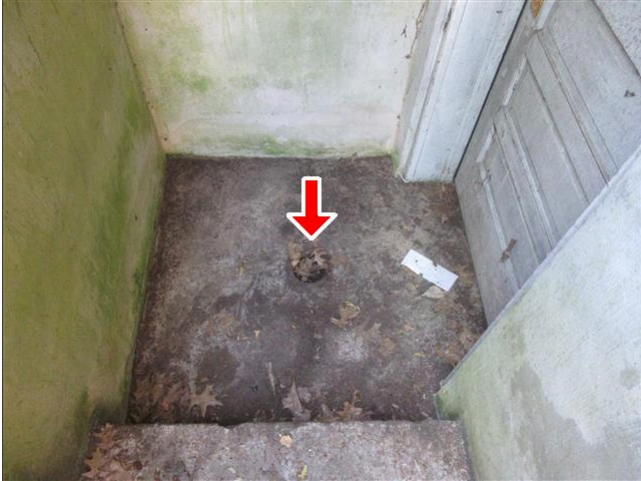
9.4 Item 2(Picture) Basement Stairwell Drain

(2) A floor drain was observed in the basement stairwell. Its operation was not verified. Suggest having the drain cleaned to ensure proper flow thus reducing the potential of water intrusion under the basement door.
