Home Inspection Report

Property Address:
528 N Market Street
Salem VA 24153

Bateman Home Inspections, LLC

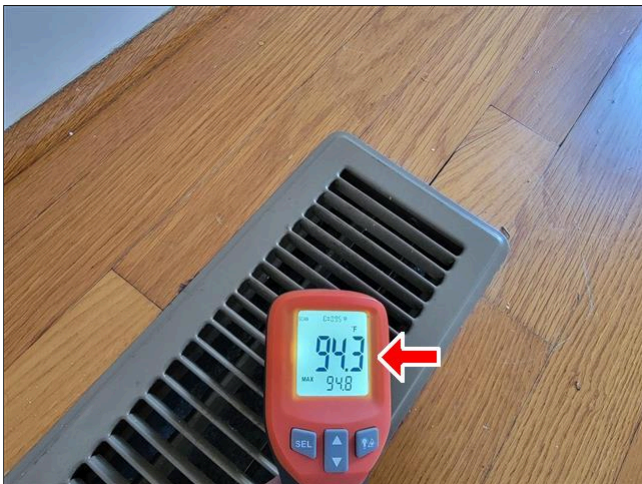
The electric heating system functioned as intended at the time of the inspection and produced adequate temperatures. A picture has been provided for reference.

2.1 Item 1(Picture) 94.3 Degrees

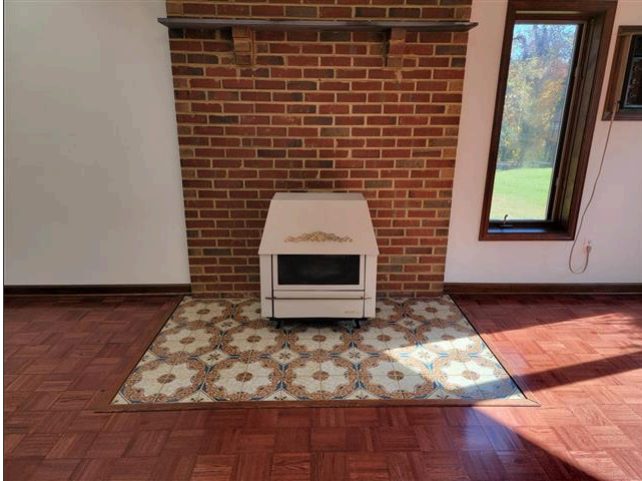
2.6 Item 1(Picture) Right Side Den

The right side den wood stove is not the primary source of heat and is thus excluded from the scope of the home inspection. Suggest having a qualified contractor fully inspect the unit prior to any use to ensure safe and proper operation.

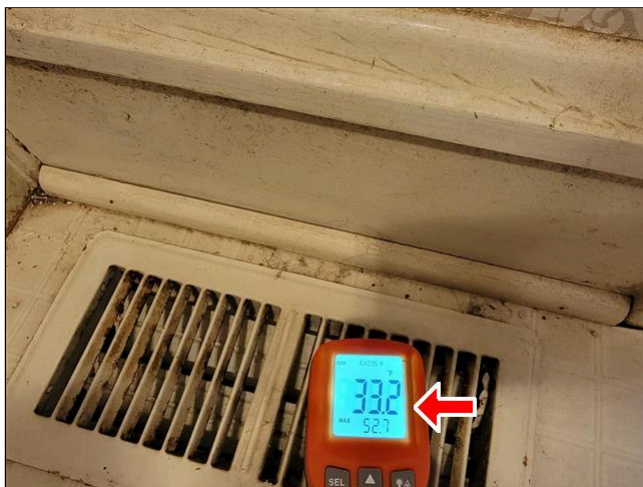
The cooling system functioned as intended at the time of the inspection and produced adequate temperature differentials. A picture of the supply temperature has been provided for reference.

2.10 Item 1(Picture) 33.2 Degrees (Supply Temperature)

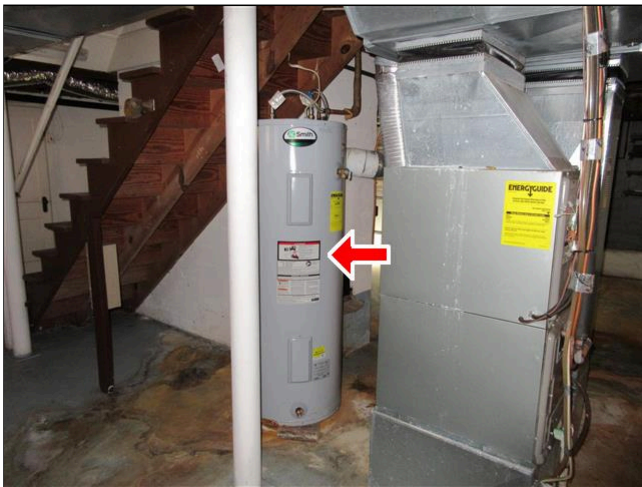
3.6 Item 1(Picture)

Comments: Inspected
The water heater is located in the basement under the steps

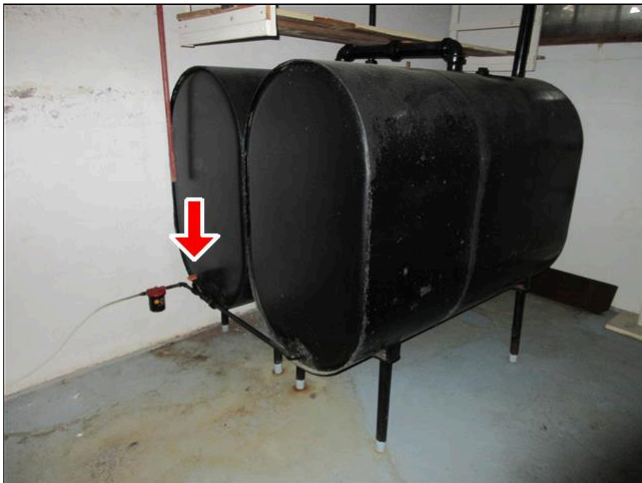
Comments: Inspected
The main fuel oil shut off is located on the tank inside.

3.8 Item 1(Picture) Main Valve

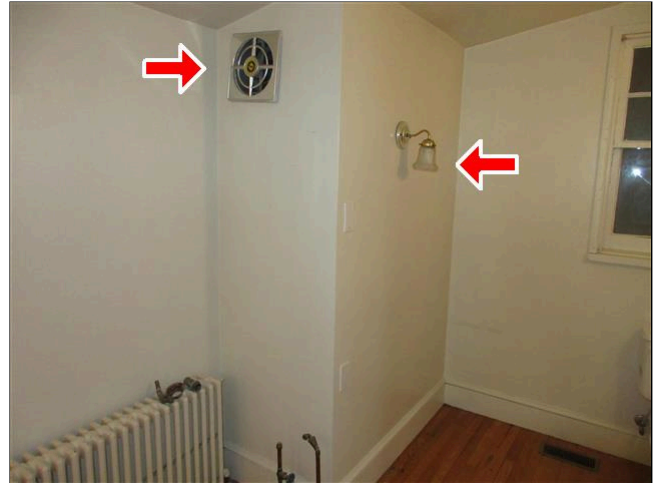
4.4 Item 2(Picture) Inactive (Primary Bathroom)

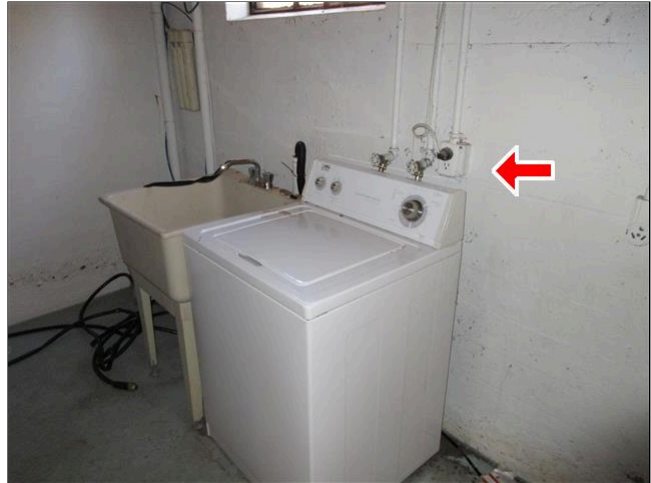
4.5 Item 3(Picture) Grounded (Basement)
