# Pre-Listing Inspection Report

**Property Address:**  
516 N Market Street  
Salem VA 24153

<b>Date:</b> 7/9/2024	<b>Time:</b> 09:00 AM	<b>Report ID:</b> 0724516
<b>Property:</b> 516 N Market Street Salem VA 24153	<b>Customer:</b> Catherine Potter	<b>Real Estate Professional:</b>

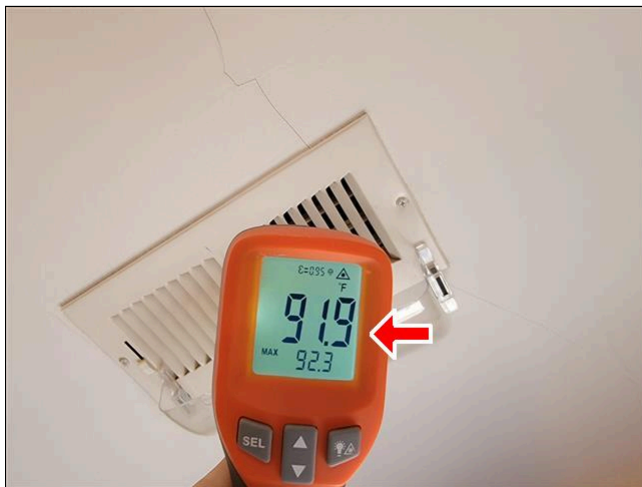
The heating system functioned as intended and produced adequate temperatures. Pictures have been provided for reference.

2.1.A Item 1(Picture) 91.9 Degrees (Heat Stage 1)

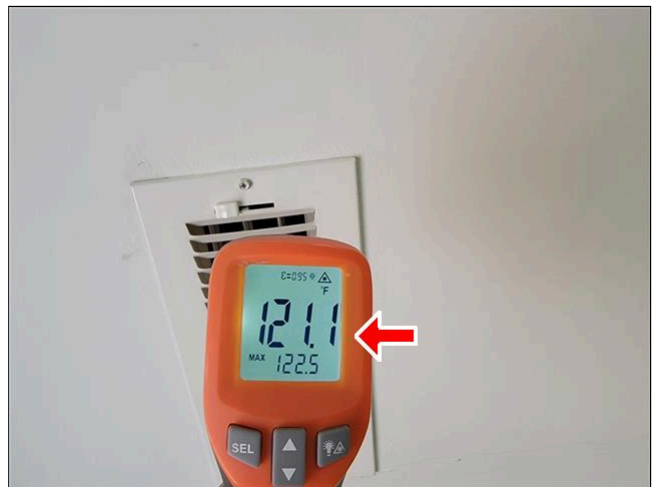
2.1.A Item 2(Picture) 121.1 Degrees (Heat Stage 2 "Aux")

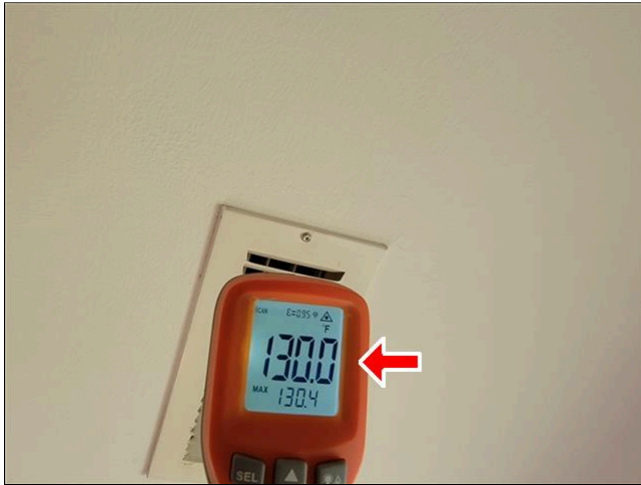
2.1.A Item 3(Picture) 130 Degrees (Em.Heat)

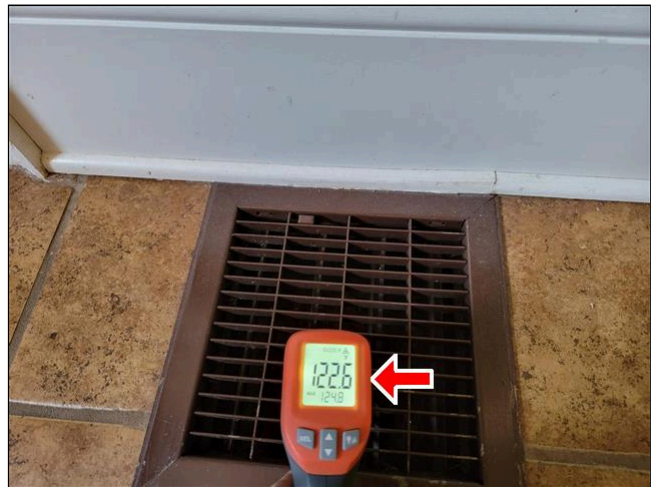
2.1.B Item 2(Picture) 122.6 Degrees (Heat Stage 2 "Aux")

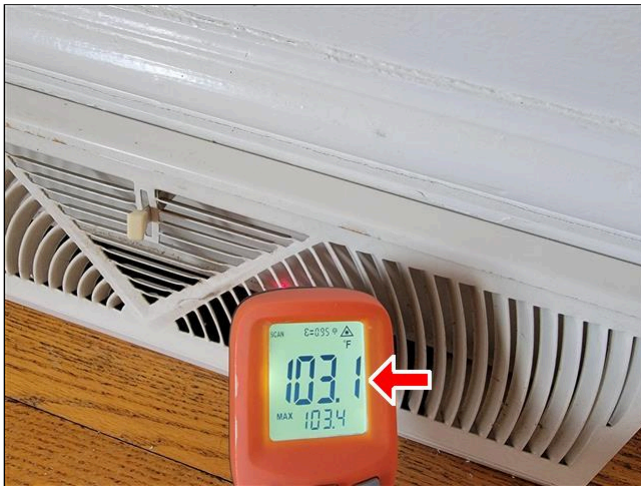
2.1.B Item 3(Picture) 103.1 Degrees (Em.Heat)

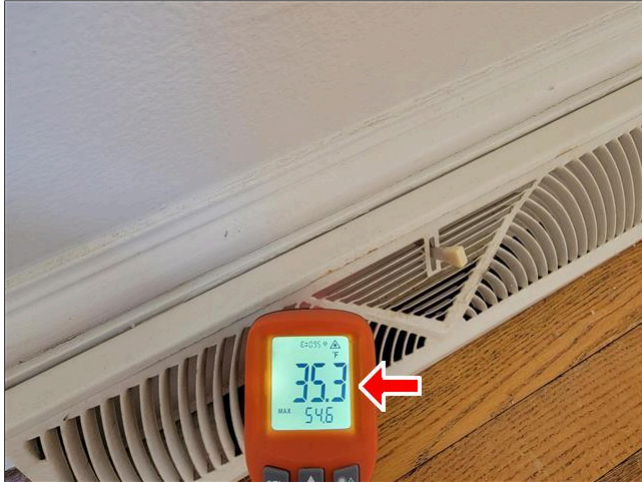
The cooling system functioned as intended and produced adequate temperature differentials. Pictures have been provided for reference.

2.10.B Item 1(Picture) 35.3 Degrees (Supply Temperature)

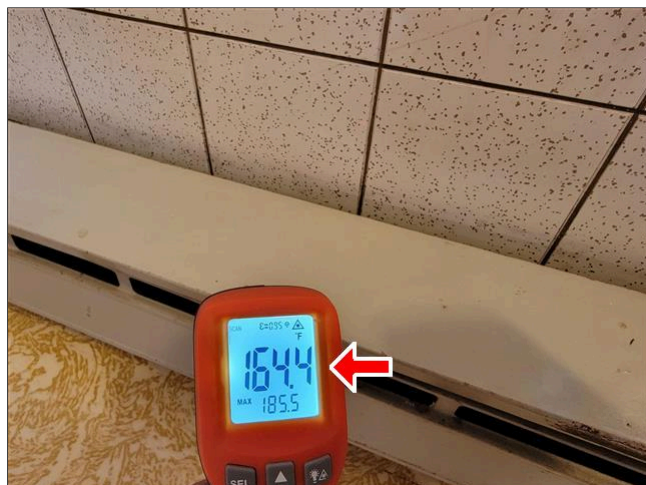
2.12.B Item 1(Picture)

The main level rear bathroom baseboard heater functioned as intended. A picture has been provided for reference.
