Pre-Listing Inspection Report

Property Address:
432 N Market Street
Salem VA 24153

Date: 7/2/2024	Time: 09:00 AM	Report ID: 0724432
Property: 432 N Market Street Salem VA 24153	Customer: Catherine Potter	Real Estate Professional:

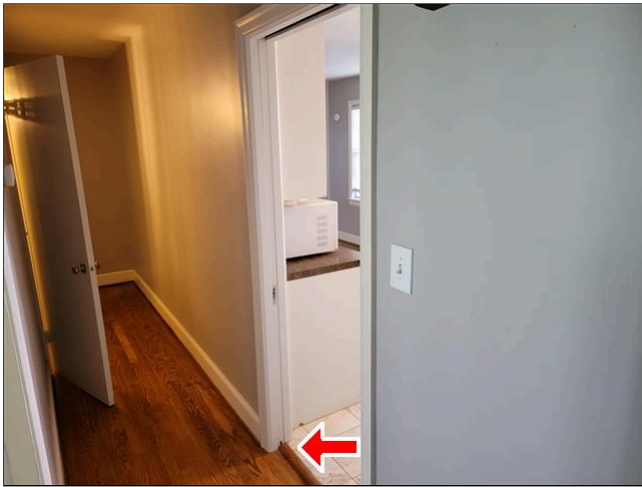
The kitchen pocket door would not close due to contact with the transition strip. Identified for reference.

1.5 Item 1(Picture) Contact (Kitchen Pocket Door)

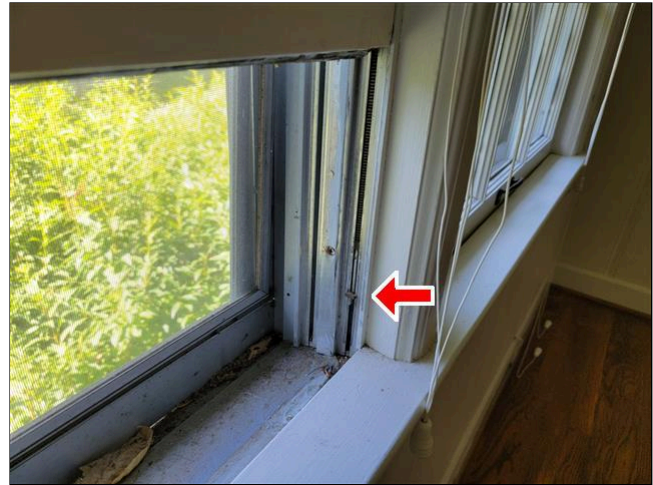
1. Cracked glass was observed at the noted basement bedroom window. Recommend repair to reduce the safety concern and/or restore sealing capacity.
2. The noted window sashes were observed disconnected from the balance. The sash balances are the devices that assists in lifting the weight of the sash and holds the sash in the up position. Window sashes are equipped with one on each side. Suggest caution when lifting the window as property damage and/or personal injury can result from the falling sash. Recommend repair to reduce the concerns.
3. Most basement windows were observed stuck shut due to paint and/or lack of use, plus from the wall framing restricting the windows from opening. This creates a safety concern as it can impede an emergency exit. Suggest repair to restore normal use and to restore normal use.

1.6 Item 4(Picture) Additional View of the Balance

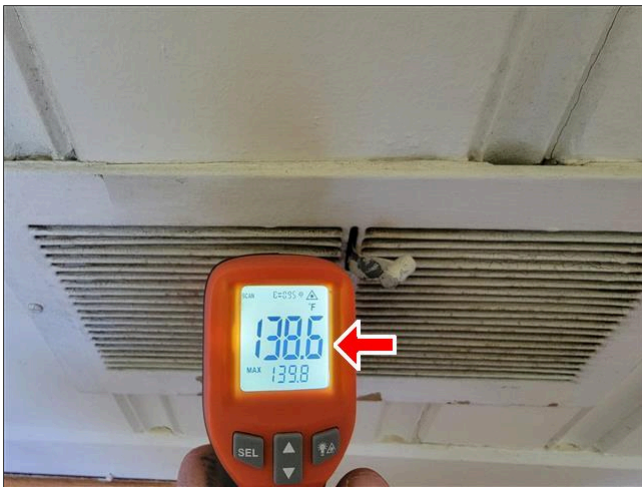
The heating system functioned as intended and produced adequate temperatures. A picture has been provided for reference.

2.1 Item 1(Picture) 138.6 Degrees (Gas Heat)

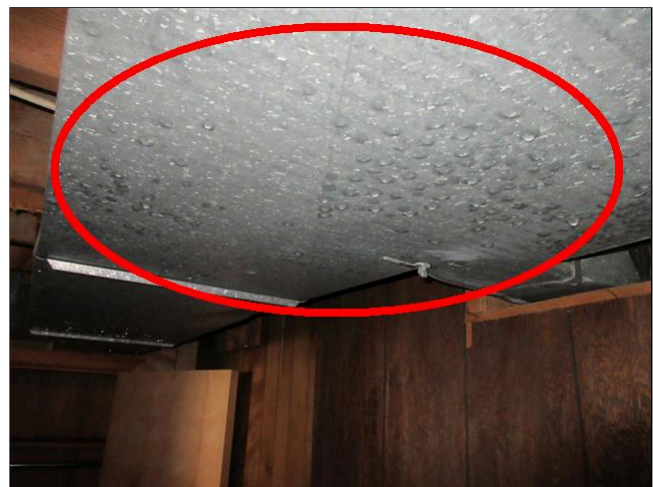
(1) The ducting was condensing in the basement thus allowing condensation to form and drip on the floor, and the ceiling materials. Suggest consulting with a qualified contractor on ways to reduce condensation as this can keep the basement damp.

2.3 Item 2(Picture) Additional View

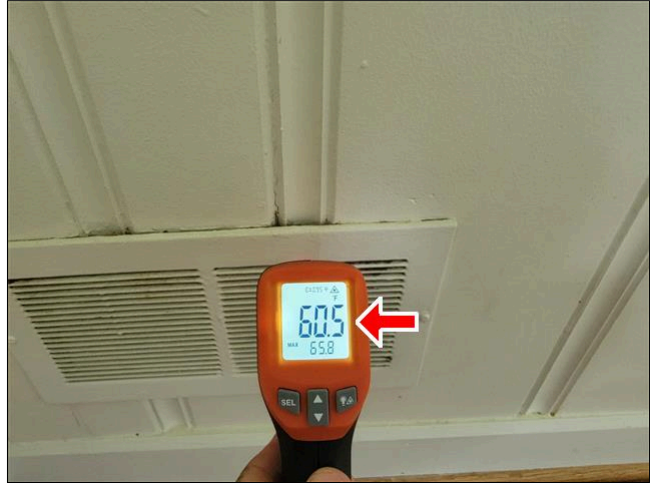
The cooling system functioned as intended and produced adequate temperature differentials. Pictures have been provided for reference.

2.10 Item 2(Picture) 60.5 Degrees (Return Temperature)

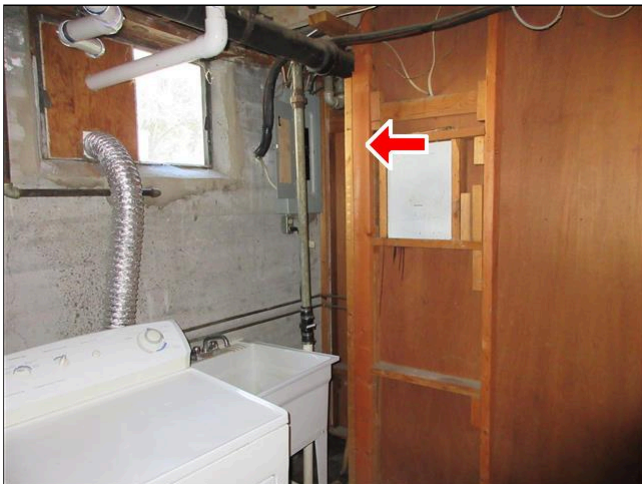
- 🔍 (2) Although the cover was removed, access/visibility to the service panel was restricted. At least a 3' clearance in front of the panel and a 30" wide working space in front of the panel is required for safe removal and access.

4.2 Item 2(Picture) Restricted Access

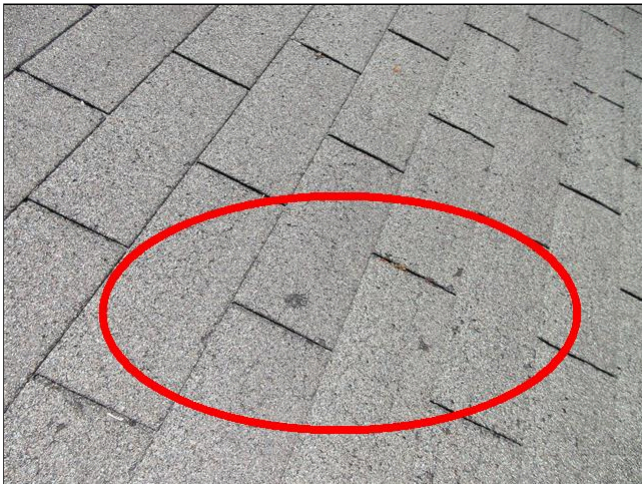
8.0 Item 3(Picture) Potential Hail Impact (Multiple Locations)

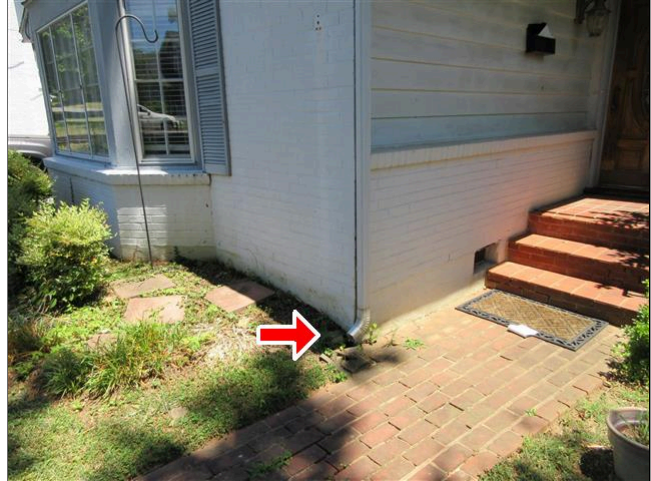
Although the guttering was observed intact and complete, a section appeared to be improperly sloped, areas were clogged with debris, and a downspout was discharging directly at the foundation. Excessive slope and debris will cause water to pile up at the lowest point and overflow. Downspouts should discharge water 4'-6' away from the foundation. Due to the lack of rain during the inspection, gutter functionality was not determined. Suggest adjusting gutters to drain properly, clearing debris, installing downspout leaders, and monitoring gutter function during a moderate rain event to identify if any additional sections need slope adjustments.

8.3 Item 2(Picture) Discharge
