# Pre-Listing Inspection Report

**Property Address:**  
502 N Market Street  
Salem VA 24153

**Bateman Home Inspections, LLC**

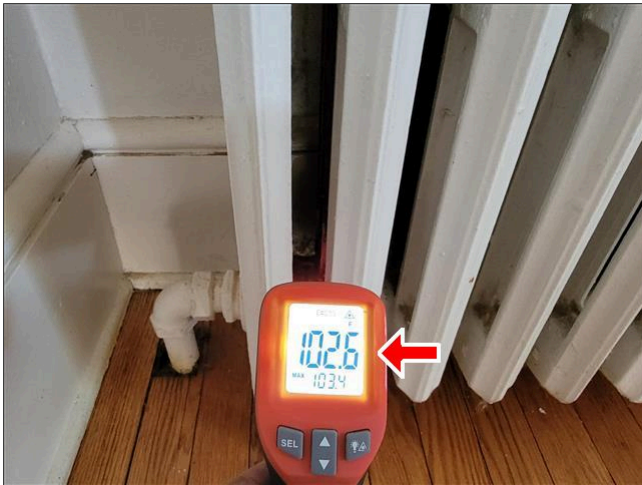
The heating system functioned as intended and produced adequate temperatures at each radiator. A picture has been provided for reference.

2.1 Item 1(Picture) 102.6 Degrees and Rising (All Radiators)

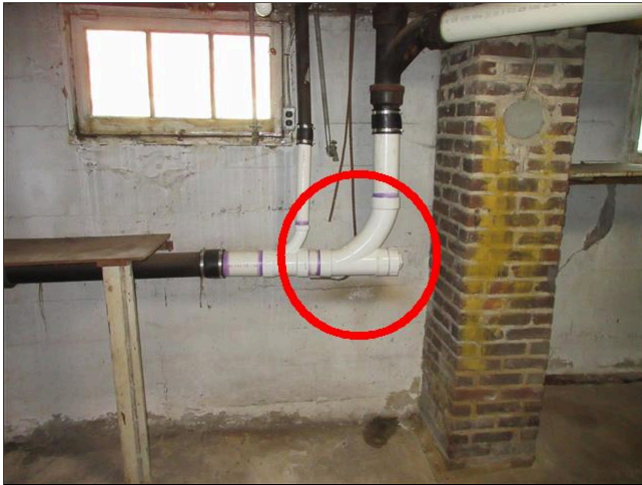
3.0 Item 5(Picture) Support Strap and Sagging Line

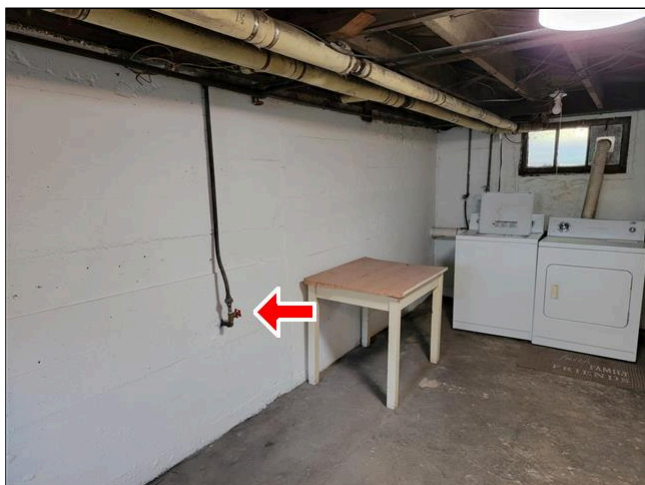
3.6 Item 1(Picture) Main Valve

The main water shut-off valve is located in the basement on the front wall.

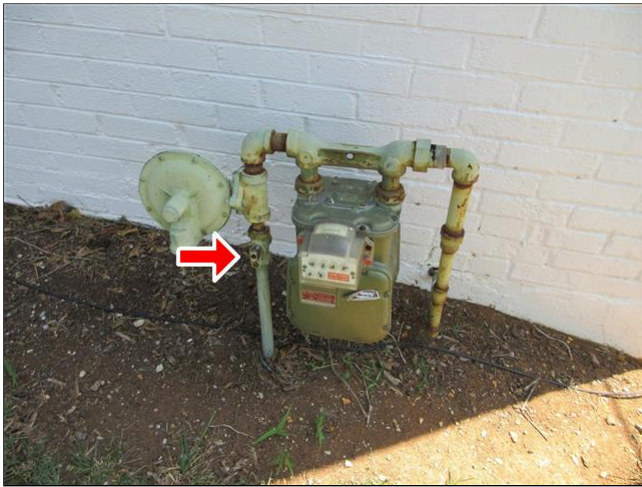
3.7 Item 1(Picture) Main Valve

The main fuel shut off is located on the gas meter outside.
